VALLANCE COTTAGE ALEXANDRA

Conservation Plan

July 2016

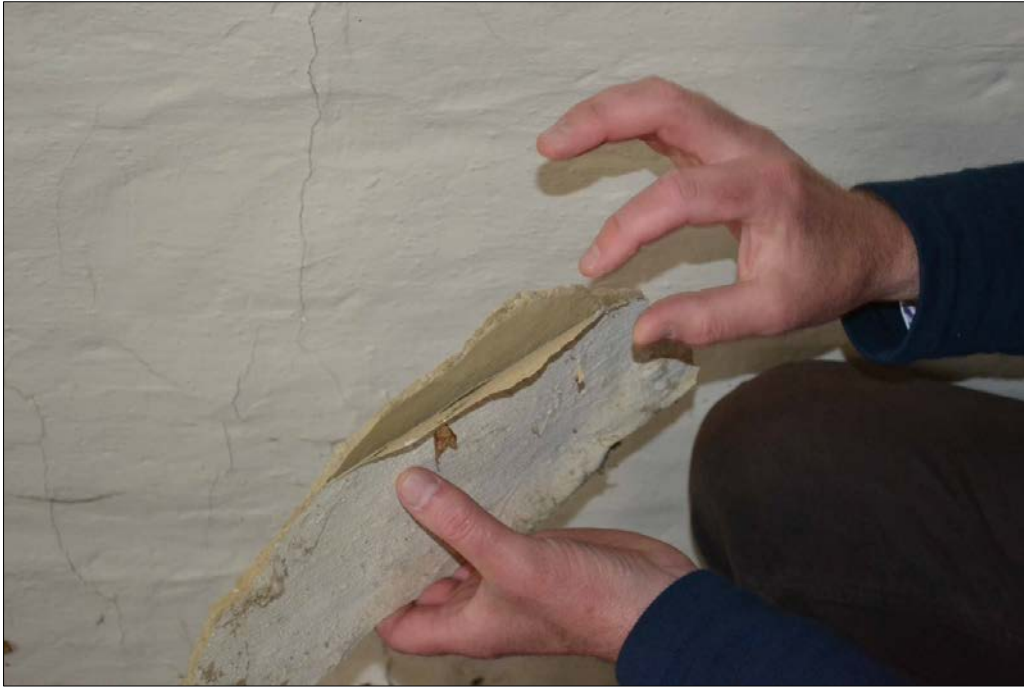
Figure 18: A detached section of painted, earth plaster skim to one of the internal walls. *Photograph: Origin Consultants*

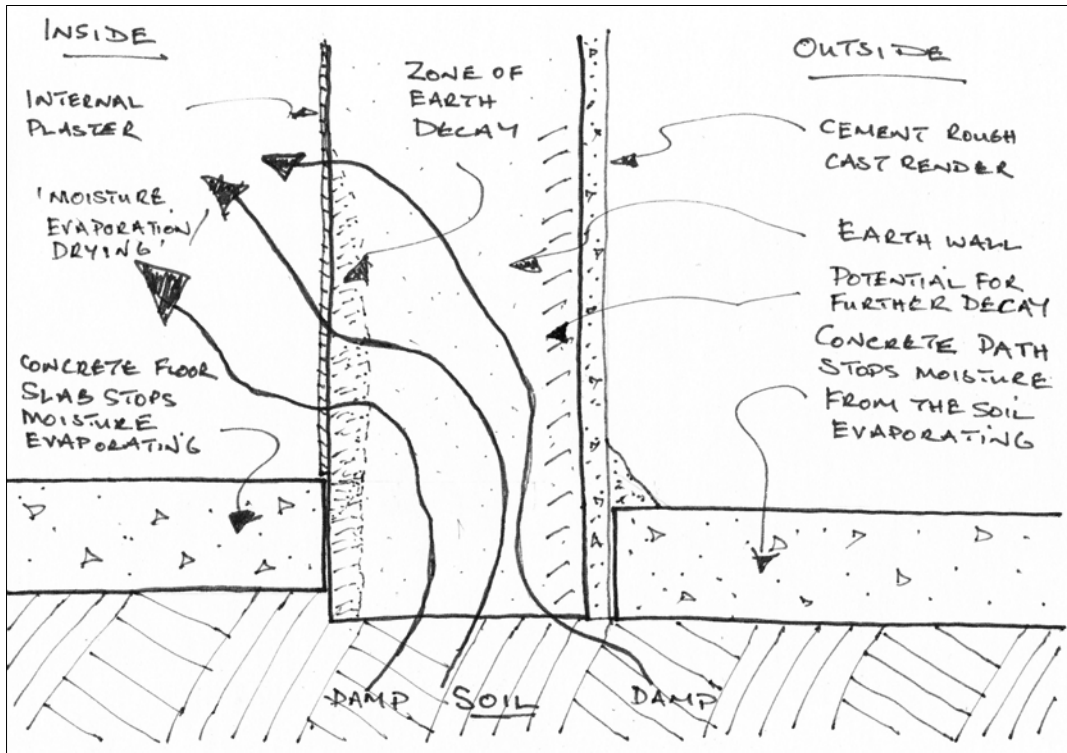
Figure 22: Sketch showing how earth walls can act as a wick for ground moisture trapped by concrete paths and slabs. Moisture is drawn to the inside of the earth wall where it evaporates depositing natural salts, which then crystallise. A further zone of potential earth decay is behind the external cement rough cast render. This is hidden from view, but again causes the earth to deteriorate and the render to become hollow and off-key.

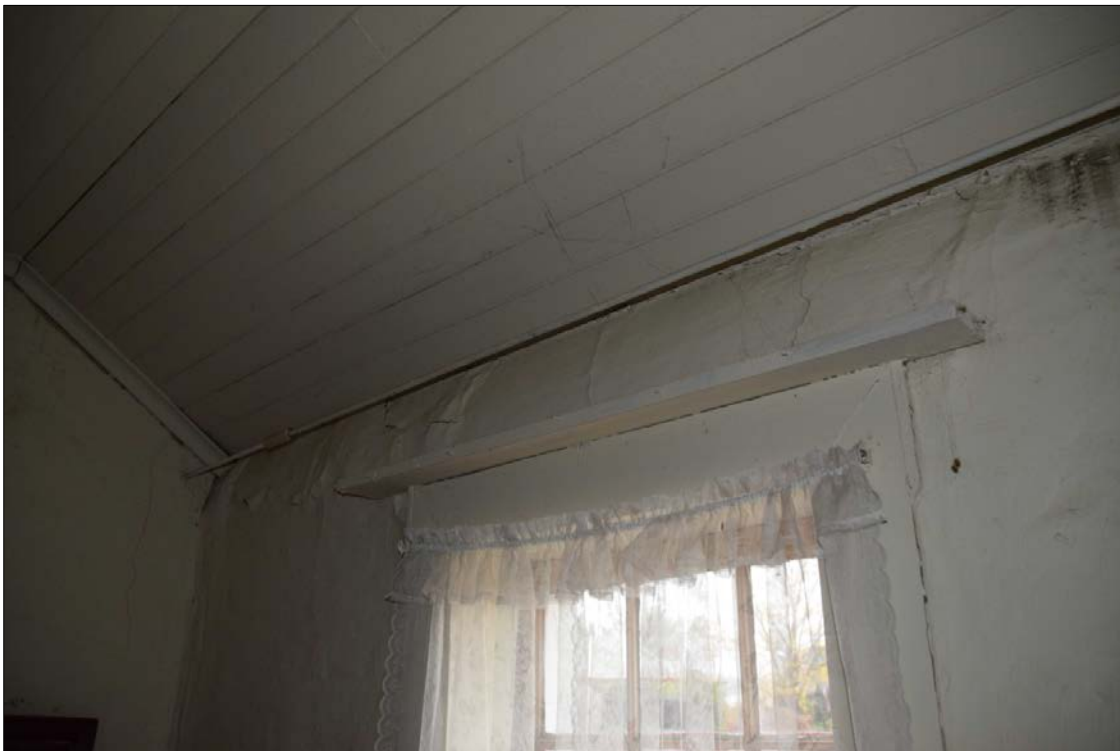
Figure 23: The head of the front wall with cracking and signs of water ingress. Photograph: Origin Consultants

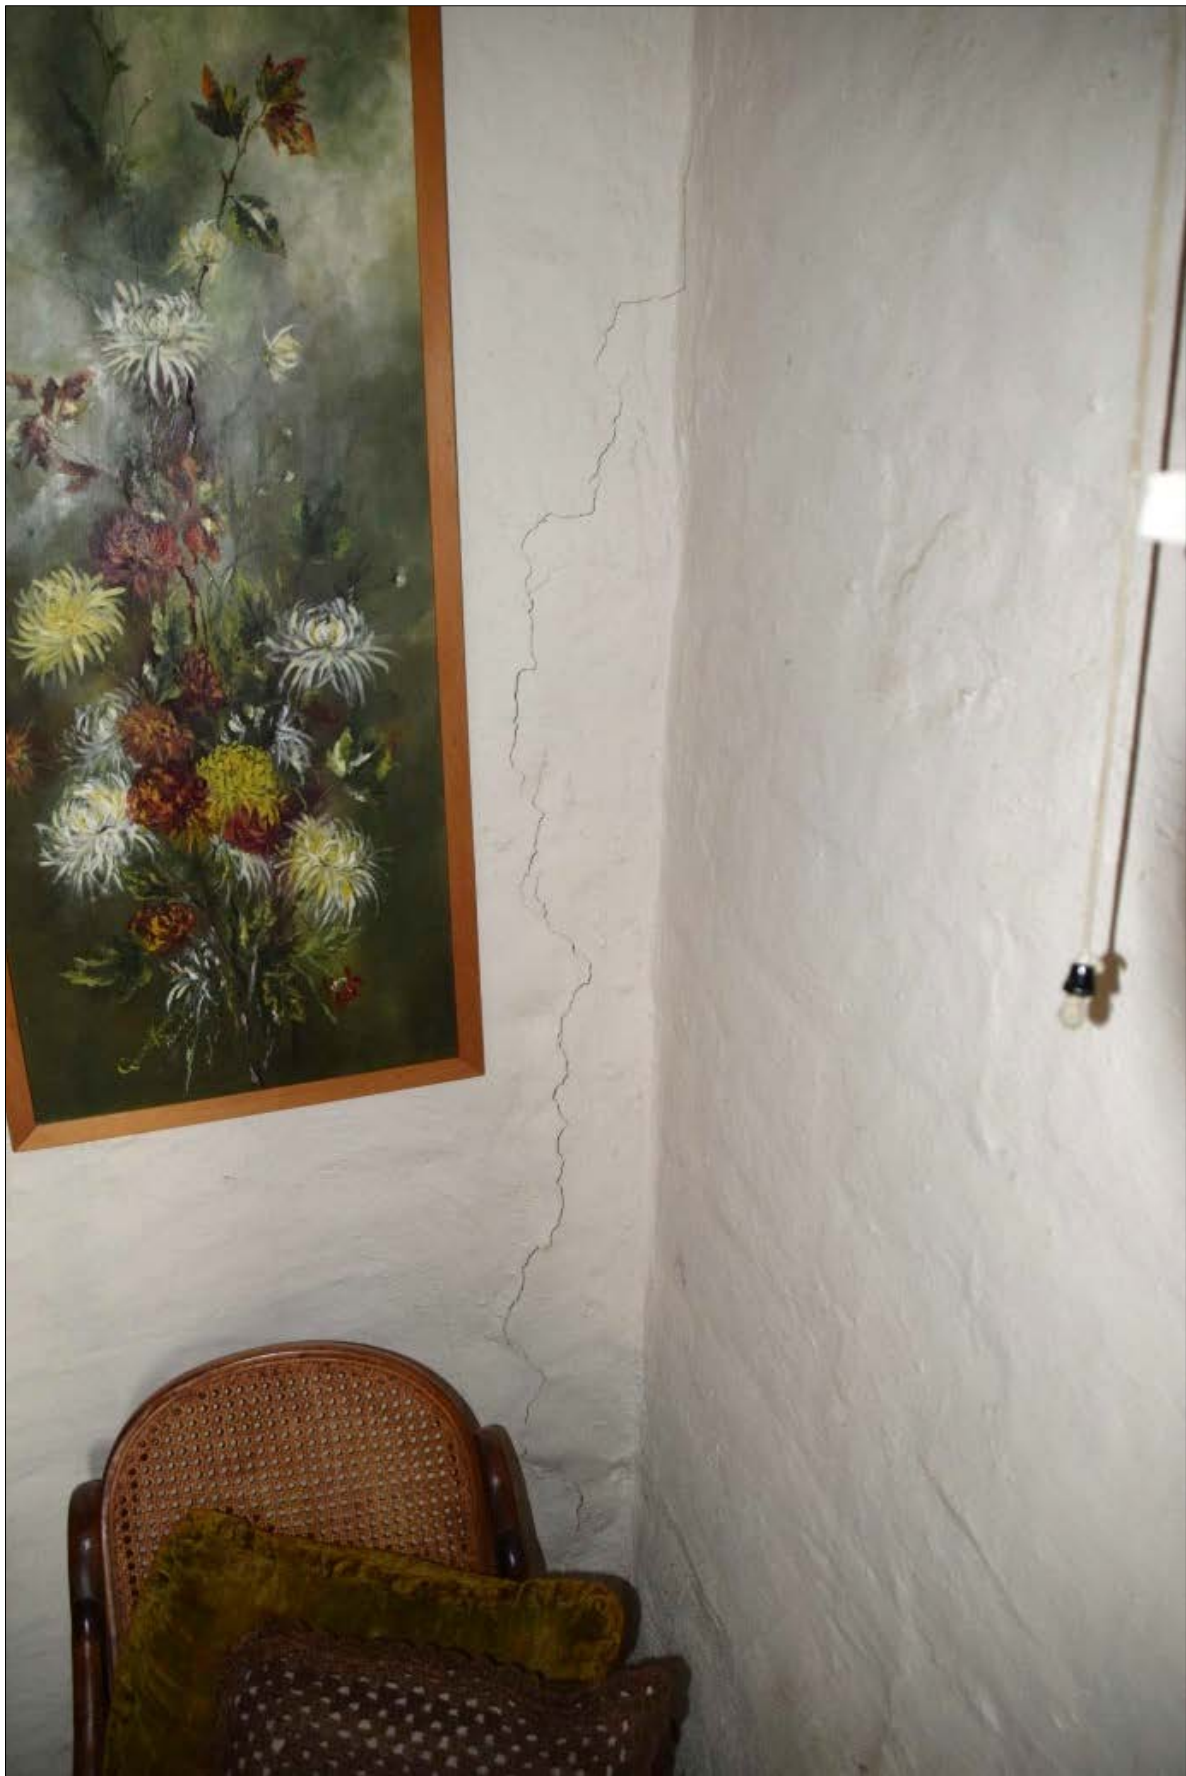
Figure 24: Cracking in the southwest corner of room 2. *Photograph: Origin Consultants*

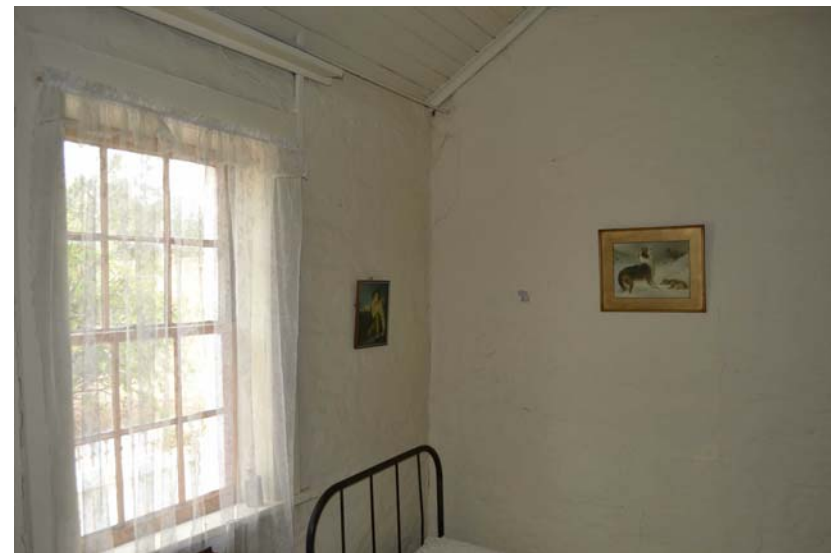
2. Room 1 showing cracking to the wall junction.

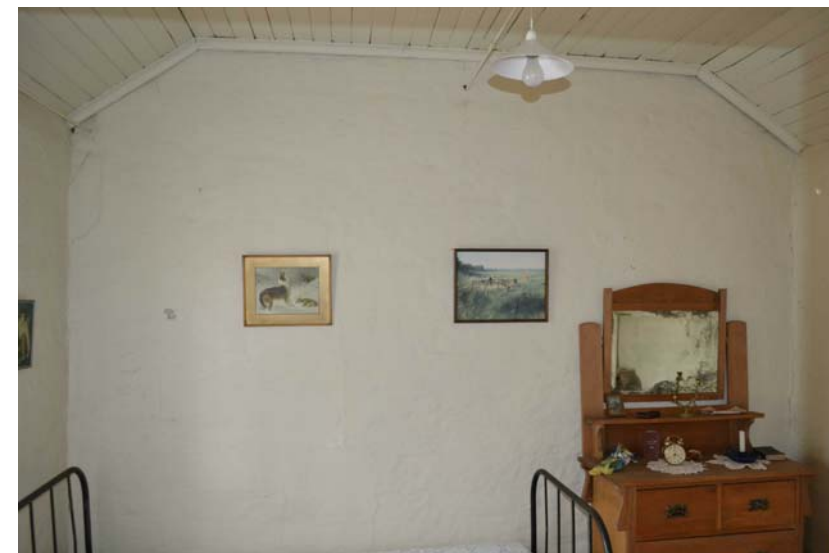
3. Room 1 showing the T&G ceiling and rods at high level. There is cracking in the walls at both corner junctions.

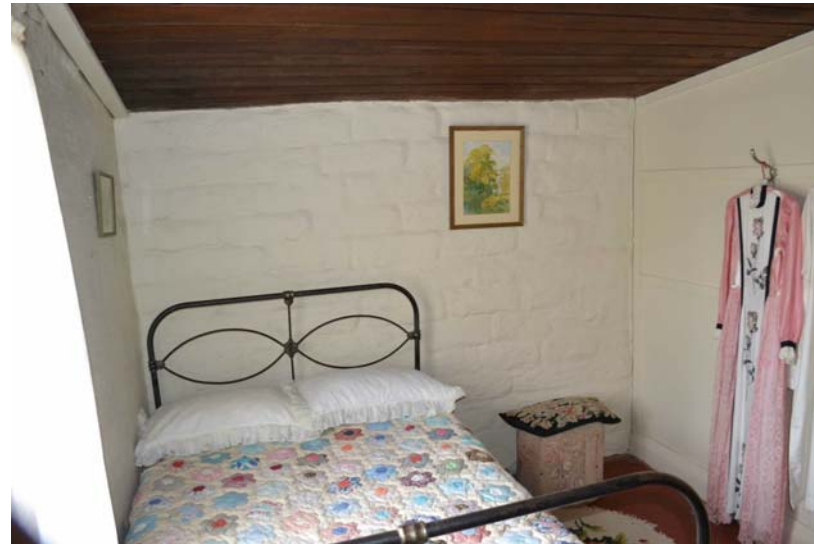
2. Room 3 with unplastered painted mudbrick wall at the rear of the room, there is significant decay at the base of the wall.

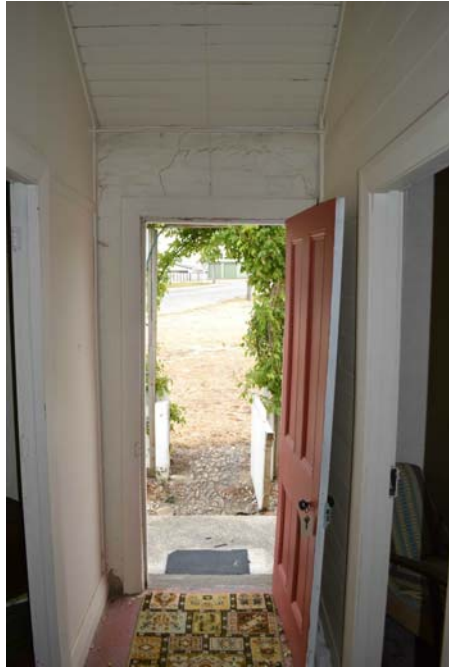
1. Room 5 front door with no threshold and cracks above the door.

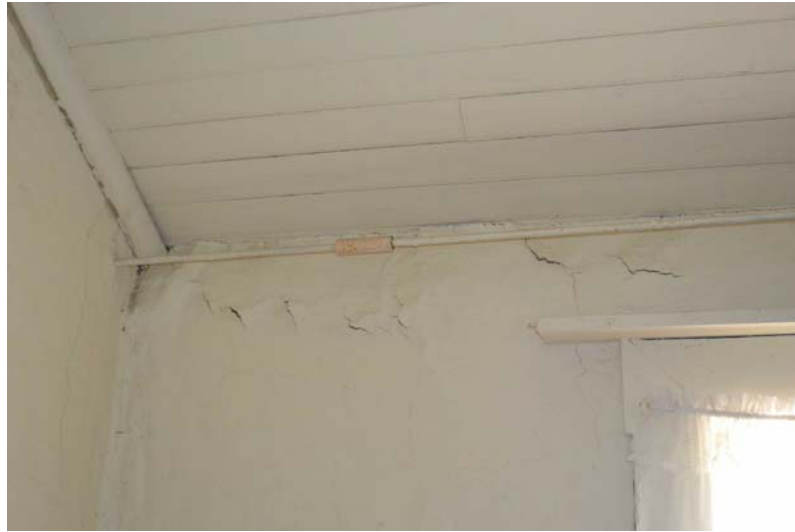
1. Room 1 water damage and movement in the wall head at eave level.

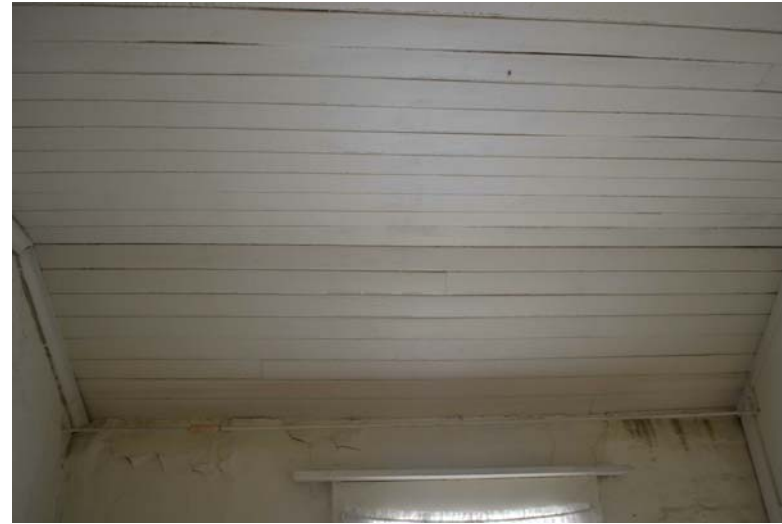
2. Room 1 Water damage and movement of wall at eave level and sagging to some T&G ceiling boards.

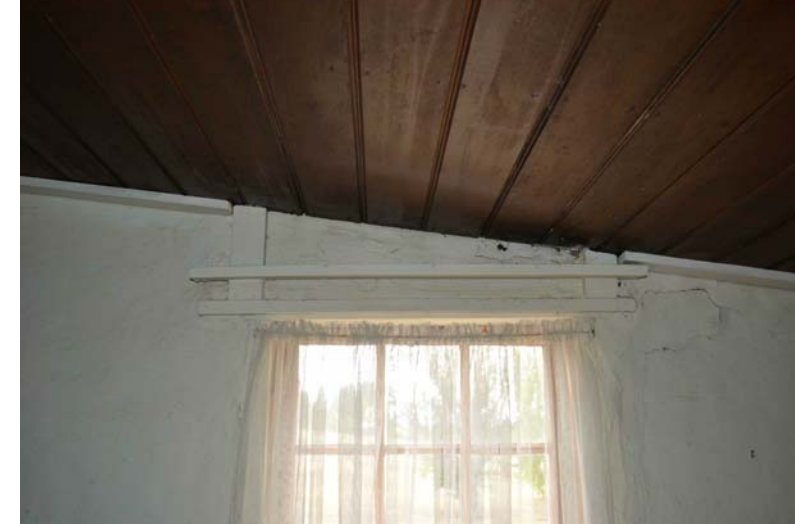
3. Room 3 Cracking to walls around window, missing architrave.

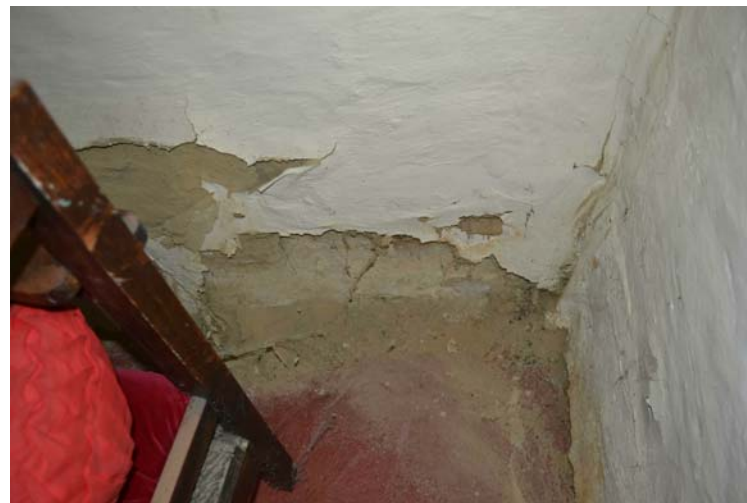
4. Room 3 decay in the base of the earth wall with plaster broken off and wall disintegrating.

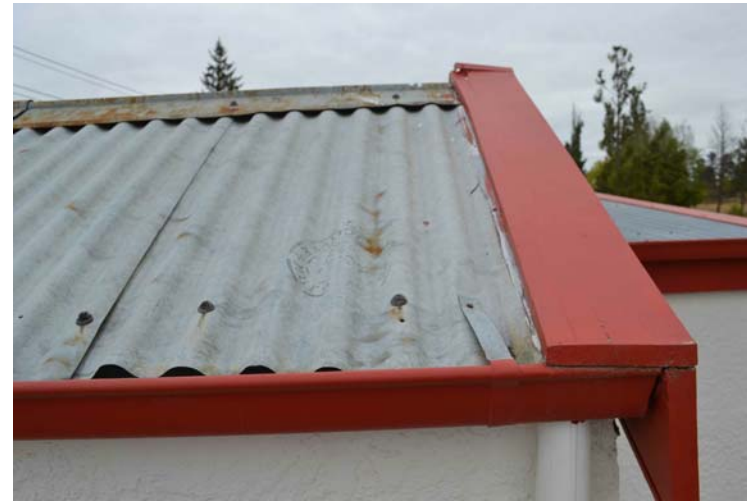
5. Roofing over Room 6 with raised nail heads.
