# CLYDE MUSEUM BRIAR HERB FACTORY, CLYDE

Conservation Plan  
August 2018

Commissioned by Central Otago District Council

Prepared by Dr Andrea Farminer MCIFA & Robin  
Miller MNZIBS MRICS

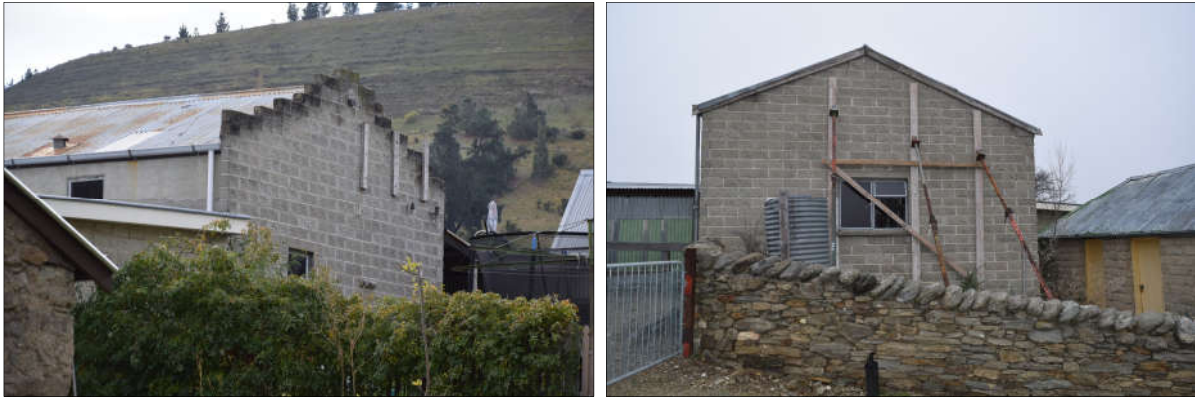
*Figure 11: The Briar Herb Factory building (F) east elevation (left) and west elevation (right) with modern propping in place.*

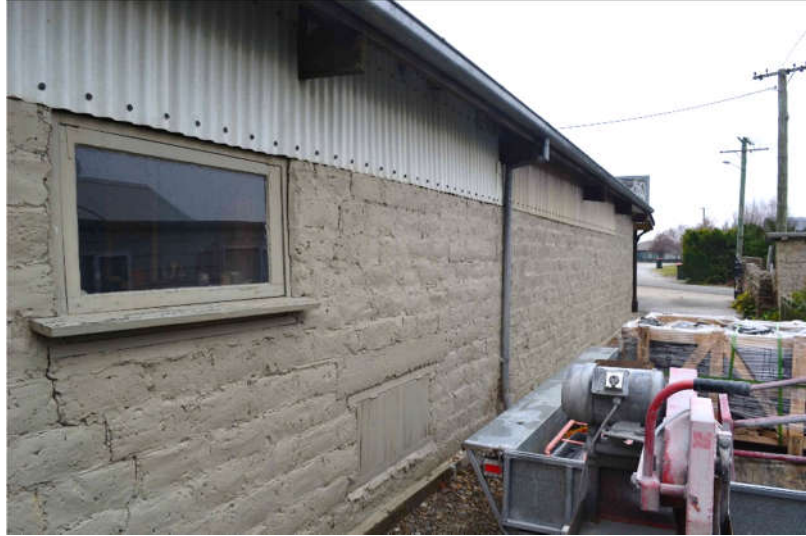
Part of the mud brick south wall with timber and fiberglass upper wall.

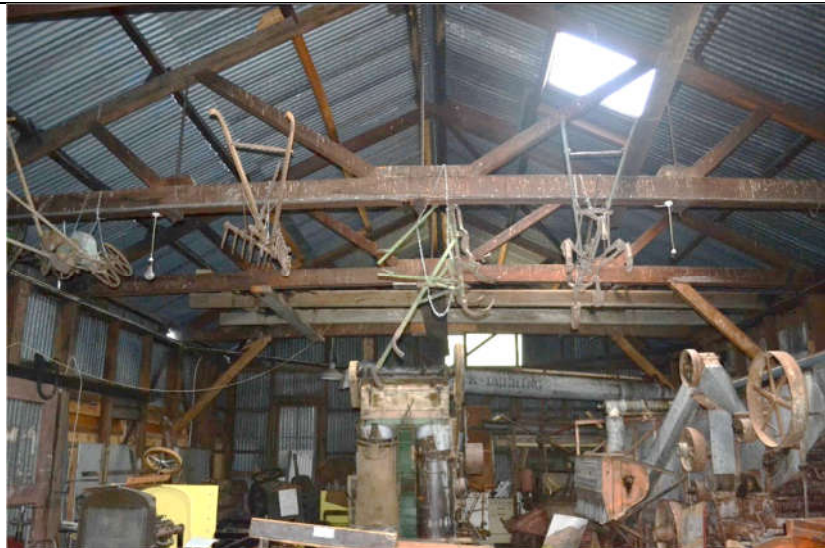
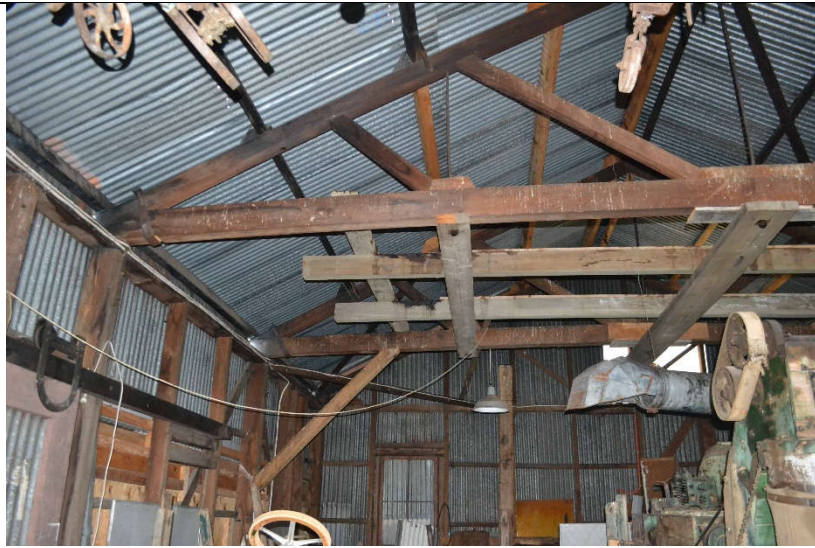
The trussed roof frame of the Shed – the bottom chords appear to deflect

Missing strut and slack steel tie to the bottom chord in the foreground

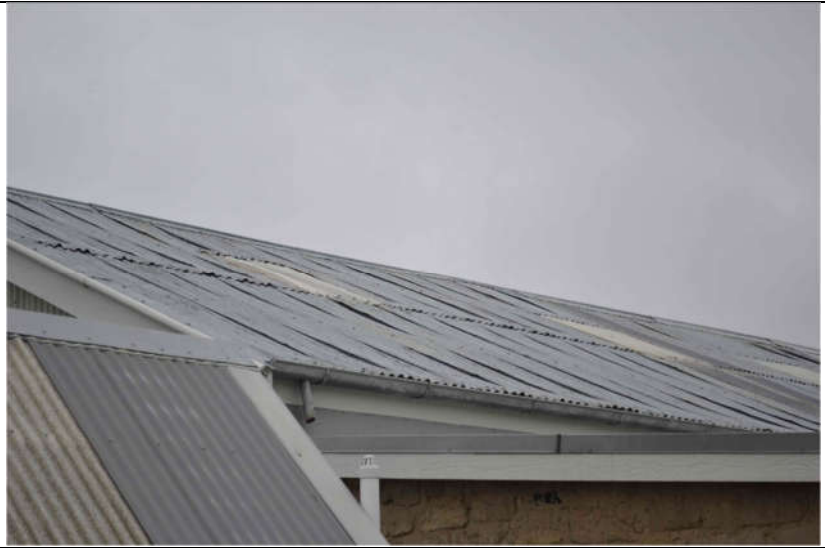
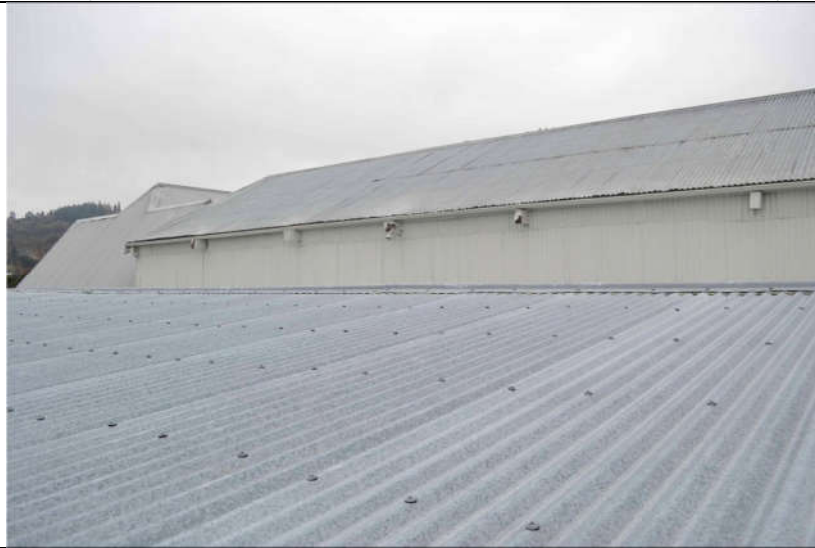
Lifting of roofing sheets to the north slope

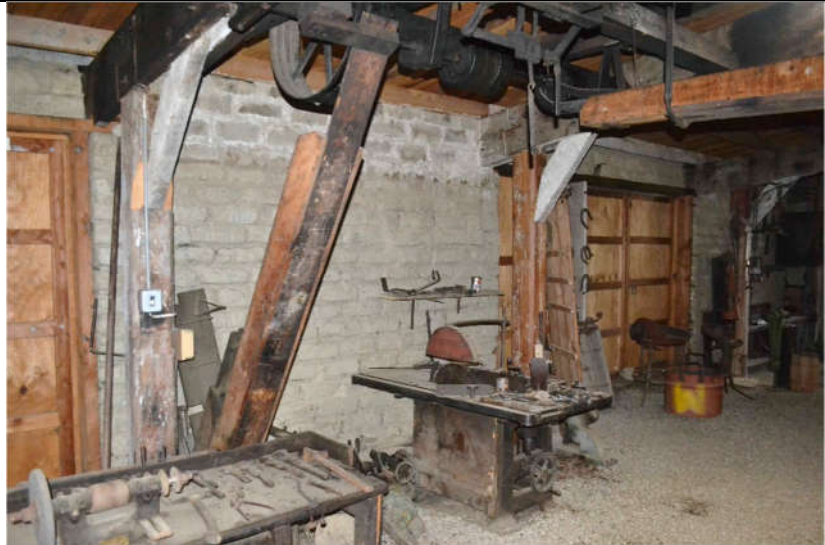
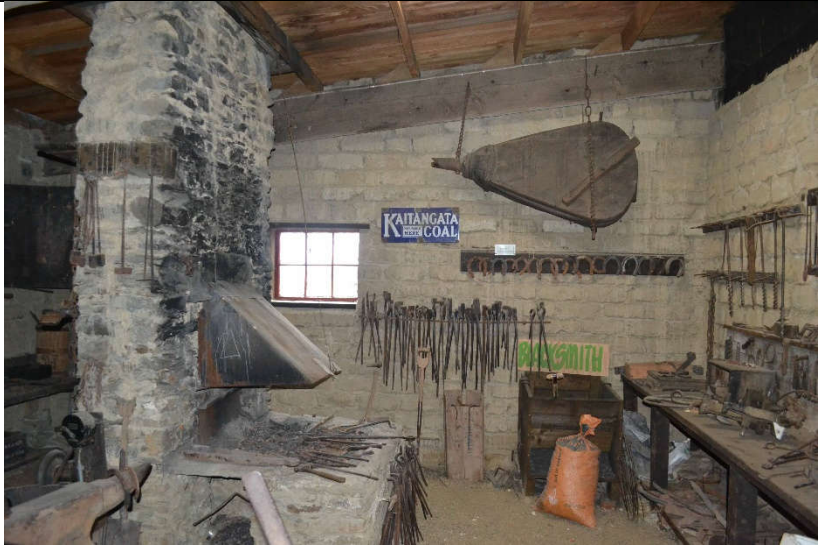
Outward deflection at base of wall

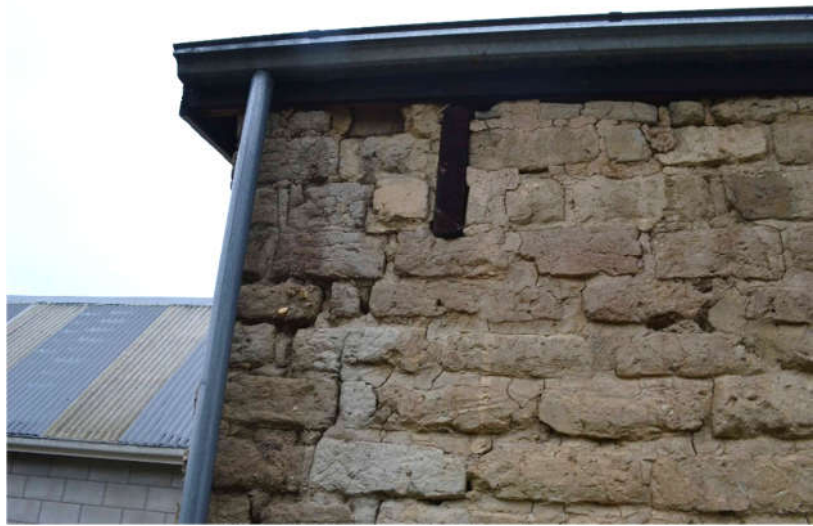
Cracking and loss of mortar in mud brick wall

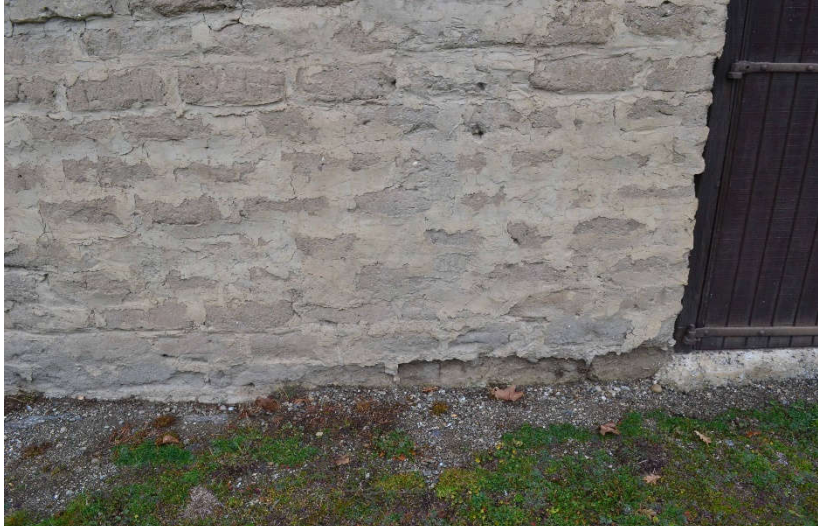
Poor repointing and mud brick decay near foundation

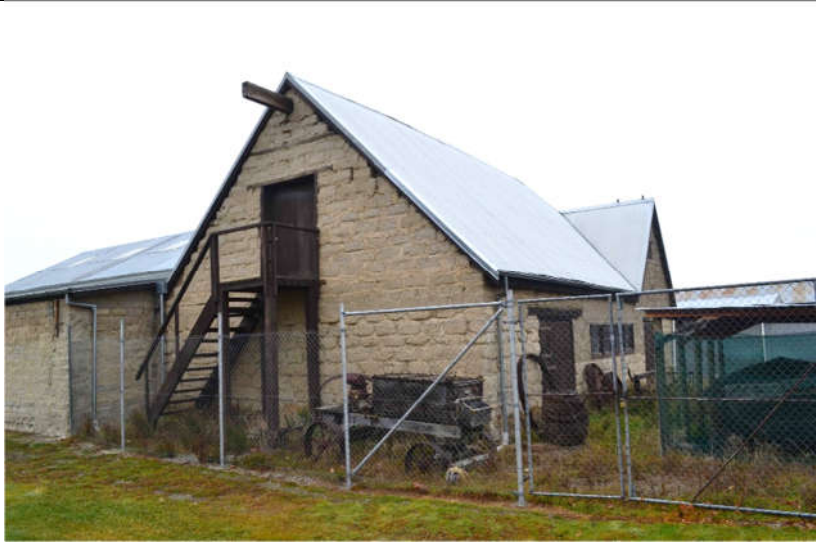
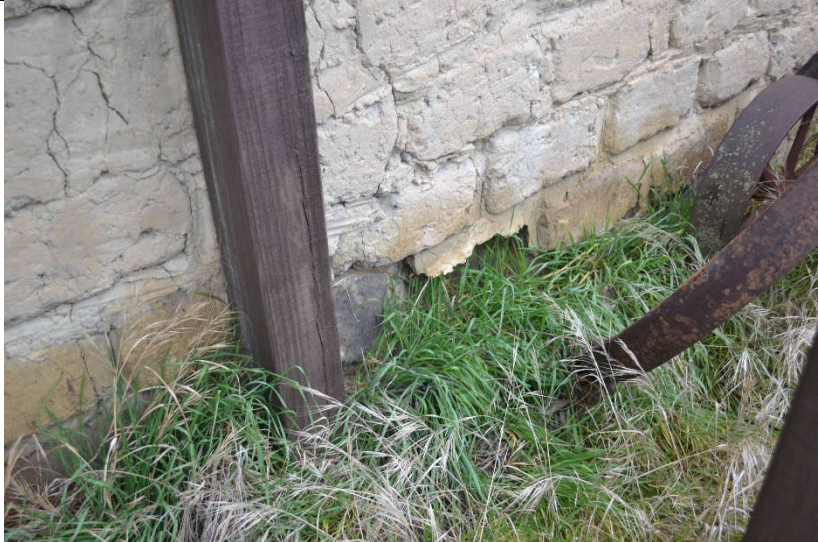
Defective mud bricks and stairs to the north elevation

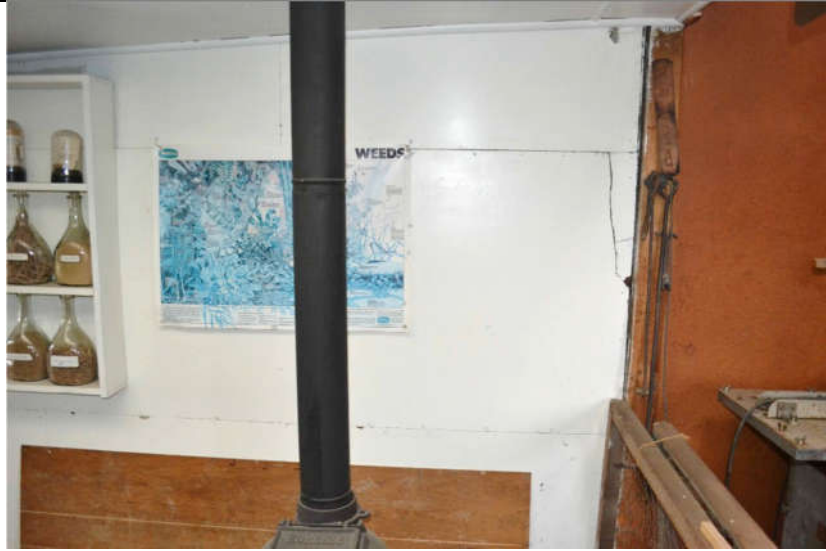
Building G – some internal linings may contain asbestos fibres
