Review of existing conservation plans for the Clyde Museums Feasibility Study Project

Clyde Railway Station,

Prepared by Robin Miller MNZIBS MRICS

Building: Clyde Railway Station

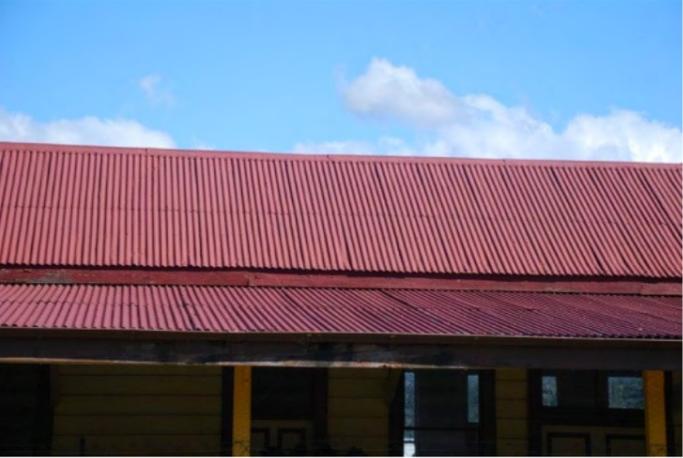
<ul style="list-style-type: none"> • Generally, the roofing sheets are in good condition. There are a few areas where the sheeting is uneven or dented, but no significant signs of water ingress were evident within the roof void. • There are a number of areas where the sheet is lifting and some of the nails are raised or missing. Early maintenance is required to replace these and ensure the covering remains wind and waterproof. • The decorative paint finish to the roofing sheets is peeling and needs renewal. • Flashings to the central chimney stack appeared to be in reasonable condition and there was no sign of water ingress around this stack in the roof void. • In places there is little overhang to the roofing sheets at the eaves. • The timber fascia board is heavily weathered in places and requires maintenance/re-decoration. It has previously been patched. 	<p>A</p> <p>B</p> <p>B</p>

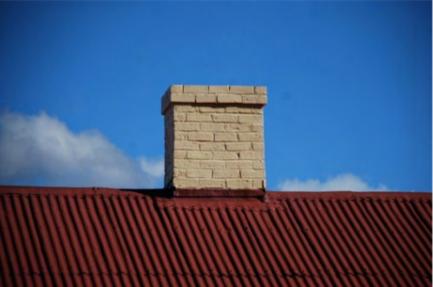
<ul style="list-style-type: none"> • The brickwork is in good condition. The durability of the mortar could not be checked above roof level, but mortar joints appear to be in good condition. The stack has previously been painted, although this is not thought to be original. Painting of brickwork with modern masonry paints is generally not recommended. • It should be checked whether the stack has been capped and the flue should be ventilated. No capping was evident from ground level. Old photographs show that the stack originally had at least one chimney pot and consideration should be given to 	<p>B</p>

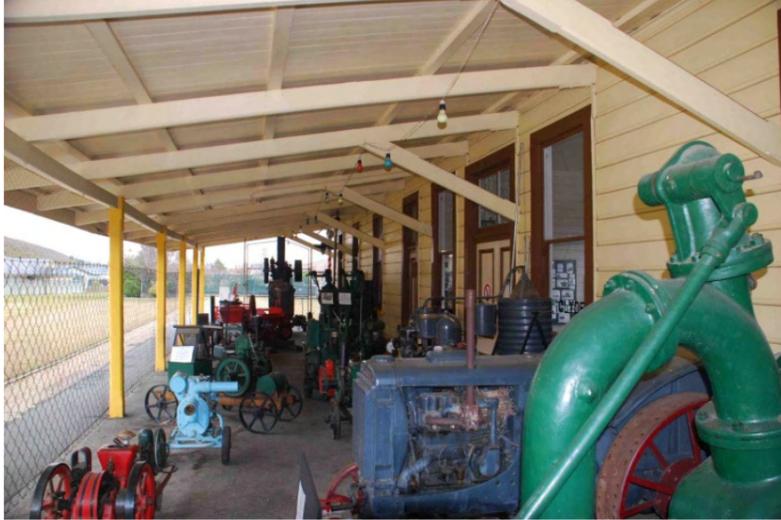
<ul style="list-style-type: none"> Generally the cladding is in good condition and there are no signs of significant movement or distortion in the wall/framing. The level of the platform encroaches on the thresholds to the doors in this elevation. As the platform is covered, this does not seem to be causing decay or weakness in the thresholds or weatherboards with the exception of the ends of the elevation. Here water discharges from the main roof eaves as there is no guttering (see above). The framing, subfloor timbers and piles abut the platform and at the ends of the elevation, there is the risk that water is running back into the building and subfloor area. The timbers in these areas are concealed from view and their condition needs to be checked when the gable end weatherboards/baseboards are repaired. 	<p>A - investigate</p>

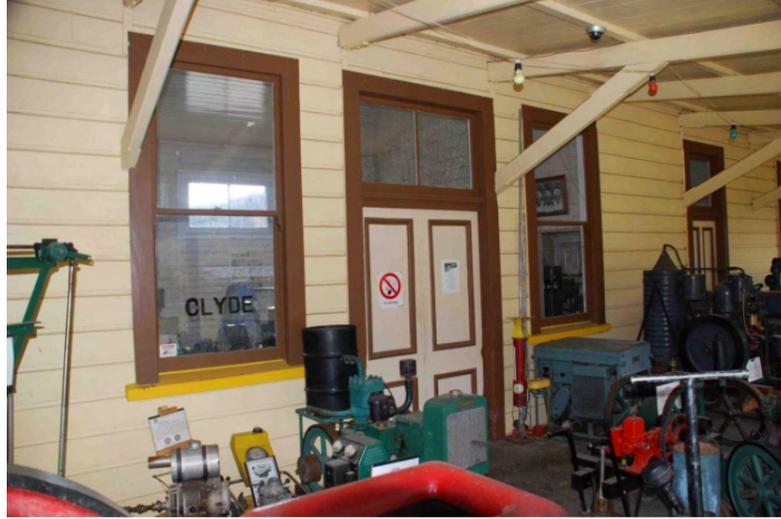
<ul style="list-style-type: none"> The windows and doors have been protected from the weather by the canopy and are generally in good condition. Both panes to the sash window on the west side of the doors onto the platform are cracked and need repair or replacement (to include recreation of the name painted on the lower sash). The bottom of the louvered vent to the breezeway has had the louvres removed and a pane of glass inserted, presumably to light the passage now that the roof light has been removed and roofed over. The vent could be reinstated if the roof light is put back into use. 	<p>B C</p>

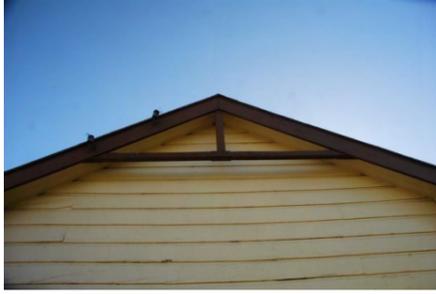
<ul style="list-style-type: none"> • The bargeboards and vergeboards that cover the end of the roof are heavily weathered and the fixings need to be checked. The end of the north vergeboard in particular has decayed and split. • The feet of the bargeboards have warped and the north foot is decayed. • Generally, repair/maintenance is needed to the joinery, together with redecoration. 	<p>A</p> <p>A</p> <p>B</p>

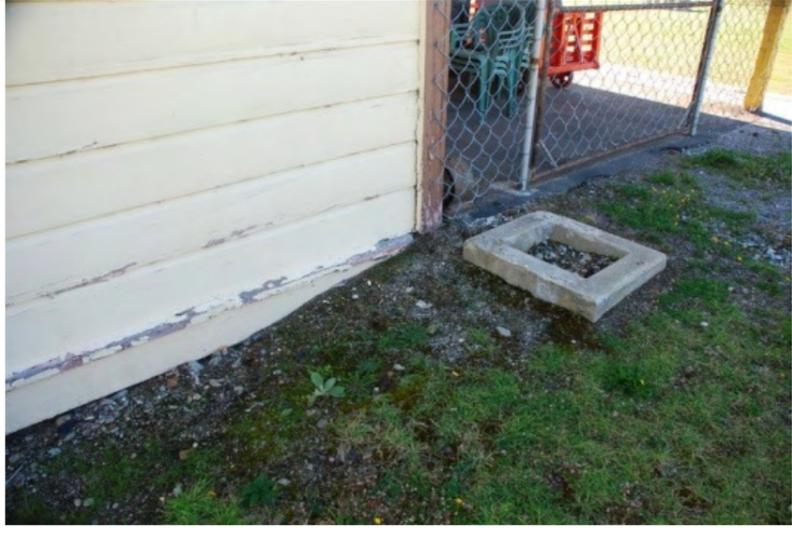
<ul style="list-style-type: none"> • Within the roof void, the gable framing is in good condition. At the foot of the gable wall the ground level slopes up to cover the baseboard at the north end and at the south end water discharging down the wall from the gutter (downpipe missing) has caused decay in the subfloor structure and weatherboards. Without opening up of the structure, the extent of decay/damage cannot be seen, but the need for repairs to the bearers and joists is anticipated and, possibly, to some of the piles as well. • Decay is also possible in the structure on the north east corner, where there is no gutter and water discharges onto the wall and platform below. • The areas potentially affected by decay and borer should be opened up to establish the extent of the problem. • Save for the decayed areas at low level, the weatherboards are in reasonable condition, although the bottoms of the corner cover boards have warped and deteriorated and should be repaired. • Redecoration of all joinery is required. 	<p>A</p> <p>B</p> <p>B</p>

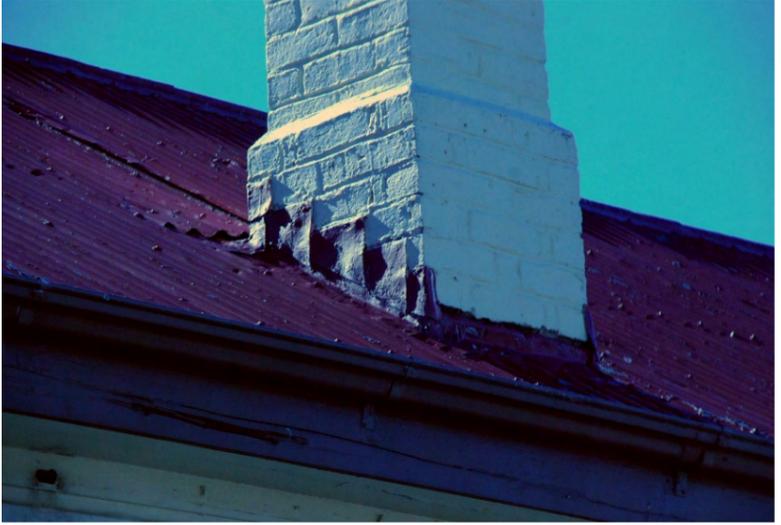
<ul style="list-style-type: none"> • Generally, the roofing sheets are in good condition. There are a few areas where the sheeting is uneven or starting to lift, but no significant signs of water ingress were evident within the roof void. • The decorative paint finish to the roofing sheets is peeling and needs renewal. Prior to redecoration, the nails should be checked at close hand and all loose, corroded or missing nails replaced. • The timber fascia board is in reasonable condition, but a section of it has split (below the stack) and should be renewed to match the existing prior to redecoration. • The flashings have started to pull away from the brickwork and there is a wide open joint at the junction with the front apron. The condition of the back gutter could not be seen. The flashings need to be examined at close hand and repaired to ensure water tightness. • The soffit boards undulate over the former entrance doors and breezeway. They need to be checked at close hand and re-affixed or repaired as necessary. 	<p>B</p> <p>B</p> <p>A/B</p> <p>B</p>

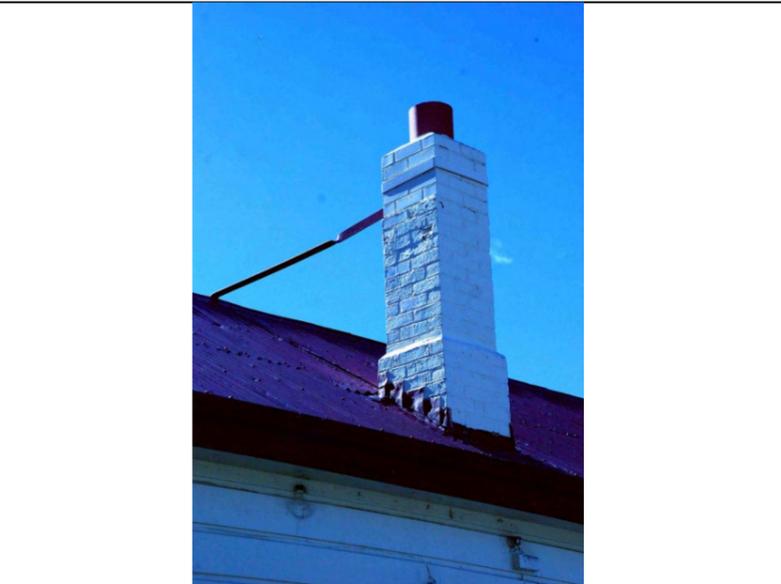
<ul style="list-style-type: none"> • The crispness of the brickwork to the top of the stack suggests that it has been partly rebuilt. In old photographs it appears to have had a projecting brick weathering course close to its top. • Below this the brickwork appears to be softer and some of the bricks seem to be eroding and to have deteriorating joints. • The older brickwork should be checked at close hand, together with the condition of the fixing of the tie to the ridge. • The stack has previously been painted, although this is not thought to be original. Painting of brickwork with modern masonry paints is generally not recommended. • It appears that the pot is open allowing rain (and possibly birds) in. It should be capped. 	<p>B</p> <p>B</p>

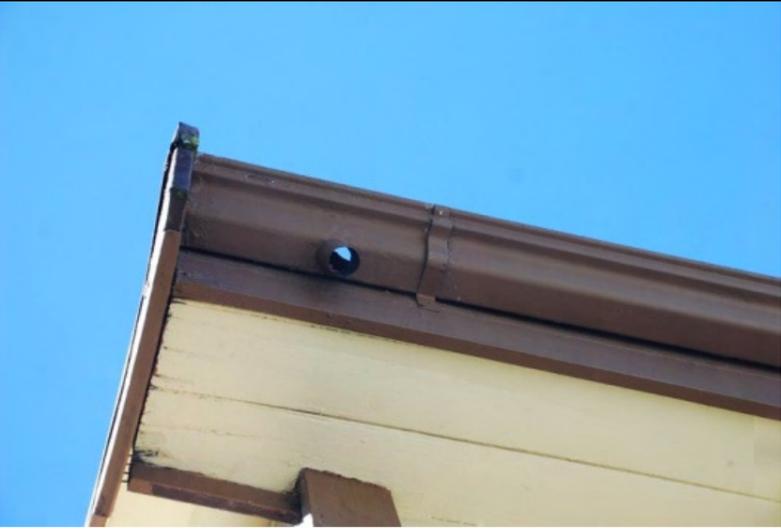
<ul style="list-style-type: none"> • Downpipes need to be fitted at either end of the gutter as water currently discharges from the gutter outlets onto the wall and ground below. This is causing potentially substantial decay in the building's structure. As part of this work, the water needs to be led away from the buildings, for example, by the construction of a proper soakaway system(s). • Staining to some joints indicate that they are corroding and leak. The condition of the back of the gutter and stopends could not be seen, but these parts of the gutter are the most vulnerable to corrosion, as are the backs of the brackets and their fixings. • As referred to later (see roof void), staining to the eaves in the roof space suggests that the back of the gutter overflows or leaks. 	<p>A</p> <p>A</p> <p>A</p>

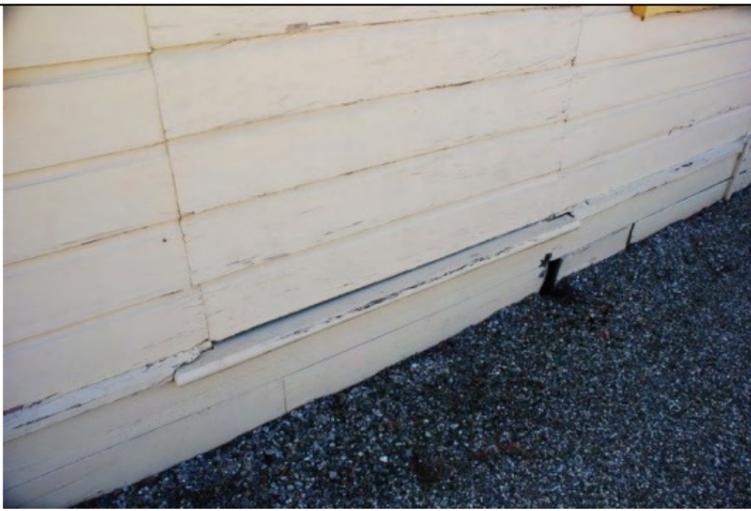
<ul style="list-style-type: none"> • The corner cover boards at the west end of the building have deteriorated where water discharges from the gutter above. There is the risk that decay extends into the structure. • The ground level along the elevation partially covers the baseboard and should be lowered and profiled to run water away from the building. • At the east end of the elevation, the baseboard and plinth seem to bow outward suggesting a problem in the floor/subfloor structure (see also east gable wall). This should be investigated. It is possible that this may also be associated with the fire that occurred at this end of the building. • Weatherboards are in reasonable condition, save for isolated areas of decay or splitting. There are signs of rodents getting in under the floors and localised repairs are needed to the baseboards. • Redecoration of all joinery is required. • The original double doors have been in-filled with similar weatherboarding, although the threshold remains. 	<p>A -investigate</p> <p>A</p> <p>A - investigate</p> <p>B</p> <p>B</p>

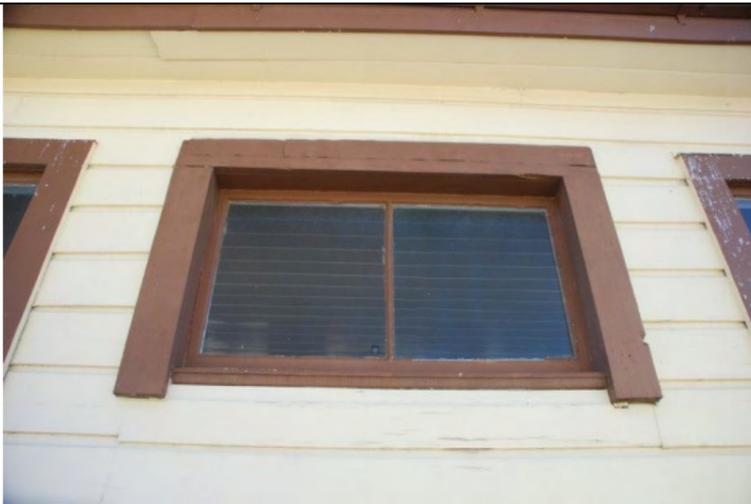
<ul style="list-style-type: none"> • The windows and fanlights are in reasonable condition, but require overhaul to maintain them and to ensure that they remain functional. Typically repairs required include: localised joinery repairs where there are pockets of decay; repair to open sash joints (particularly to the meeting rails); easing of sashes; renewal of cracked/missing putties; redecoration; and renewal of several broken sash cords. • Window/vent head flushings exist but appear to be nailed onto the weatherboards for the most part. They are likely to be ineffective and should be dressed under the board above. 	<p>B</p> <p>B</p>

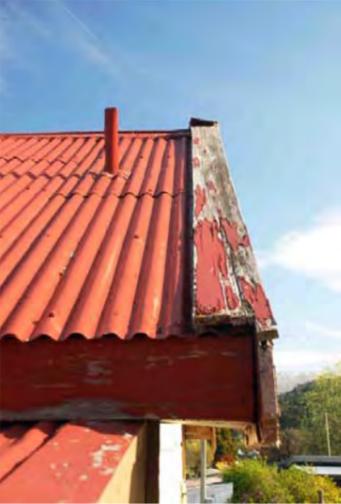
<ul style="list-style-type: none"> The bargeboards and coverboards are weathered and beginning to split/warp. The fixings need to be checked. The south board has been covered with a piece of metal trim that extends over onto the bargeboard. The north board requires renewal to match the existing. The feet of the bargeboards have warped and ends of the boxed eaves have distorted. Generally, maintenance is needed to the joinery, together with redecoration. 	<p>B</p> <p>B</p> <p>B</p>
<p>Walls</p> <p>The West gable is constructed of 4" x 2" timber studs clad with painted, rusticated boards. The foot of the gable has a timber drip with baseboards below.</p> <p>The remnants of the former electrical and telephone connections exist in the apex of the gable.</p>

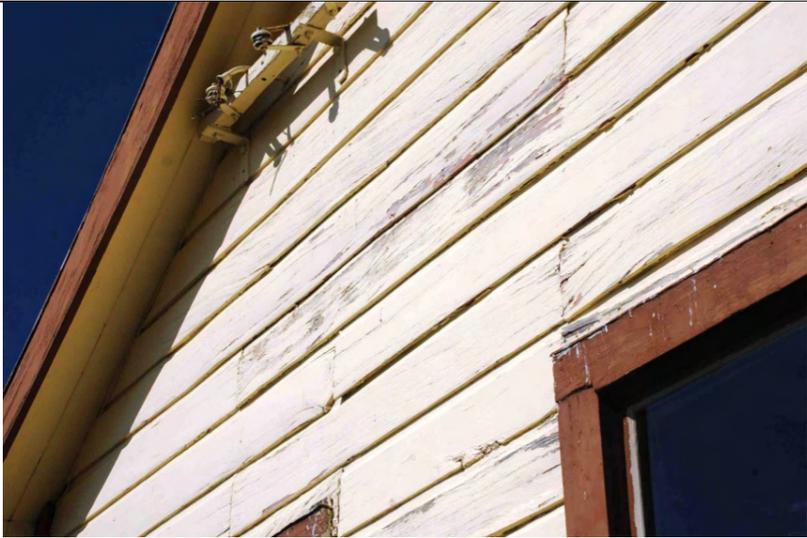
<ul style="list-style-type: none"> Within the roof void, the gable framing was found to be in good condition, but is water stained where rain drives in through gaps in the cladding. Paintwork is particularly poor here. At the foot of the gable wall the ground level slopes up to cover the baseboard at the north end and at the south end water discharging down the wall from the gutter (downpipe missing) has caused decay in the subfloor structure and weatherboards. Without opening up of the structure, the extent of decay/damage cannot be seen, but the decay seems to run the length of the gable. The need for repairs to the bearers and joists are anticipated and, possibly, to some of the piles here. Similar decay is possible in the structure on the northwest corner, where there is no gutter and water discharges onto the wall and platform below. In addition, there is an outside tap here which has been seen to be dripping on a number of occasions, so increasing the water in the soil adjacent to the wall The areas potentially affected by decay and borer should be opened up to establish the extent of the problem. The weatherboards are in fair condition, but are particular exposed to the weather on this elevation. They are generally in poorer condition than elsewhere on the building and require replacement of defective sections, together with making good to open joints and gaps. Decayed baseboards, weatherboards and the plinth above ground level will require renewal to match following framing/structural repairs. Redecoration of all joinery is required. 	<p>A/B</p> <p>A</p> <p>A</p> <p>A</p> <p>A/B</p> <p>A/B</p>

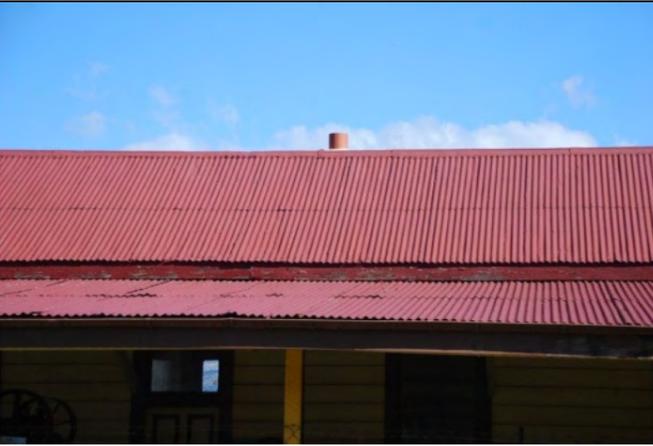
<ul style="list-style-type: none"> • Generally the roof covering is in good condition. At the time of maintenance to the main North slope, the opportunity should be taken to overhaul the Veranda covering replacing loose/missing nails and undertaking redecorations. • Decayed sections of the fascia board require renewal. • There are loose nails to the metal trim over the ends of the roof. 	<p>B/C</p> <p>B</p> <p>B</p>

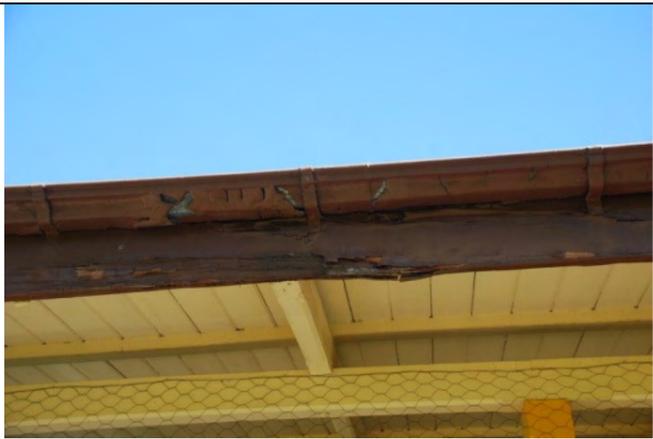
<ul style="list-style-type: none"> • The gutter requires the fitting of downpipes at either end and proper disposal of rainwater. • The gutter leaks/overflows in one or two places and this is causing decay in the eaves joinery. Repairs to defective sections are necessary. • Decorations to the gutter are peeling and require renewal. 	<p>A</p> <p>A</p> <p>B</p>
Structure	<p>The structure is relatively simple and comprises 8 chamfered, painted timber posts supporting an eaves beam, which in turn supports the feet of the principal rafters. The heads of the rafters bear into the north wall of the station building and each have a single diagonal strut. These rafters are overlaid with purlins clad with timber sarking boards and the corrugated iron sheets.</p>

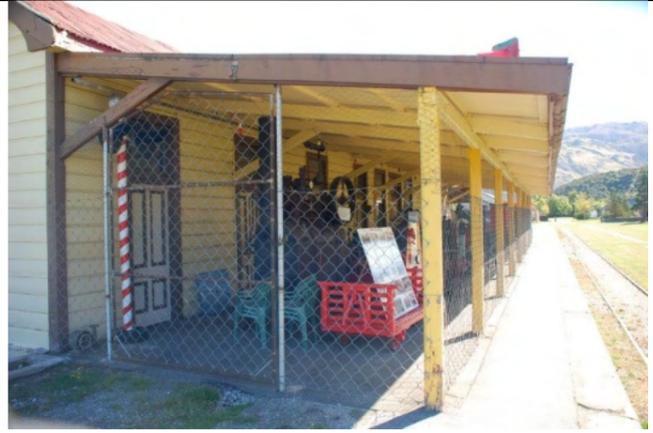
<ul style="list-style-type: none"> • The eaves beam and some of the purlins deflect between the posts, but this is considered to be longstanding. An eye should be kept on the situation and if necessary, the beam could be strengthened by the additions of steel behind. • There is decay in 3 or 4 of the posts, where their feet bear into the platform. Further decay may be found where they are concealed. The bottoms of the decayed posts will need renewal and redecoration. • The foot of the strut at the east end of the canopy looks to be decayed and may need to be renewed. • The foot of the second rafter from the east end is decayed along with a section of the fascia here. New timber needs to be scarfed in. 	<p>C</p> <p>B</p> <p>B</p> <p>B</p>

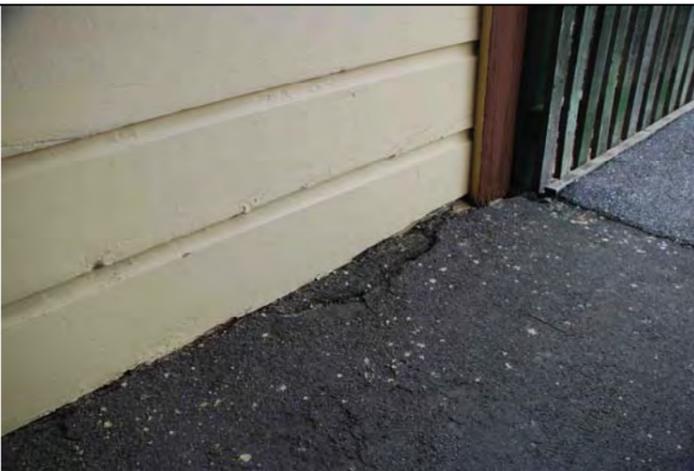
<ul style="list-style-type: none"> Generally the platform is in reasonably good condition. There are some small areas where the tarmac has cracked/slumped against the North wall and where water is likely to be trapped (see photo). 	<p>B</p>
<p>2.0 Interior rooms/areas</p>				
	<p>Please refer to the layout plan for room names and identification of particular features.</p>		<p>All the original building fabric and elements are considered to have high significance and are an important part of the buildings authenticity.</p>	
<p>2.1 Former Stationmaster's office/store</p>				
	<p>Ceiling</p> <p>Modern ceiling board lining over original timber sarking/matchlining. Moulding/fillet to junction of the walls and ceiling.</p> <p>Small manhole providing access to the station building roof void.</p> <p>Lighting is provided by a ceiling- mounted fluorescent tube striplight.</p> <p>Whilst serviceable, the modern ceiling finish is considered to have a negative impact on the room.</p>

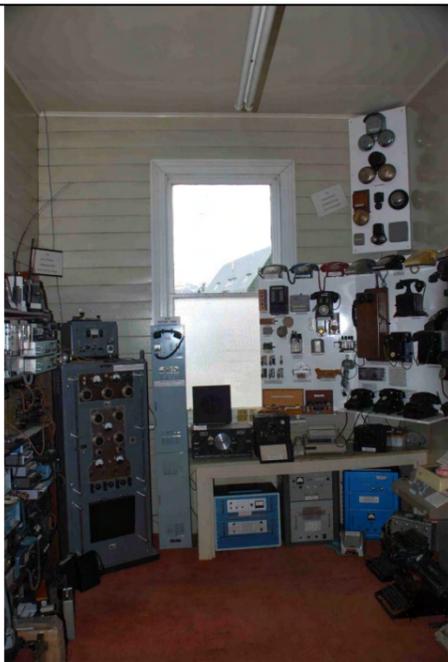
<ul style="list-style-type: none"> See also section 1.3. The window and door are in reasonable condition. The window requires overhaul, including replacement of a broken sash cord. 	<p>B</p>
<p>Floor</p> <p>The room has a suspended timber floor, which was fully carpeted and with displays around the perimeter.</p>

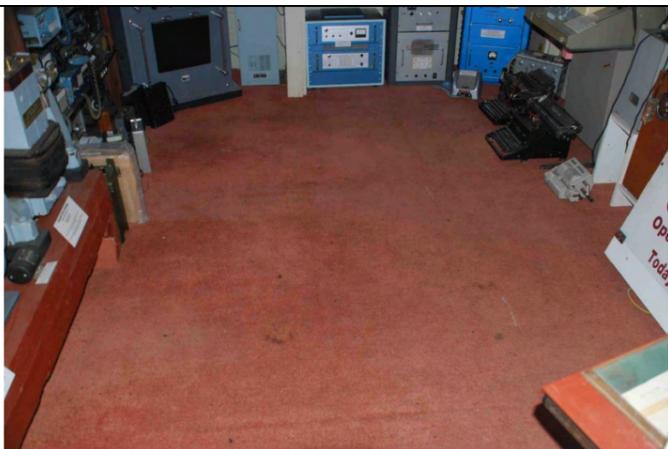
<ul style="list-style-type: none"> The floor felt firm under foot with no obvious signs of decay or failure. However, given the decay evident to the cladding and subfloor elements externally on the south east corner of the building, there is the risk that problems will be found with the floorboards and structure adjoining these areas if the carpet and exhibits are removed. Damage from the 1960's fire may be revealed. There is a similar risk to the floor in the north-east corner of the room where water has discharged from the main roof and the external ground level is built-up close to the floor. These two areas need to be checked and repaired if decay or other problems are found. 	<p>A</p>

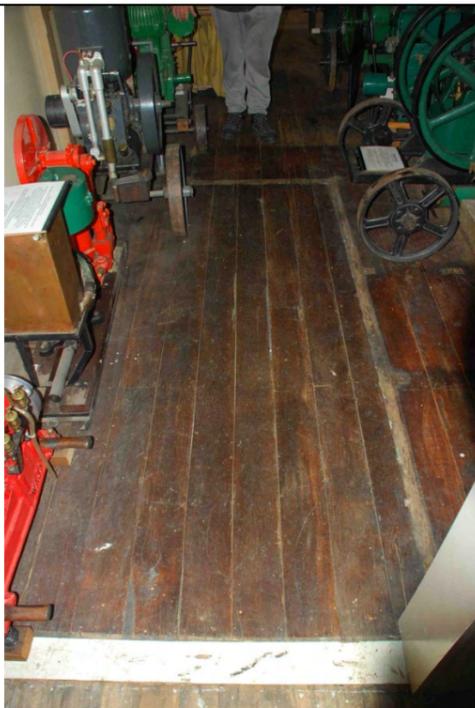
<ul style="list-style-type: none"> The floor is reasonably level and is generally in good condition, but with a number of split/damaged boards. 	
<p>Other</p> <p>The room contains a number of historic features, including a chimney breast and fireplace with cast iron fire surround and timber mantel, a large "Chubb" safe (both on the south wall) and the remains of the parcels counter on the north wall.</p>

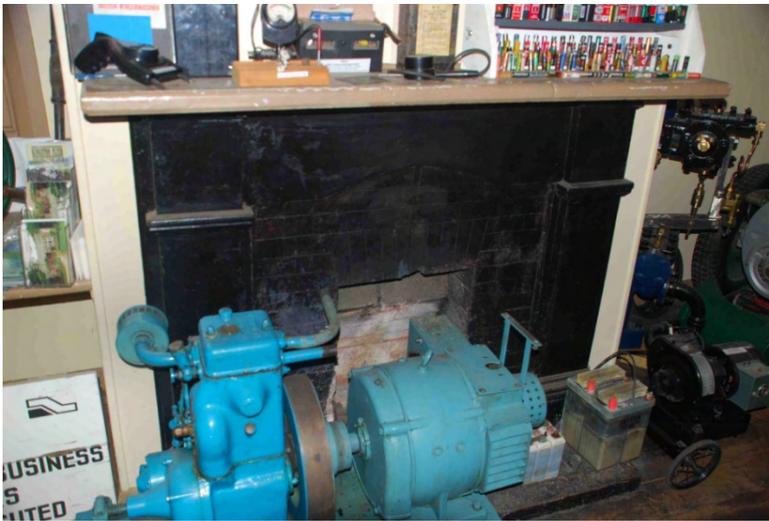
<ul style="list-style-type: none"> The basket to the fireplace is missing and it is understood that the key to the safe has been lost.

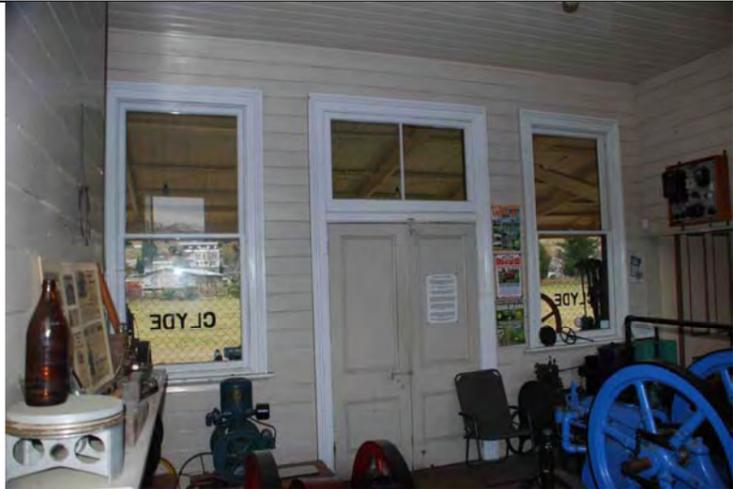
<ul style="list-style-type: none"> Two of the large panes of glass to the north wall are cracked and require repair. It may be possible to undertake glue repairs in order to retain the historic glass and original station names on the glass. If not, the cracked panes should be replaced with old, second-hand glass and the station name painted on to match the existing arrangement. Double doors to the platform are in good condition generally. The original entrance to the station could be relatively easily reinstated. 	<p>B</p>

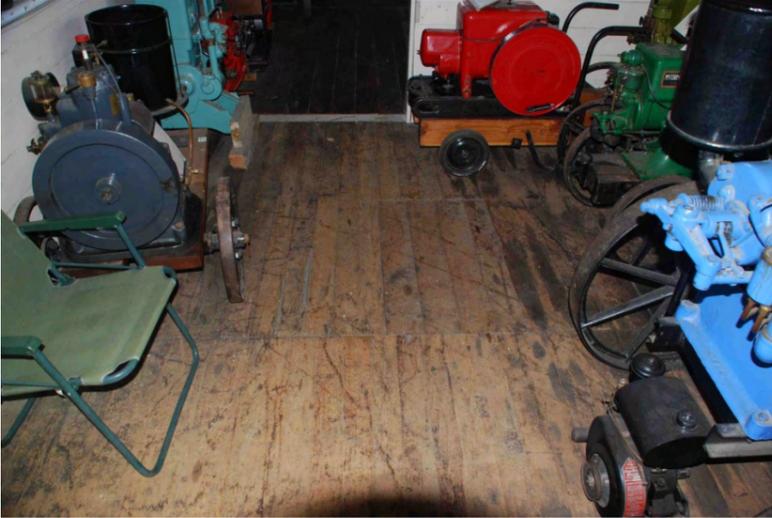
<ul style="list-style-type: none"> The floor is reasonably level and is generally in good condition, but with a number of split/damaged boards. Localised repairs to boards will be possible if considered necessary for the use of the building. 	<p>C</p>
	<p>Other</p> <p>The original ticket office window remains in the east internal wall.</p> <p>Units/shelving to the west wall, shown on the construction drawings, no longer exists (if ever installed).</p> <p>It is understood that the free-standing wall unit between the south entrance and fireplace is original to the station building.</p> <p>The original chimney breast and fireplace with cast iron fire surround and timber mantel remain on the west wall and are built back to back with the fireplace in the Ladies' waiting room.</p>

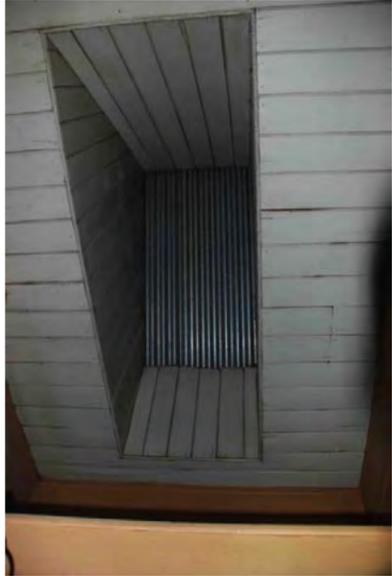
<ul style="list-style-type: none"> • Open joints and slight board distortion around the opening to the rooflight indicate that there have been leaks here in the past – presumably the reason for roofing-over. • There is also some slight discolouration and splitting of boards where they adjoin the west gable, particularly in the lavatory. This water ingress may be ongoing given the condition of the cladding and window head flashings to the west wall – see section 1.4. 	
	<p>Walls</p> <p>Timber-framing with tongue and groove sarking boards internally, laid horizontally and painted.</p>

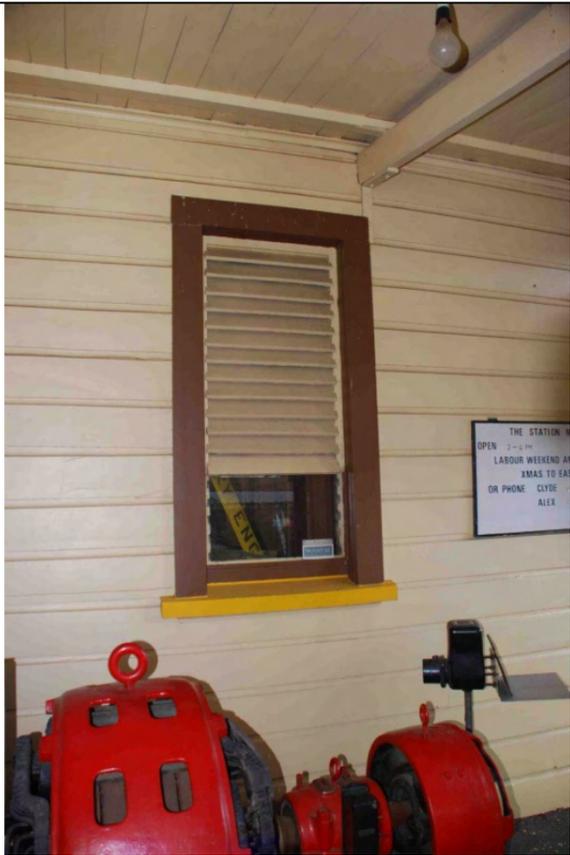
<ul style="list-style-type: none"> See also section 1.1. Internally the louvered vents are in good condition. The vent at the north end of the breezeway has had a number of the vents removed and a pane of glass inserted, no doubt to help light this area now that the skylight has been roofed over. 	
<p>Floor</p> <p>Suspended timber floor finished with tongue and groove floorboards.</p>

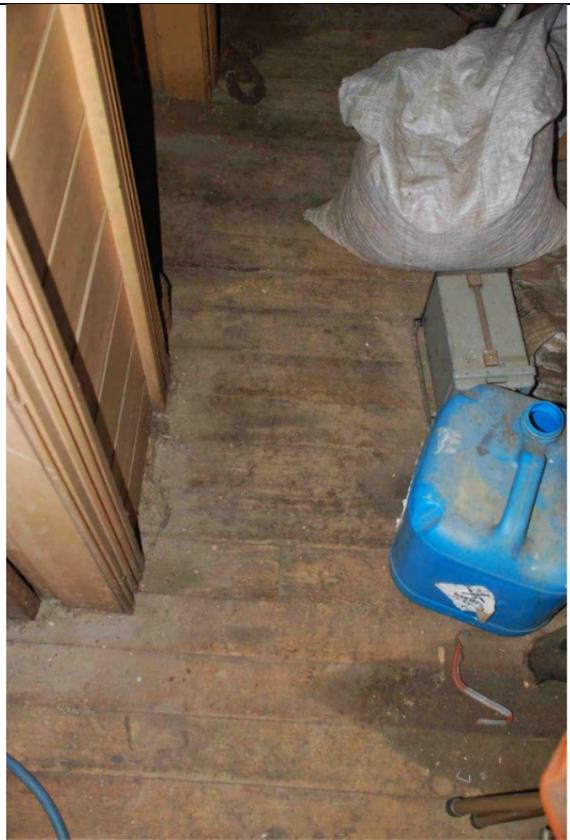
<ul style="list-style-type: none"> Where visible, the floor was found to be reasonably level and generally in good condition. However, given the decay evident to the cladding and subfloor elements externally on the west gable of the building, there is the risk that problems will be found with the floorboards and structure adjoining the external wall once items of storage are cleared out. See section 1.4. 	<p>A - investigate</p>
