APPLICATION FOR RESOURCE CONSENT OR FAST TRACK RESOURCE CONSENT FORM 9: SECTION 88 RESOURCE MANAGEMENT ACT 1991

Project	Preliminary Environmental Site Investigation Lot 1 DP408812, Bendigo Loop Road, Bendigo	Date	Apr-21	
Client	Peregrine Wines Limited	Drawn by	CM	
Project Number	21010	Approved by	JK

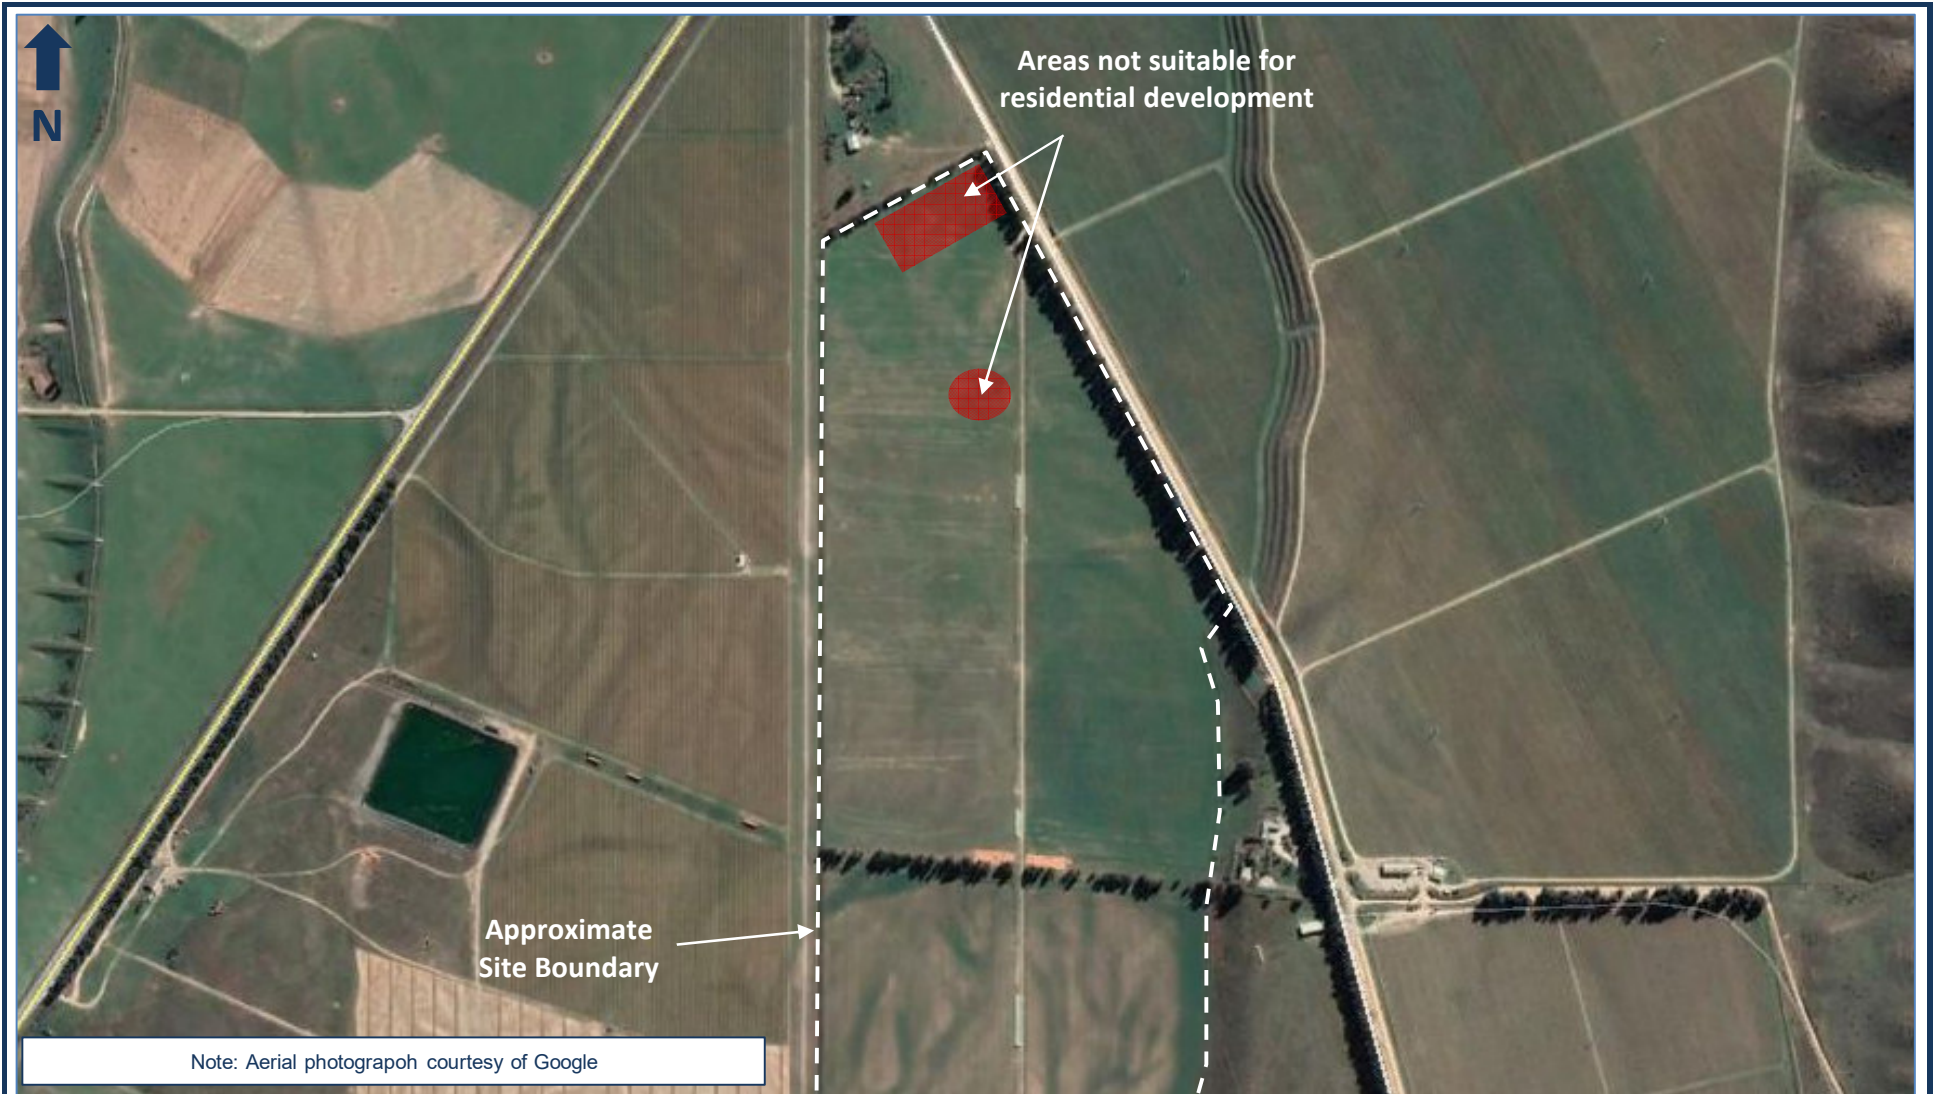
Description	Potentially Impacted Areas Plan	Figure Number	2
Project	Preliminary Environmental Site Investigation Lot 1 DP408812, Bendigo Loop Road, Bendigo	Date	Apr-21
Client	Peregrine Wines Limited	Drawn by	CM
Project Number	21010	Approved by	JK

This category is represented by the likely green waste burn area in the northern half of the site, the area where sawdust / wood chips were placed onto the ground north of the central shelter belt, as well as the small amounts of metal waste that were encountered in isolated parts of the property.

A green waste burn area was observed in aerial photographs taken between 2005 and 2007. The area was located approximately 245 m south of the northern corner of the site and measured approximately 25 m by 20 m. No visual evidence of contamination impacts was observed in that area during the site walkover inspection.

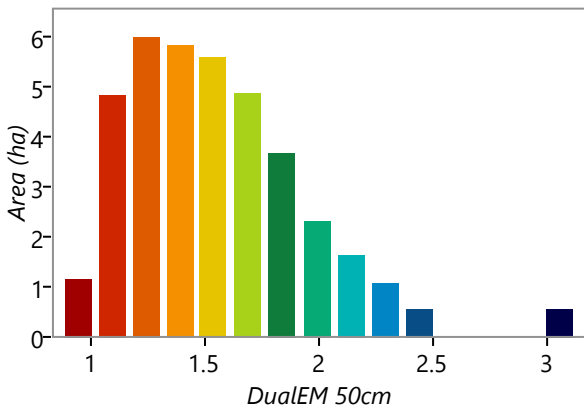
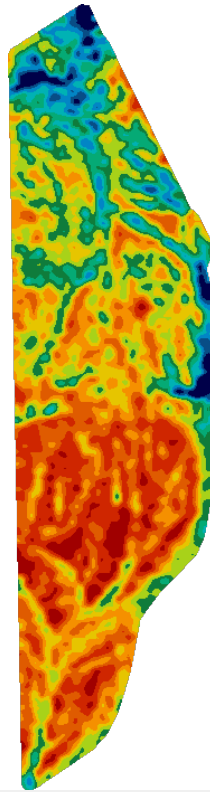
Layer name	DualEM 50cm
Field name	Cattle Block
Season	2019
Activity date	26/08/2019
Min	0.87
Min	0.87
Mean	1.55
Mode	1.25
Max	3.59
SD	0.37
CV	24.01%
Total	58.51
Total Area	37.74 ha

An electromagnetic (EM) conductivity survey was undertaken at the site by AgriOptics New Zealand Limited (AgriOptics) in 2019 (refer to Appendix 2). The results highlight zones of similar conductivity, which requires additional laboratory analysis to assess which parameters of each zone are the cause of the conductivity levels.

Zones of highest conductivity are located near to the northern portion of the site and approximately mid-way along the eastern property boundary. Further assessment would be required to determine whether those zones relate to areas of increased soil moisture, nutrients resulting from cattle manure or metal concentrations. It is possible that the results are a combination of the various factors.

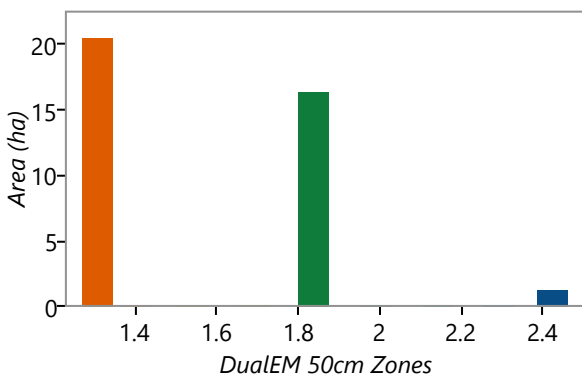
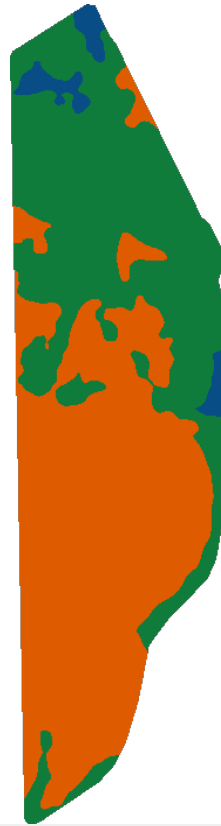
Layer name	DualEM 50cm Zones
Field name	Cattle Block
Season	2019
Min	1.3
Min	1.3
Mean	1.55
Mode	1.31
Max	2.47
SD	0.3
CV	19.10%
Total	58.5
Total Area	37.74 ha

This map simplifies the previous EM map, it is broken up to 3 zones of 2 standard deviation per zone. Areas less than 0.10ha in size have been removed and the edges have been smoothed out. This map will be a good one to use for creating management zones. This map can be further simplified if required.

Although no obvious visual indicators of contamination were observed within the former shed and livestock yards area, the EM survey (Appendix 2) has highlighted that the soil parameters are significantly different in that area, compared to the majority of the remainder of the site.

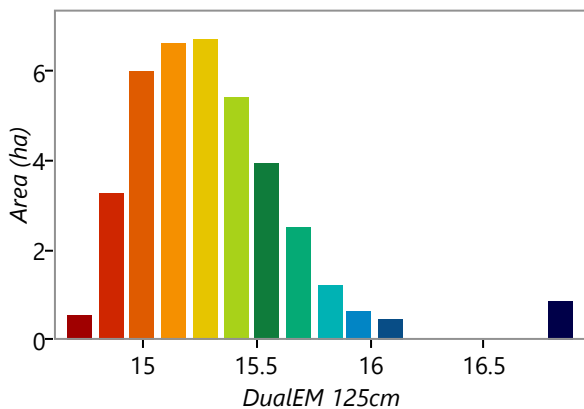
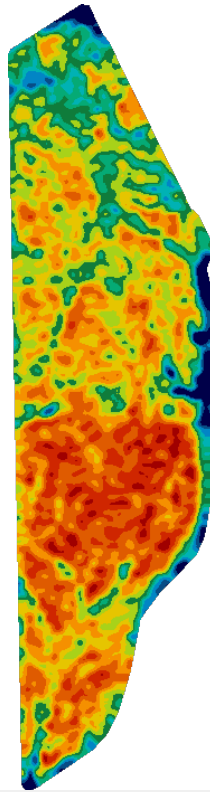
Layer name	DualEM 125cm
Field name	Cattle Block
Season	2019
Activity date	26/08/2019
Min	14.65
Min	14.65
Mean	15.3
Mode	15.27
Max	17.53
SD	0.33
CV	2.17%
Total	577.24
Total Area	37.74 ha

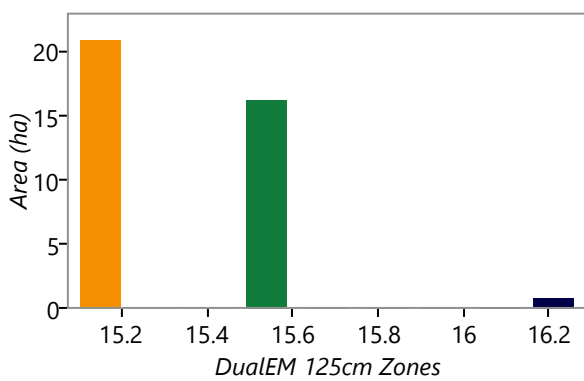
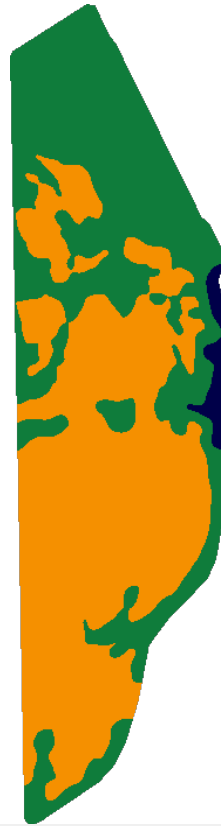
Layer name	DualEM 125cm Zones
Field name	Cattle Block
Season	2019
Min	15.09
Min	15.09
Mean	15.29
Mode	15.15
Max	16.26
SD	0.24
CV	1.59%
Total	576.88
Total Area	37.74 ha

This map is broken up to 3 zones of 2 standard deviation per zone. Areas less than 0.10ha in size have been removed and the edges have been smoothed out. This map can be simplified or made more complex if required.

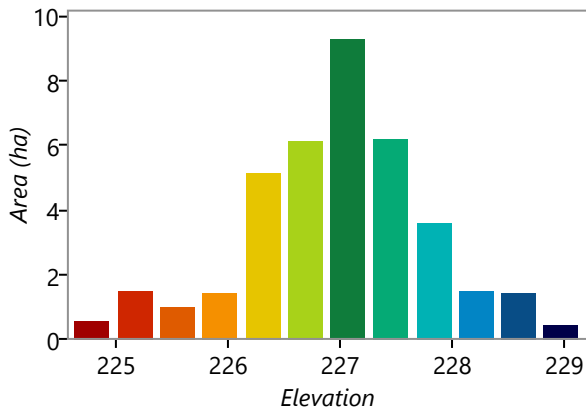
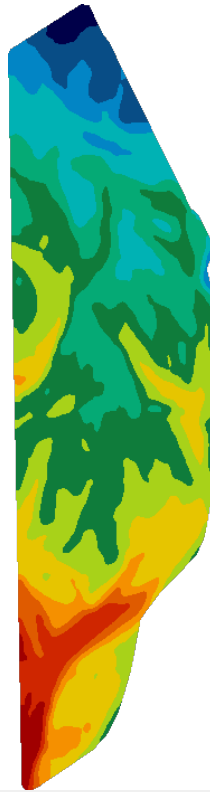
Layer name	Elevation
Field name	Cattle Block
Season	2019
Activity date	26/08/2019
Min	224.6
Min	224.6
Mean	226.97
Mode	227.07m
Max	229.16
SD	0.8
CV	0.35%
Total	8564.85
Total Area	37.74 ha

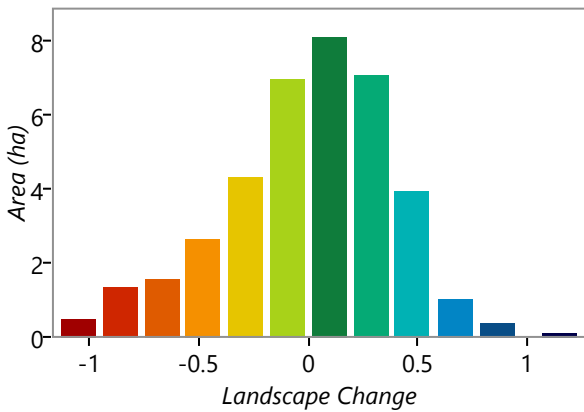
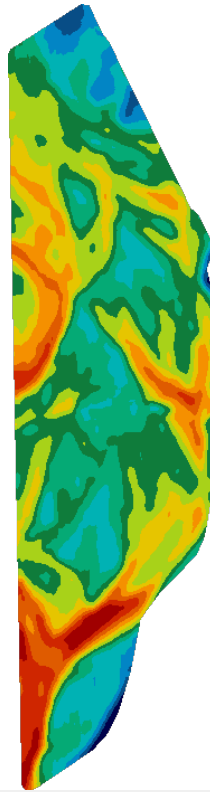
Layer name	Landscape Change
Field name	Cattle Block
Season	2019
Activity date	26/08/2019
Min	-1.15
Min	-1.15
Mean	0
Mode	0.09m
Max	1.32
SD	0.38
CV	8946.61%
Total	-0.16
Total Area	37.74 ha

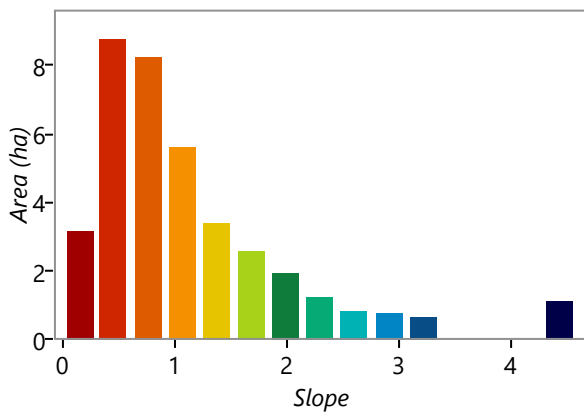
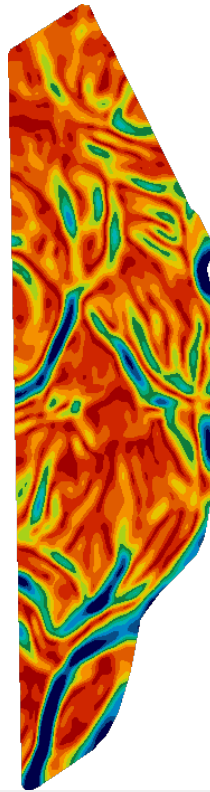
Layer name	Slope
Field name	Cattle Block
Season	2019
Activity date	26/08/2019
Min	0.01
Min	0.01
Mean	1.13
Mode	0.46
Max	5.51
SD	0.85
CV	75.49%
Total	42.47
Total Area	37.74 ha

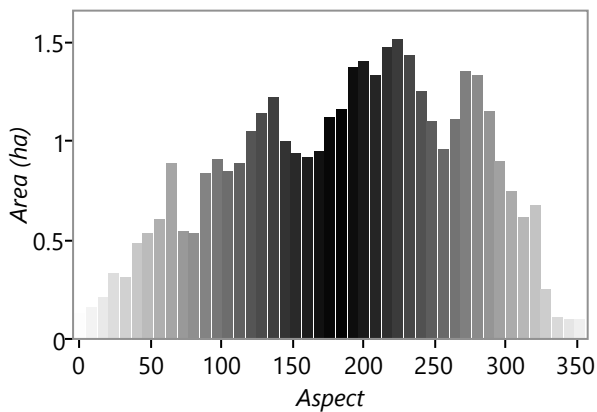
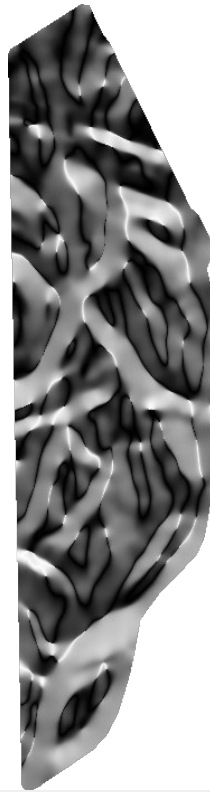
Layer name	Aspect
Field name	Cattle Block
Season	2019
Activity date	26/08/2019
Min	0.02
Min	0.02
Mean	191.24
Mode	224
Max	359.98
SD	80.38
CV	42.03%
Total	7216.69
Total Area	37.74 ha

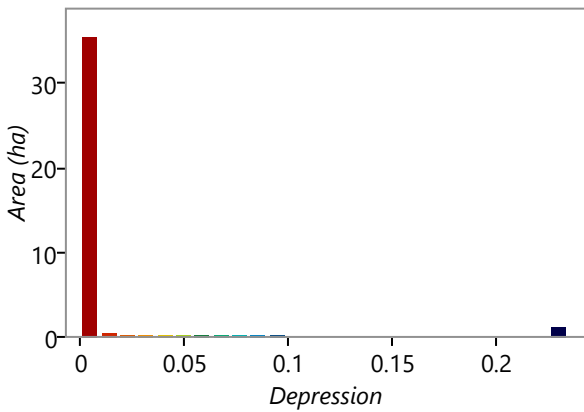
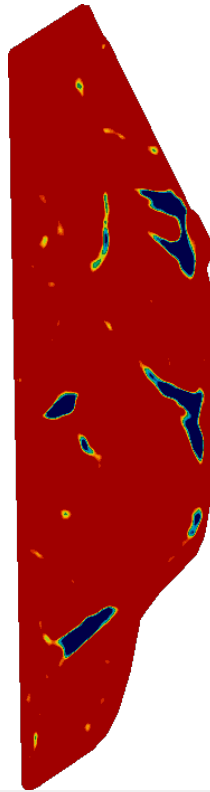
Layer name	Depression
Field name	Cattle Block
Season	2019
Activity date	26/08/2019
Min	0
Min	0
Mean	0.01
Mode	0m
Max	0.36
SD	0.03
CV	467.92%
Total	0.27
Total Area	37.74 ha

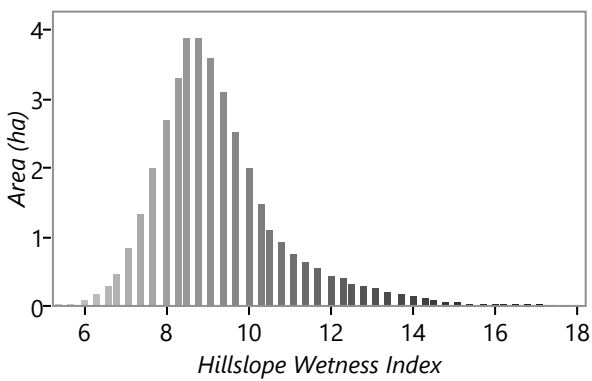
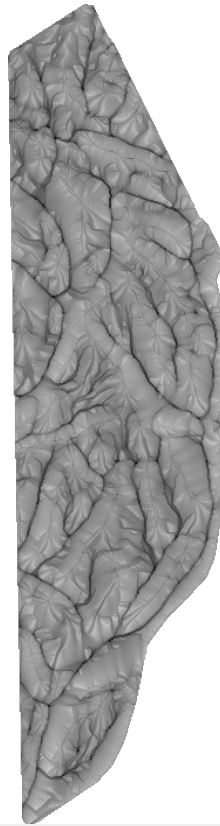
Layer name	Hillslope Wetness Index
Field name	Cattle Block
Season	2019
Min	5.41
Min	5.41
Mean	9.38
Mode	8.55
Max	18.24
SD	1.48
CV	15.81%
Total	353.82
Total Area	37.74 ha

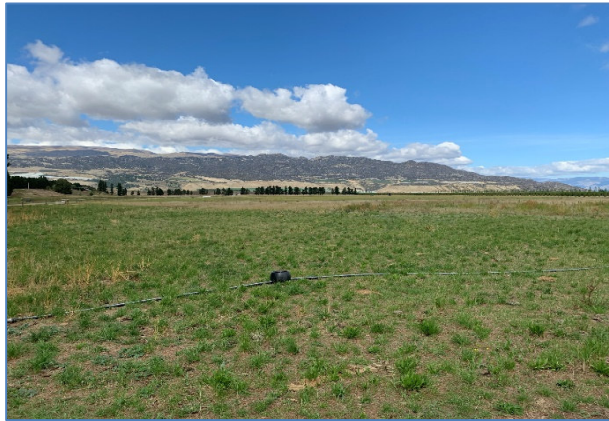
Photo 5: Former woolshed area viewed from the north, facing south east.

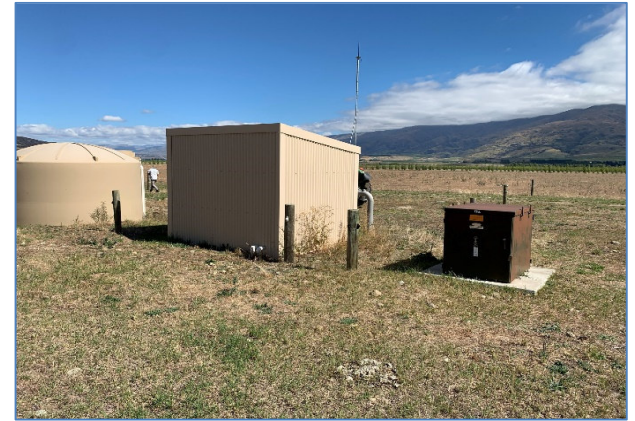
Photo 9: Well area with storage tanks, pump shed and electrical transformer.

Category B2 – Electrical transformers including the manufacturing, repairing or disposing of electrical transformers or other heavy electrical equipment.

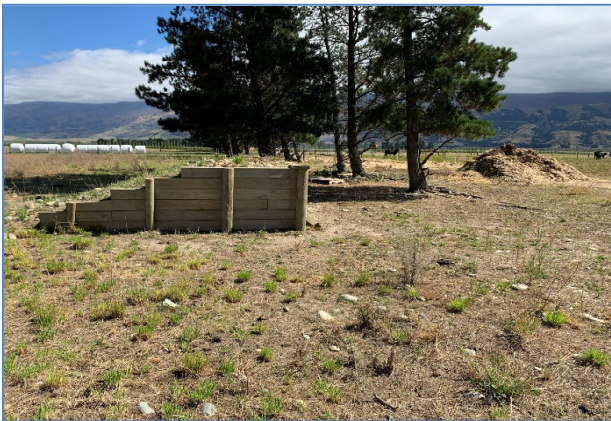
Photo 10: Livestock ramp and sawdust near to the centre of the site.

- The sawdust / wood chips placed near to the center of the site are untreated shavings used for livestock bedding.
- Green waste burning in the northern portion of the site was a one-off removal of dried tree stumps.
- Mr McLachlan indicated that the property is proposed to be used for agricultural activities, but that the option for rural residential activities is desirable.
- Mr McLachlan could not think of any activities that could have resulted in contamination impacts at the site.

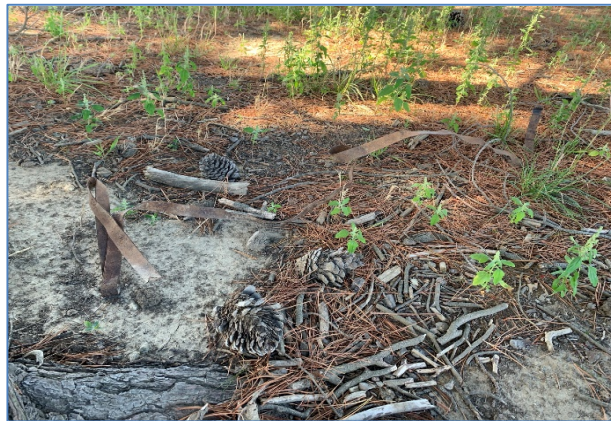
Photo 11: Small amount of metal waste near to the north eastern property boundary.
