BURN COTTAGE ROAD JV LTD - RESOURCE CONSENT APPLICATION FOR SUBDIVISION TO CREATE FOUR RURAL LIVING ALLOTMENTS AND FIVE BUILDING PLATFORMS AT 172 BURN COTTAGE ROAD

Report prepared by Vivian and Espie for Central Otago District Council			
Reviewed and Approved By	Jess McKenzie	Landscape Architect	27 April 2023

GEOTECHNICAL ASSESSMENT REPORT

172 BURN COTTAGE ROAD,
CROMWELL

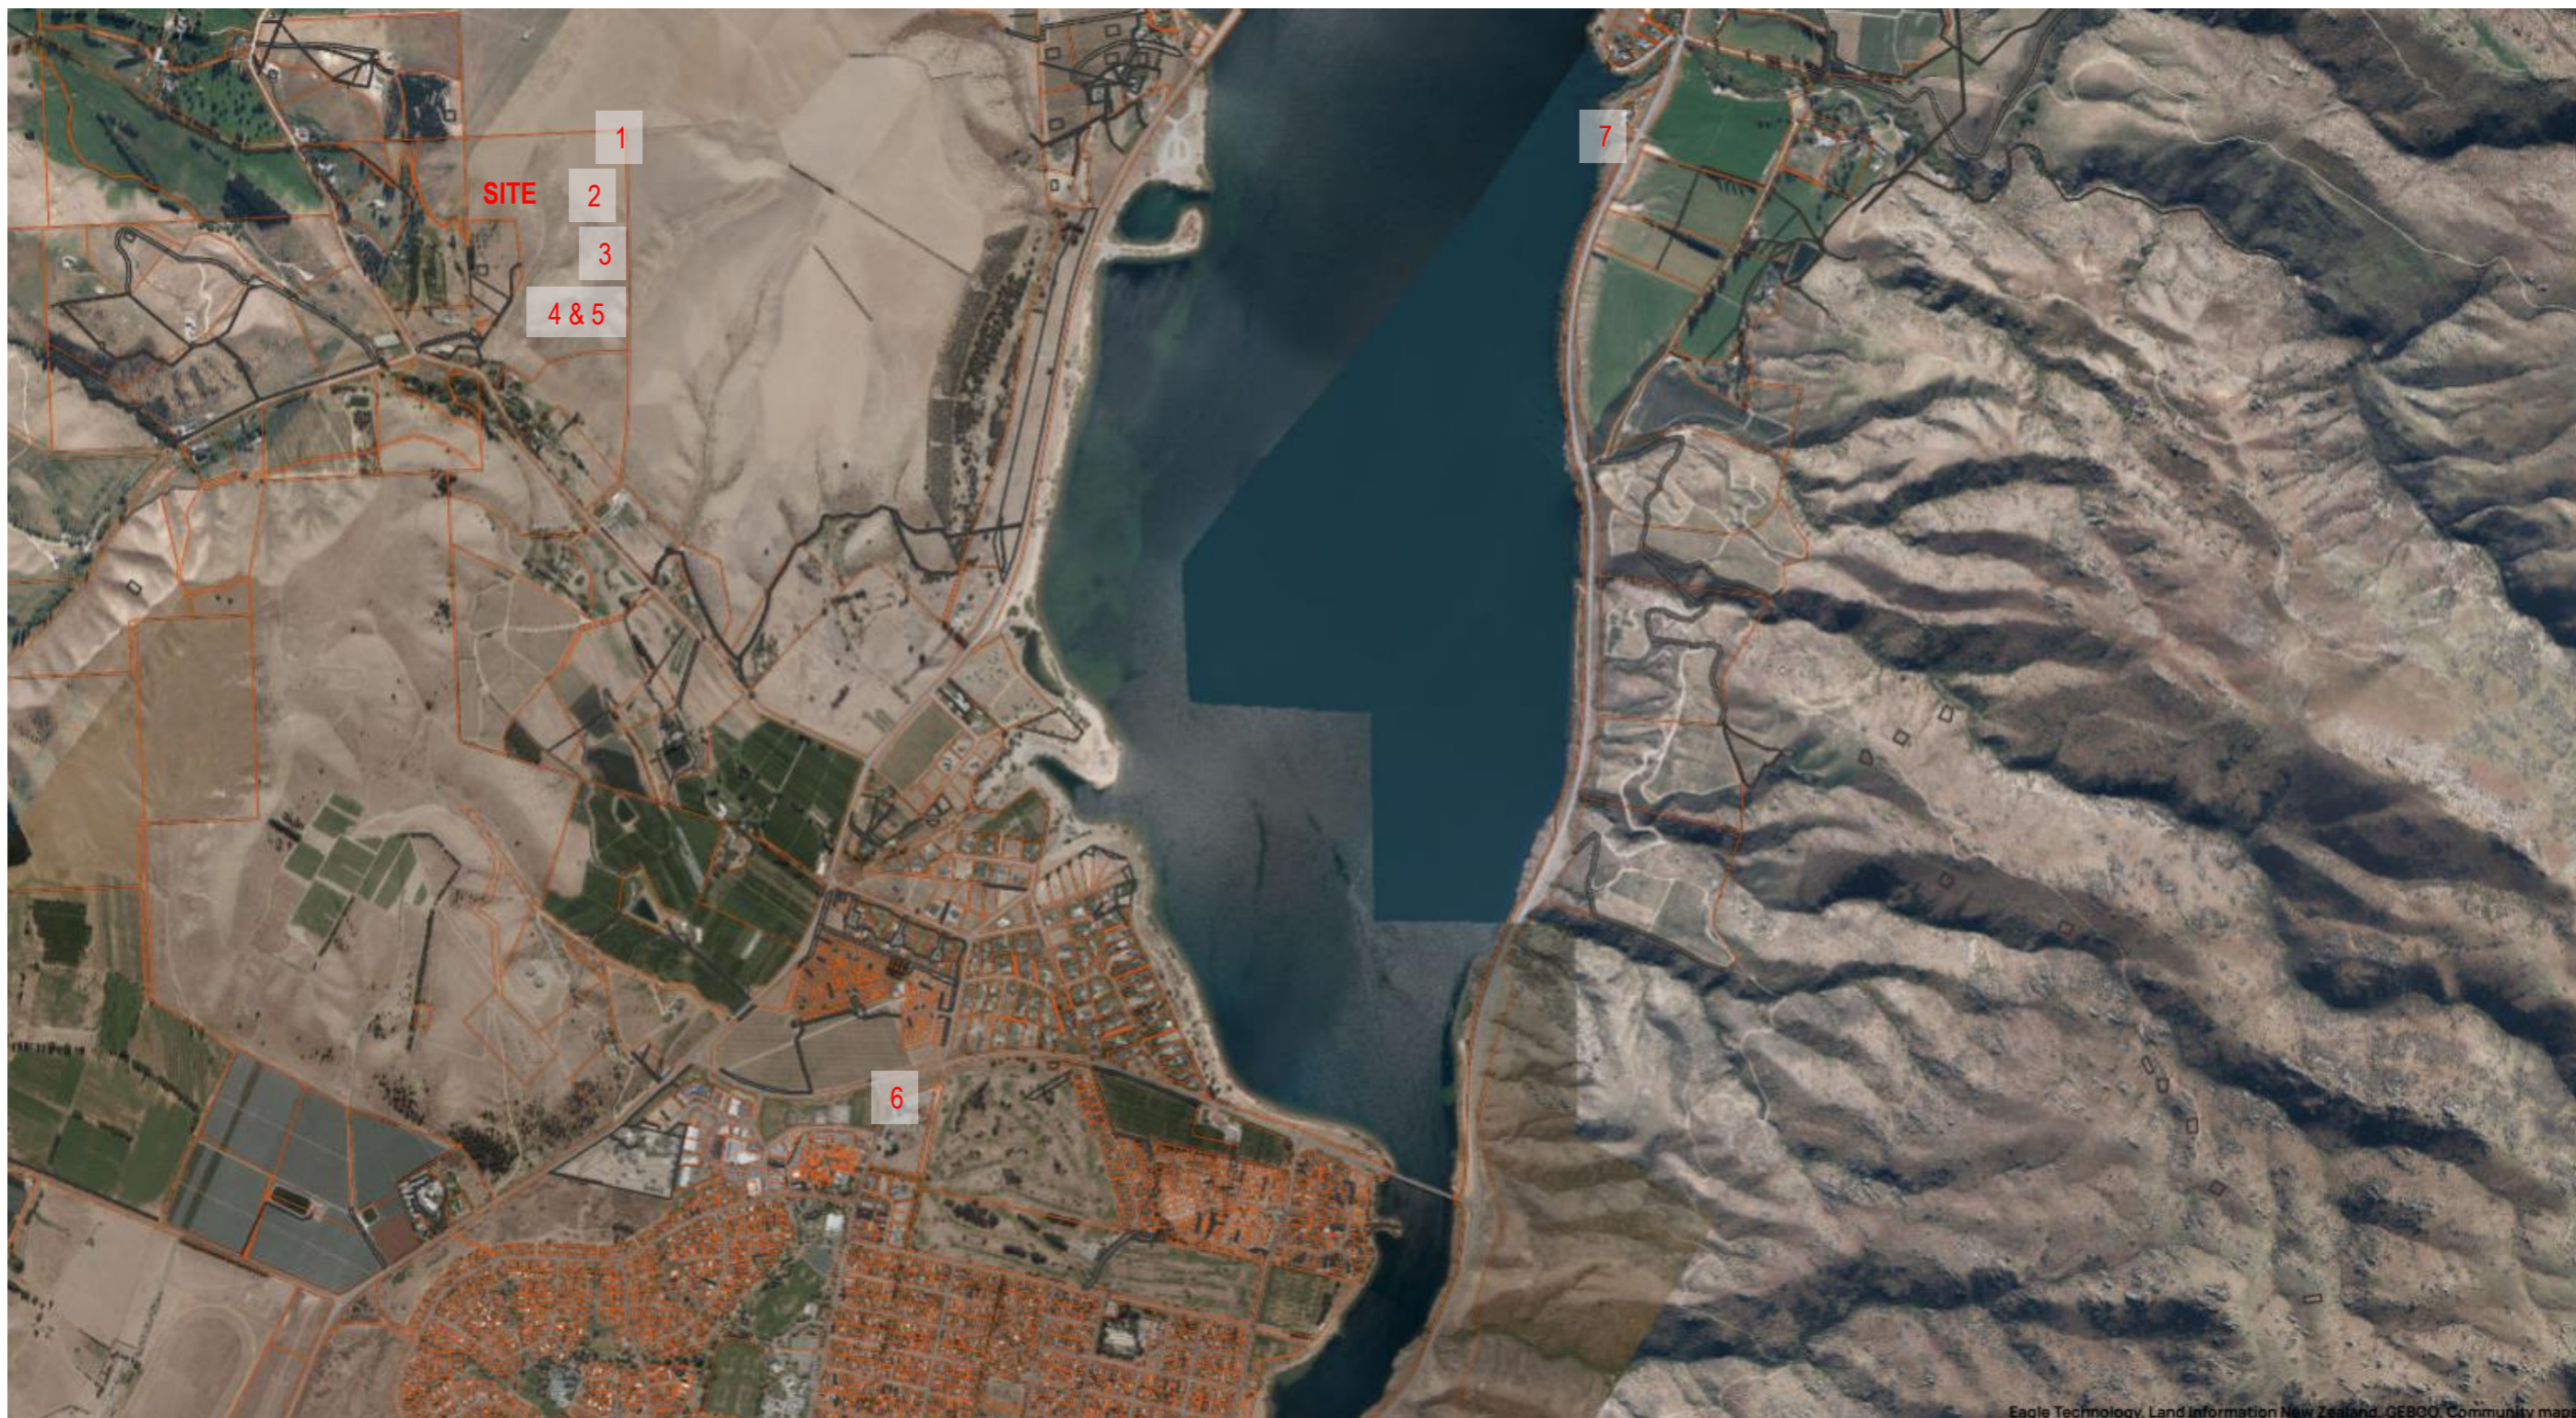
Context and Viewpoint Plan – viewpoints for photographs shown as red numbers.

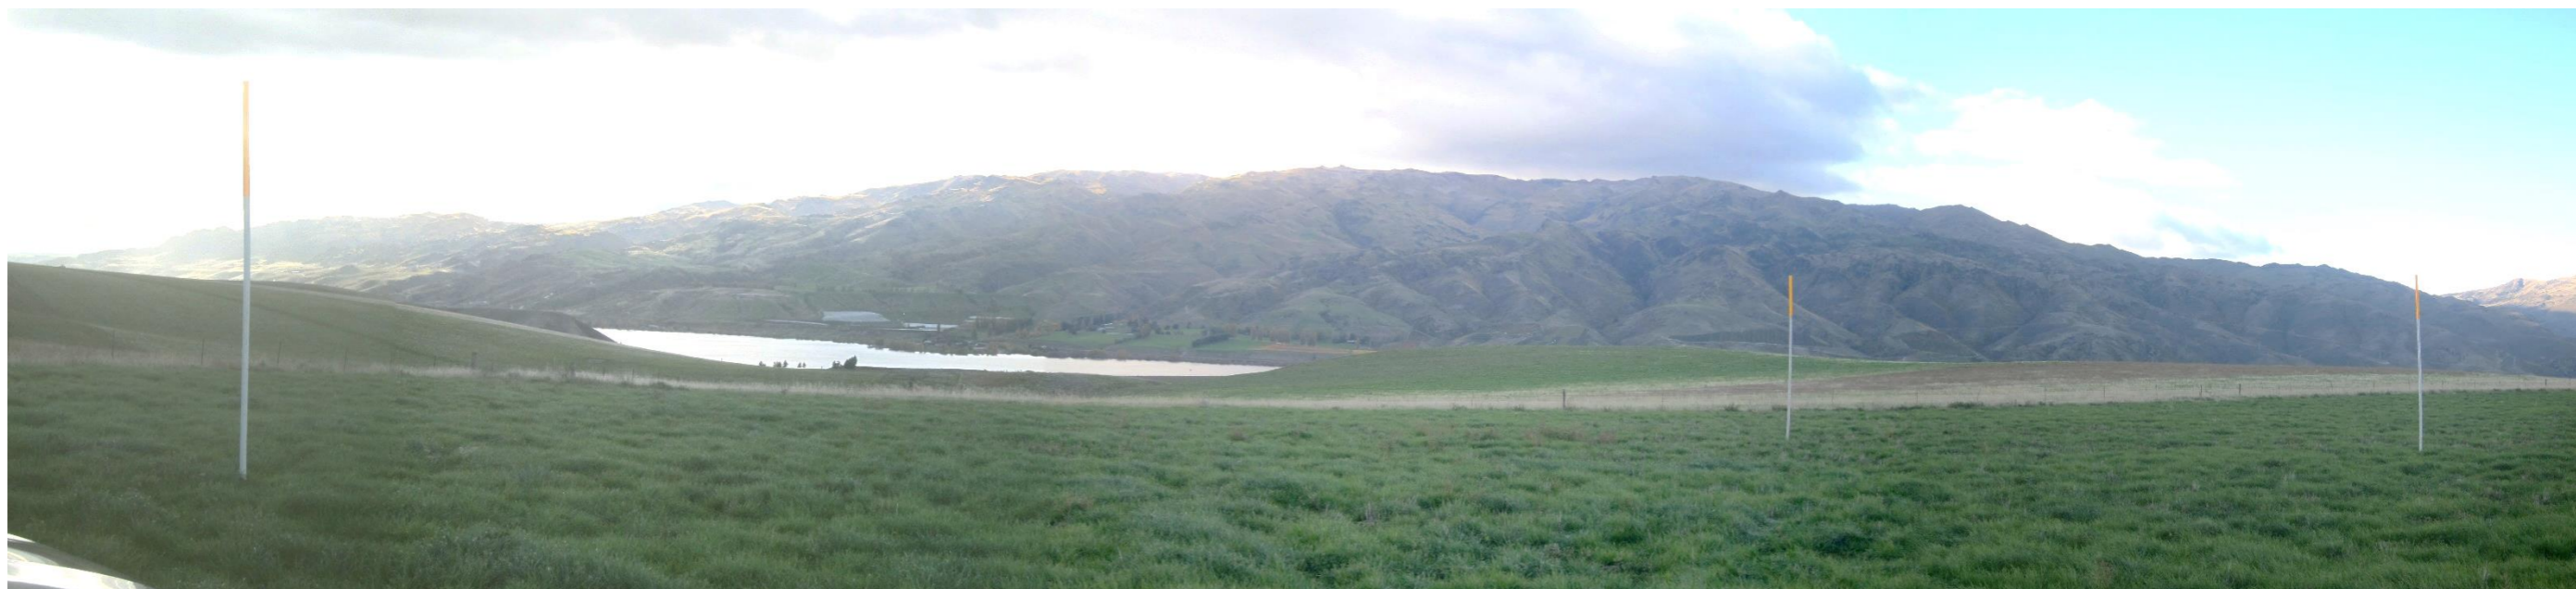
Viewpoint 1: Looking north east towards Lake Dunstan from the second proposed building platform on Lot 1. This photograph illustrates the viewshed from which the proposed platform will be visible.

- 18 As is illustrated in Photographs 1, 4 & 7 of this Review Memo, the proposed Lot 2 platform and Lot 1 smaller platform are visible from a considerable area of the surface of Lake Dunstan and its margins. The Lot 2 platform is visible from the Lakefront near the Cromwell Township and the Lot 3 platform is visible from the surface and margins of Lake Dunstan further north.

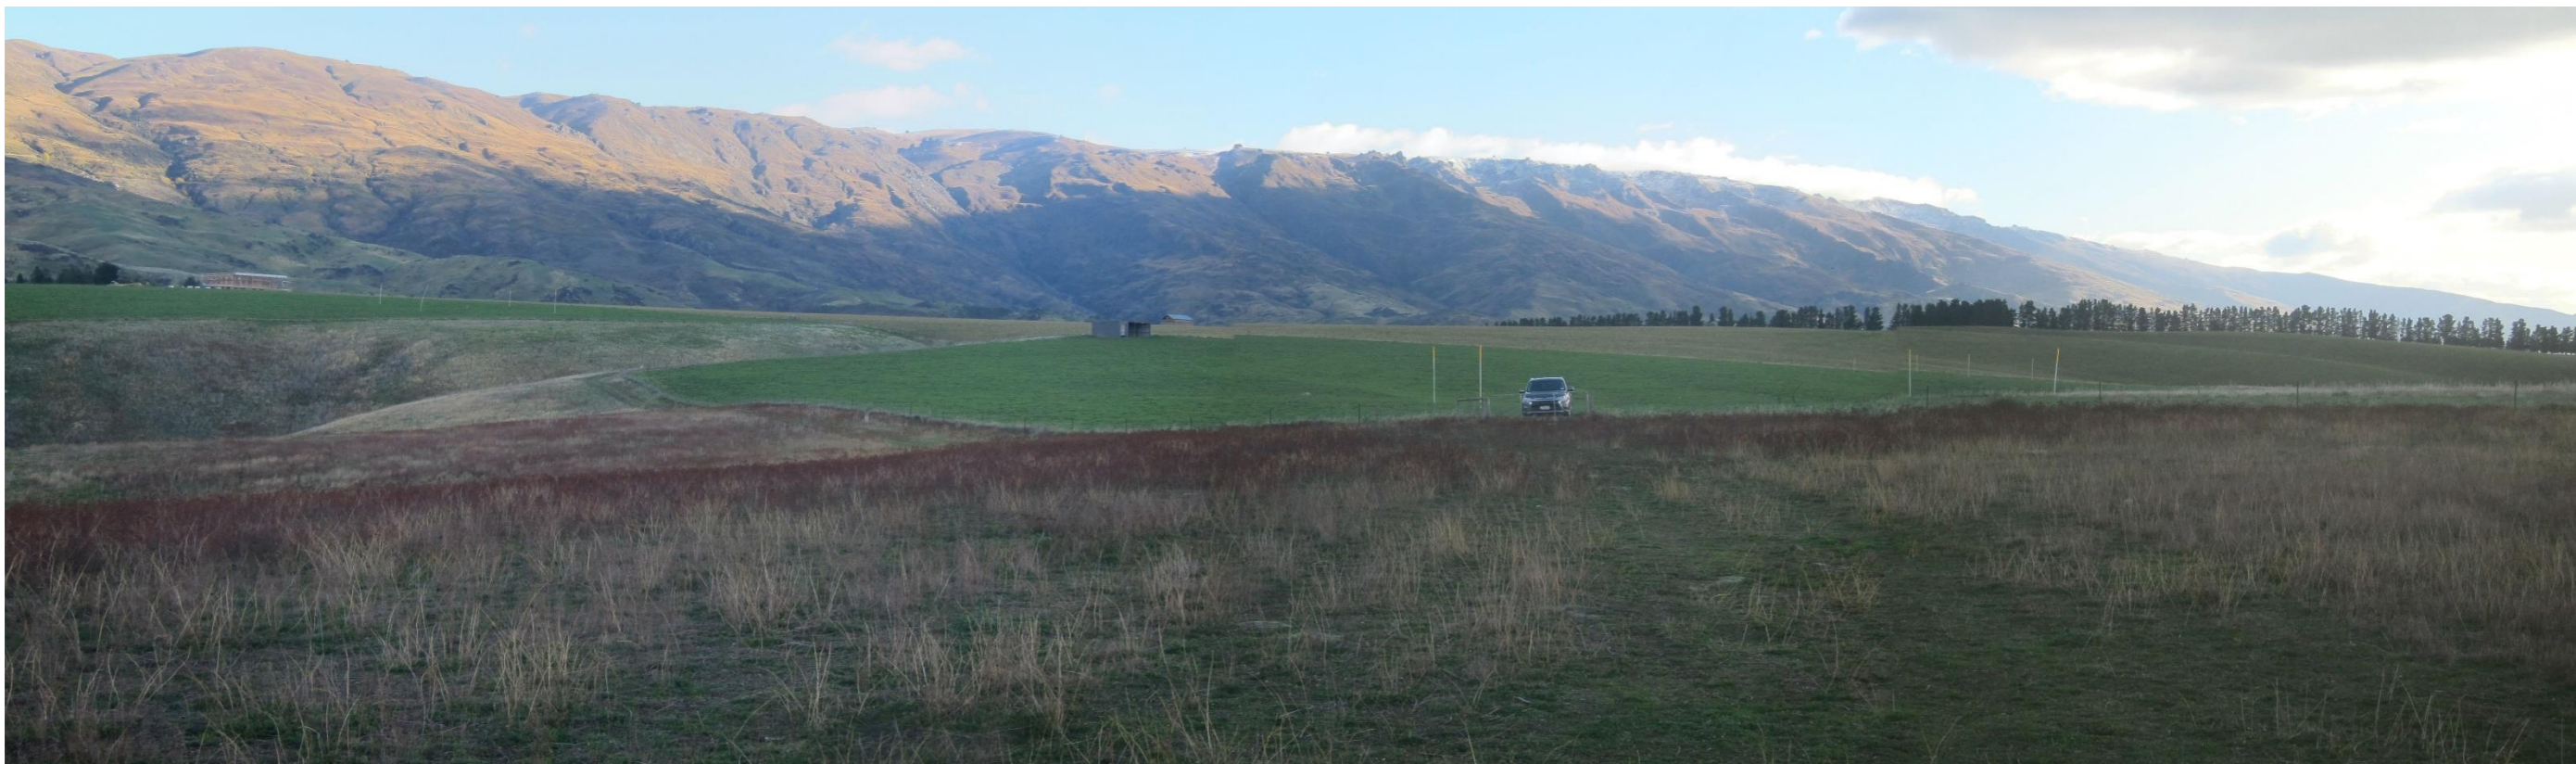
Viewpoint 3: Looking north from proposed Lot 2 towards the proposed building platforms on Lots 1 and 3. This photograph illustrates the existing and proposed level of development on the upper terrace.

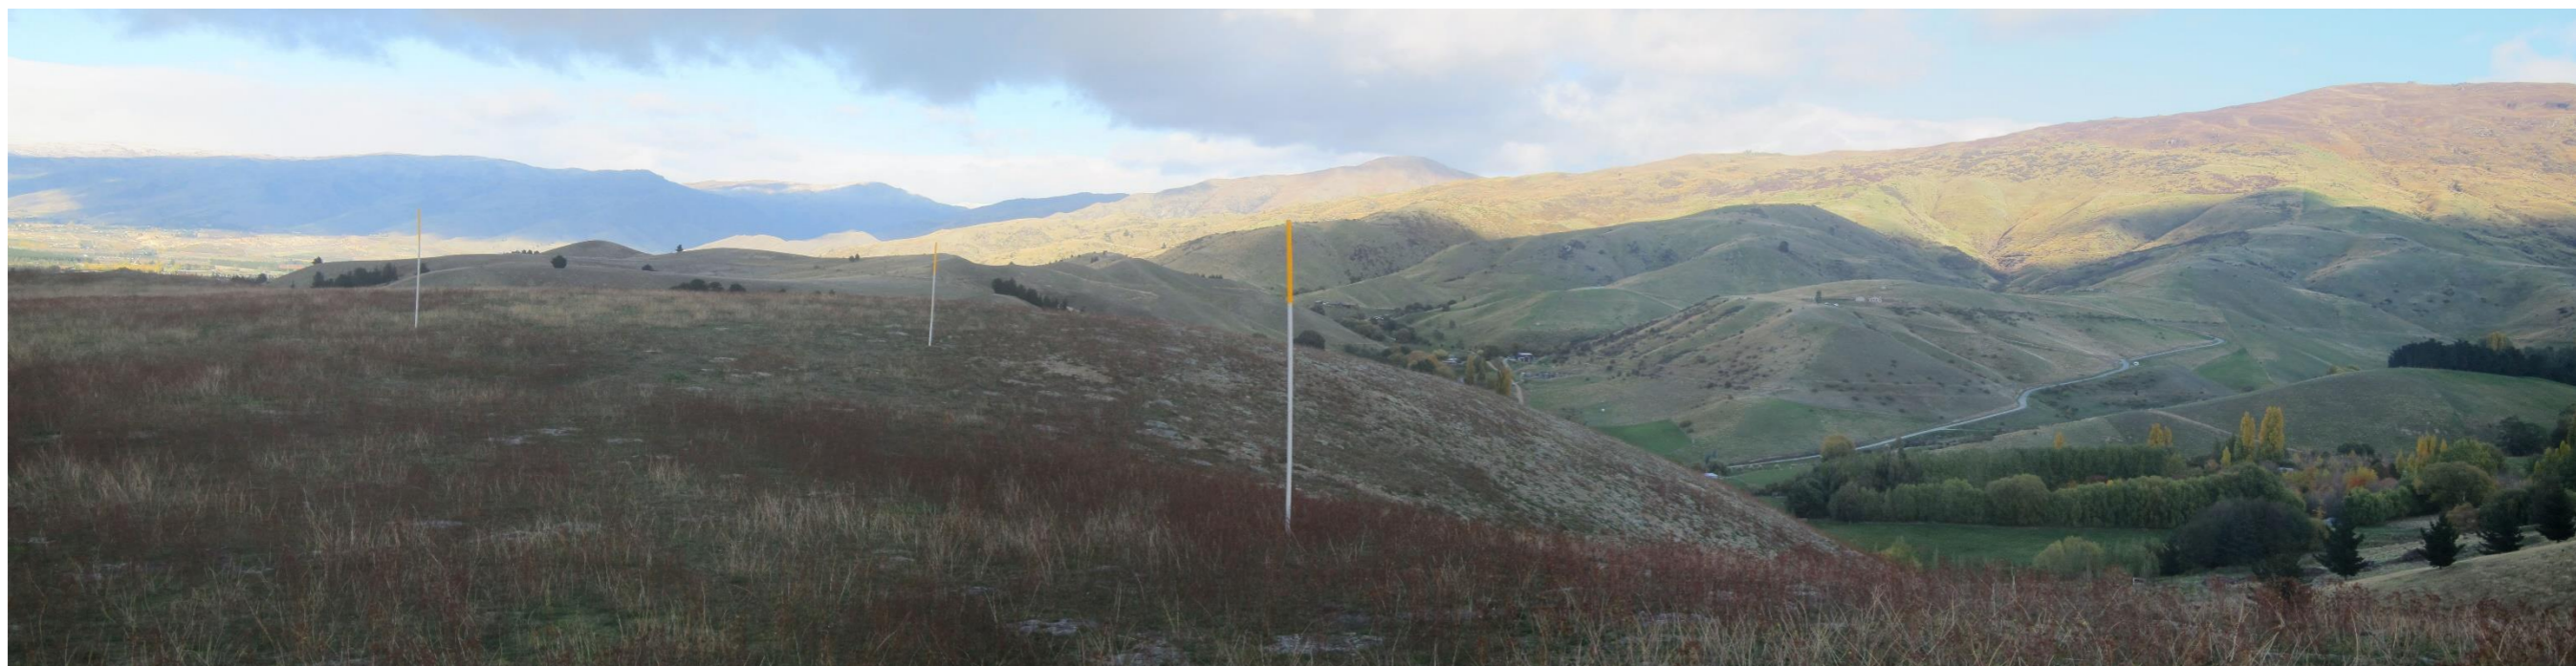
Viewpoint 5: Looking south west towards the rural living on Burn Cottage Road from the proposed building platform on Lot 2. This photograph illustrates the viewshed from which the proposed platform will be visible.

- 23 Several rural living allotments are located within the vicinity, including elevated rural living properties accessed from McFelin Road that overlook the site. We have not viewed the site from these private properties, however, attached Photograph 2 illustrates views from the site look towards surrounding rural living development and gives an indication of the indicative viewshed. In views from several of these properties, one or more of the proposed platforms will be visible. Without visiting the properties, our initial view is that the introduction of rural living development to the upper terrace appears likely to have an adverse effect on some views and visual amenity of a moderate degree.

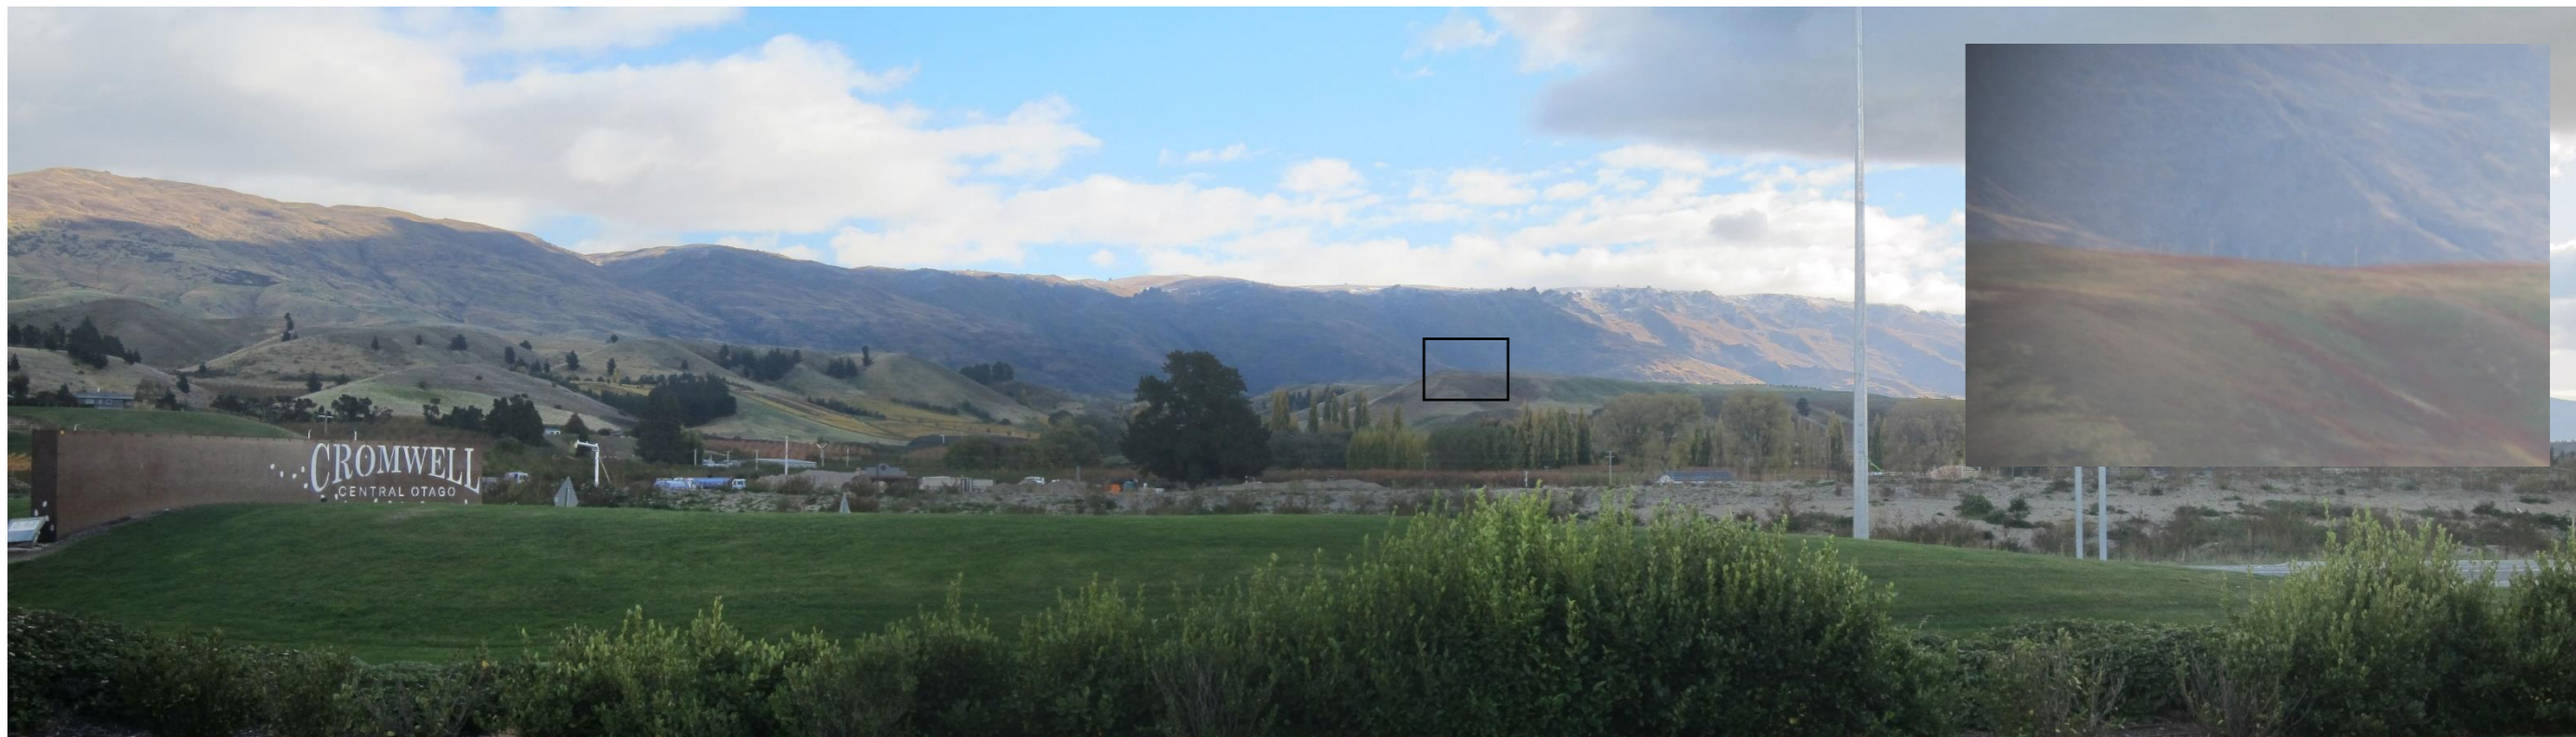
Viewpoint 6: Looking towards the proposed platform on Lot 2 from Cromwell. This photograph illustrates the degree of visibility from Cromwell. Inset photograph shows a zoom-in of the Lot 2 poles.

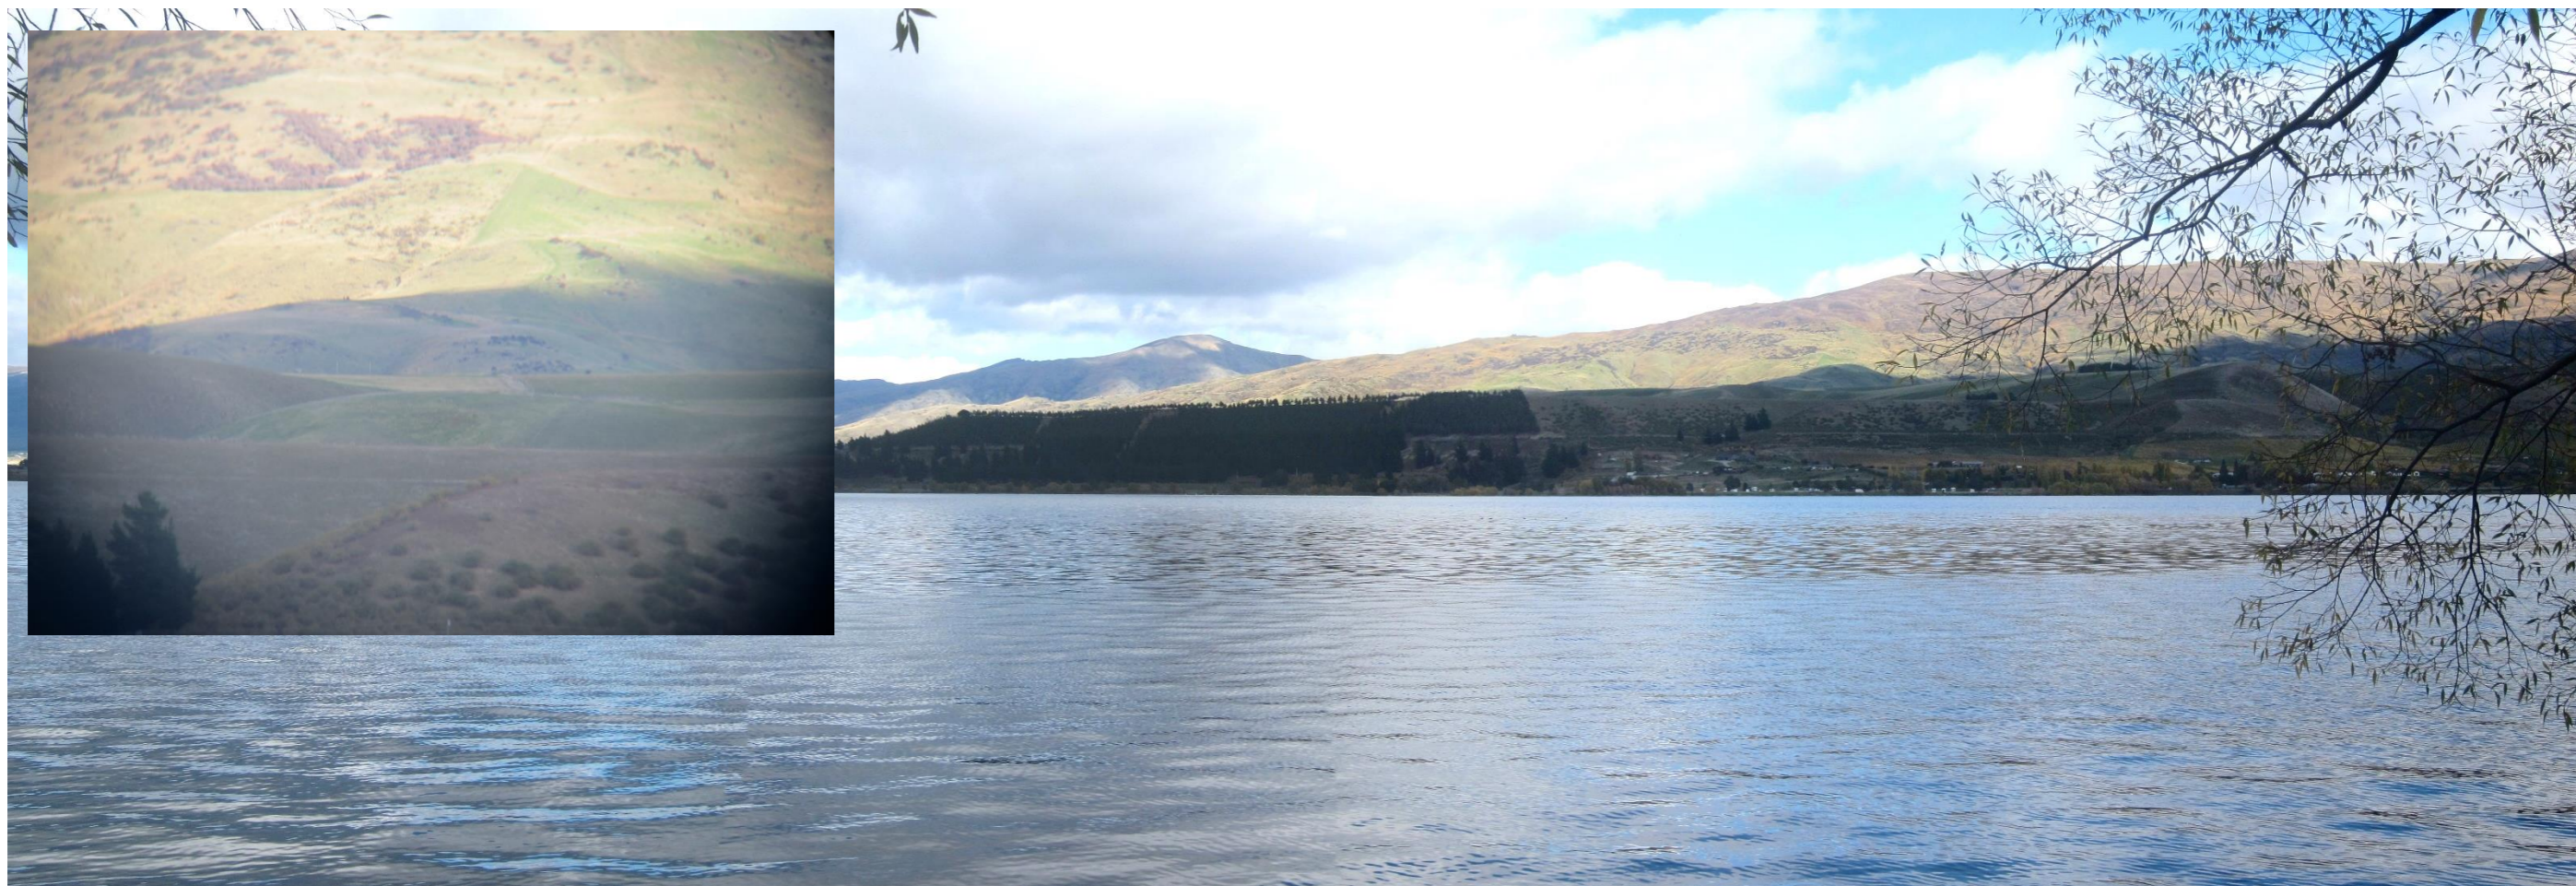
Viewpoint 7: Looking towards the proposed platform on Lot 1 from Northburn. The entire second building platform on Lot 1 is visible.

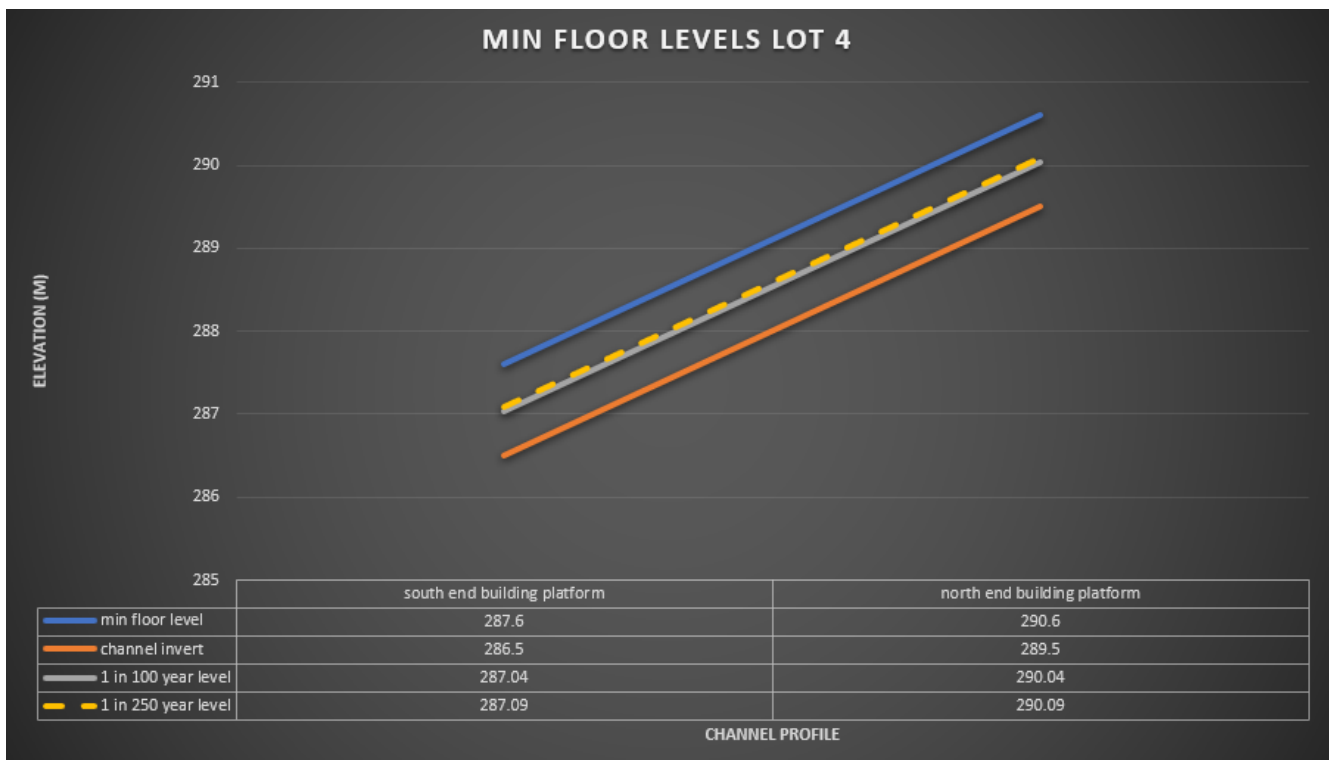
Figure 2: Minimum Floor Levels Lot 4

- An progressively decreasing minimum floor level requirement from the northeast to the southwest from 290.6 to 286.6m. This is represented graphically in figure 2 below and ensures that the FFL will be 0.5m above the 1 in 100 year flood level:-
- Minimum building platform levels are to be no greater than 0.25m below the specified minimum floor levels.

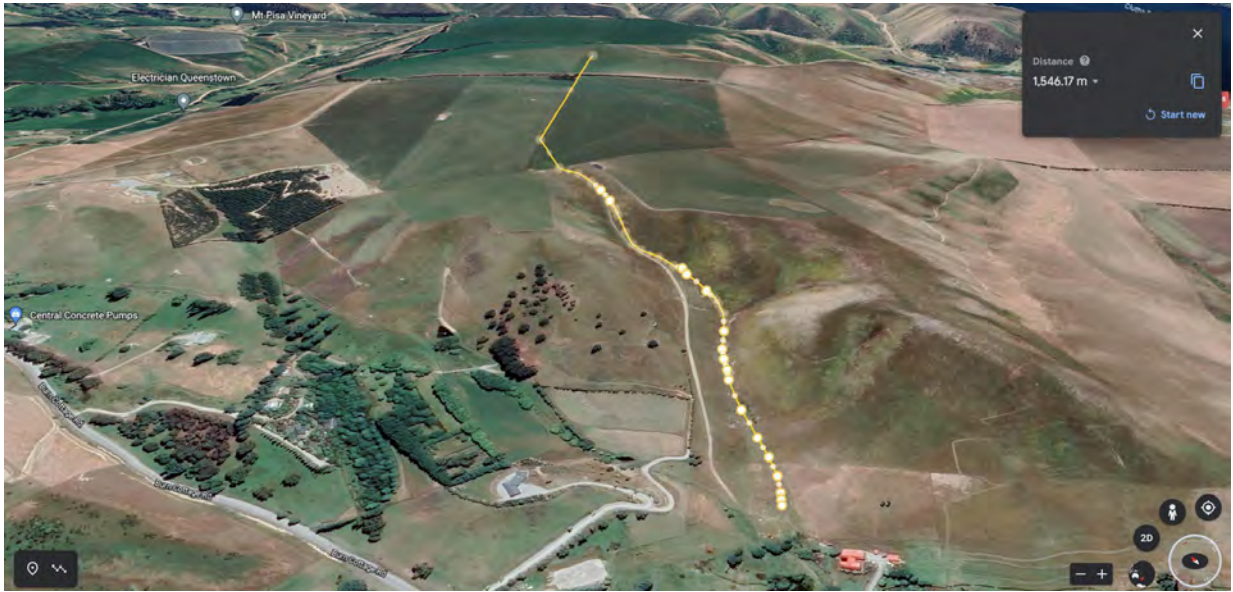
Figure 2- Length of Catchment

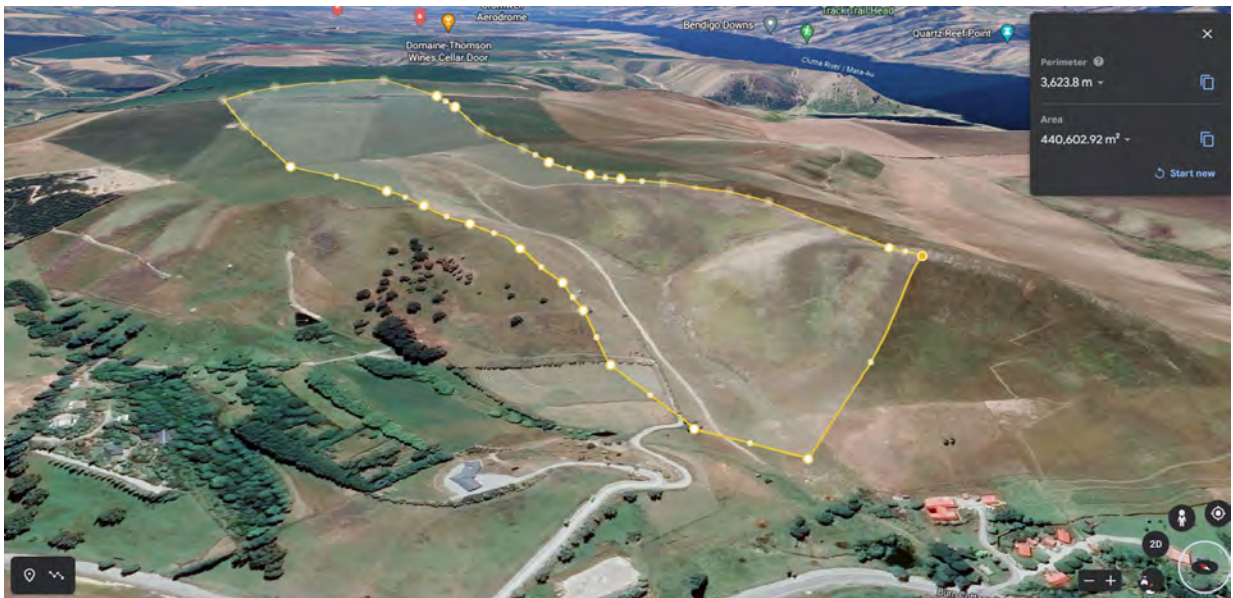
Figure 3 - Area of Catchment

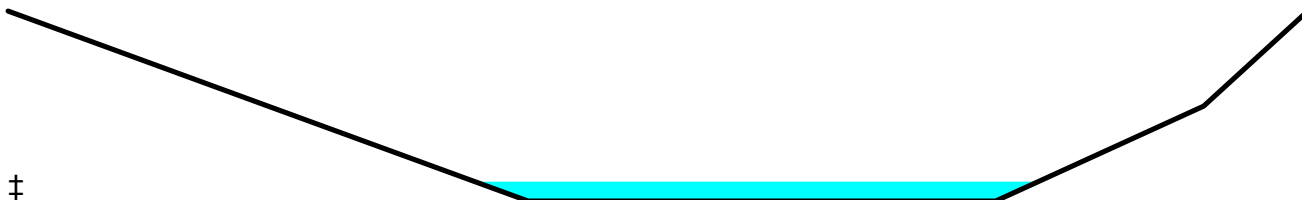
A factor of 0.10 has been applied to the discharge capacity and velocity
 Custom cross-section, Length= 30.00 m Slope= 0.3000 m/m
 Constant n= 0.030 Earth, grassed & winding
 Inlet Invert= 302.000 m, Outlet Invert= 293.000 m

Offset (meters)	Elevation (meters)	Chan.Depth (meters)
0.000	295.000	0.00
5.000	294.000	1.00
10.000	293.000	2.00
19.000	293.000	2.00
23.000	294.000	1.00
25.000	295.000	0.00

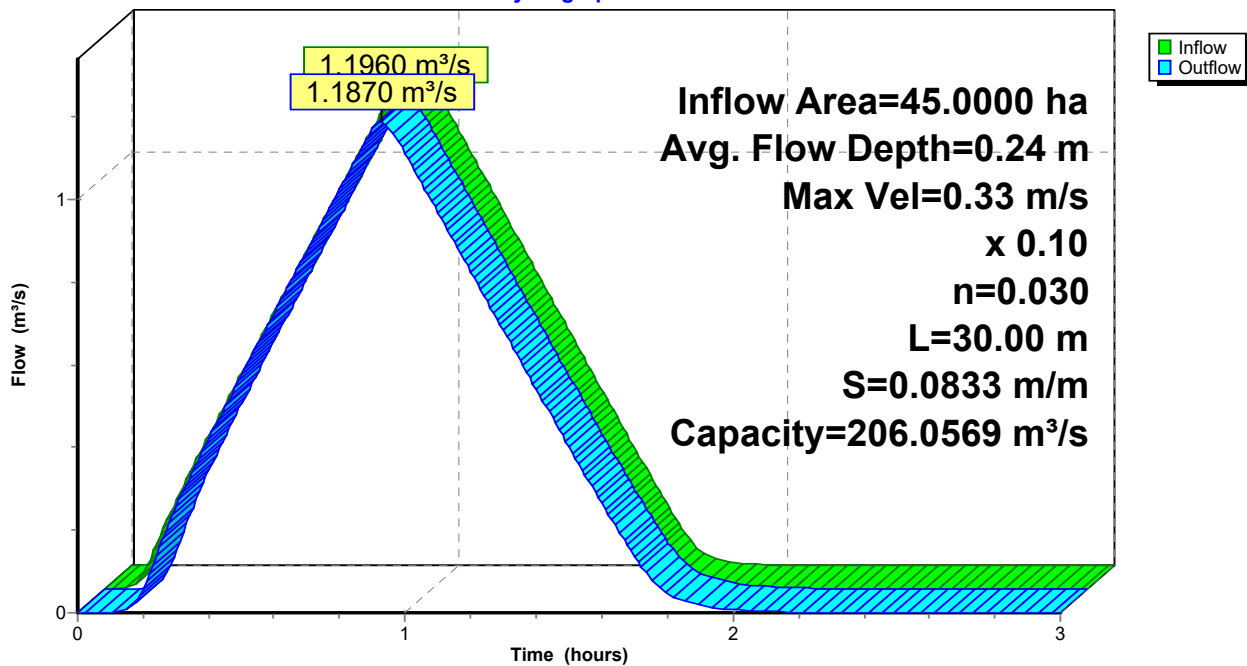
172 burn cottage-final*burn cottage 250-yr Duration=50 min, Inten=47.9 mm/hr*

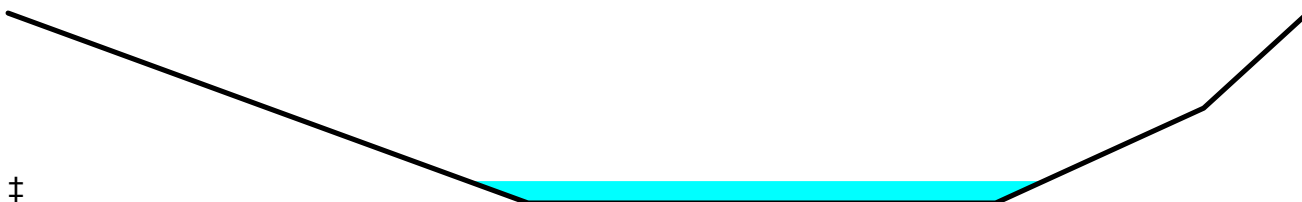
A factor of 0.10 has been applied to the discharge capacity and velocity
 Custom cross-section, Length= 30.00 m Slope= 0.3000 m/m
 Constant n= 0.030 Earth, grassed & winding
 Inlet Invert= 302.000 m, Outlet Invert= 293.000 m

Offset (meters)	Elevation (meters)	Chan.Depth (meters)
0.000	295.000	0.00
5.000	294.000	1.00
10.000	293.000	2.00
19.000	293.000	2.00
23.000	294.000	1.00
25.000	295.000	0.00

Depth (meters)	End Area (sq-meters)	Perim. (meters)	Width (meters)	Storage (cubic-meters)	Discharge (m³/s)
0.00	0.00	9.00	0.00	0.0	0.0000
1.00	13.50	18.22	18.00	405.0	20.1804
2.00	35.00	25.56	25.00	1,050.0	78.8032

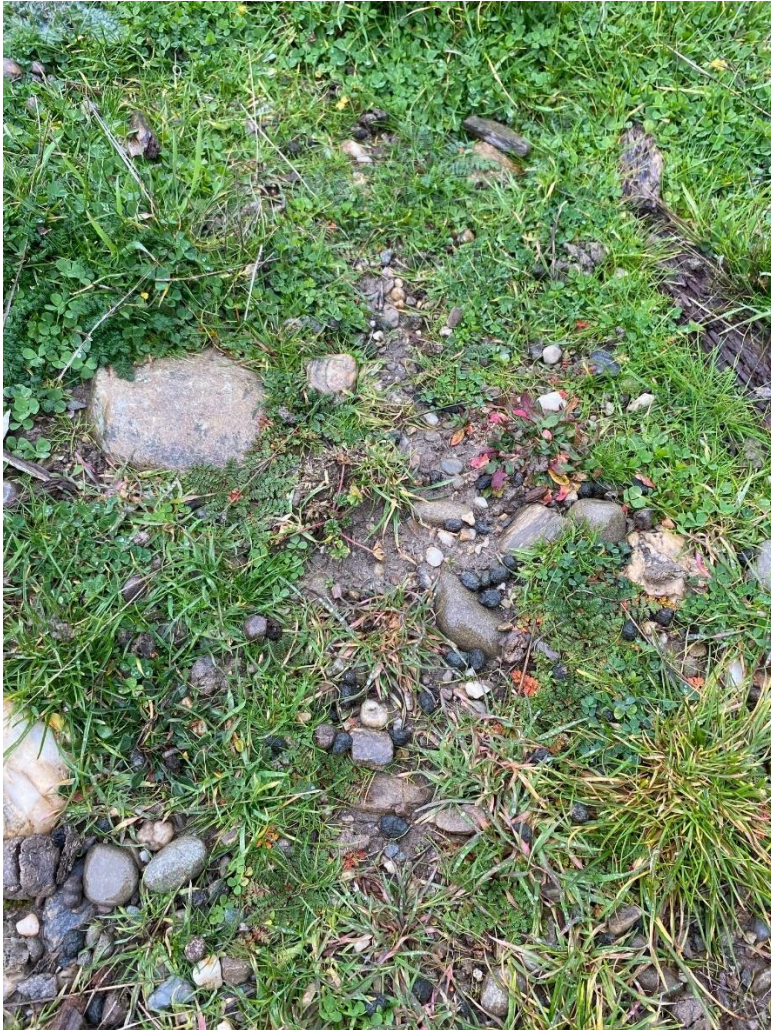
Photo 1. A general photo of the species on the parcel.

The most characteristic part of Photo 1 is the vegetation and a low biological function of the soil is. In healthy agricultural production areas plants typically are upright and ready for defoliation by animals, even during dry conditions. In this photo we have an example of a semi arid environment whereby everything dies and relies on seed to re germinate in the autumn to survive.

The primary species growing on this land parcel are a range of introduced species, such as annual native grasses, some small leaf legumes and woody weeds such as borage spp. Their agricultural utility is limited

due to the limited seasonality of production and low nutritive value from a ruminant production perspective. While these species could be re sown with more productive species, this process involves heavy cultivation and the use of a lot of herbicides to kill resident weeds. Cultivation of this country is challenging due to wind blowing away topsoil and the use of herbicides is also a little challenging with a number of sensitive crops nearby on flat areas being prone to spray drift and consequently reverse sensitivity is a real challenge.

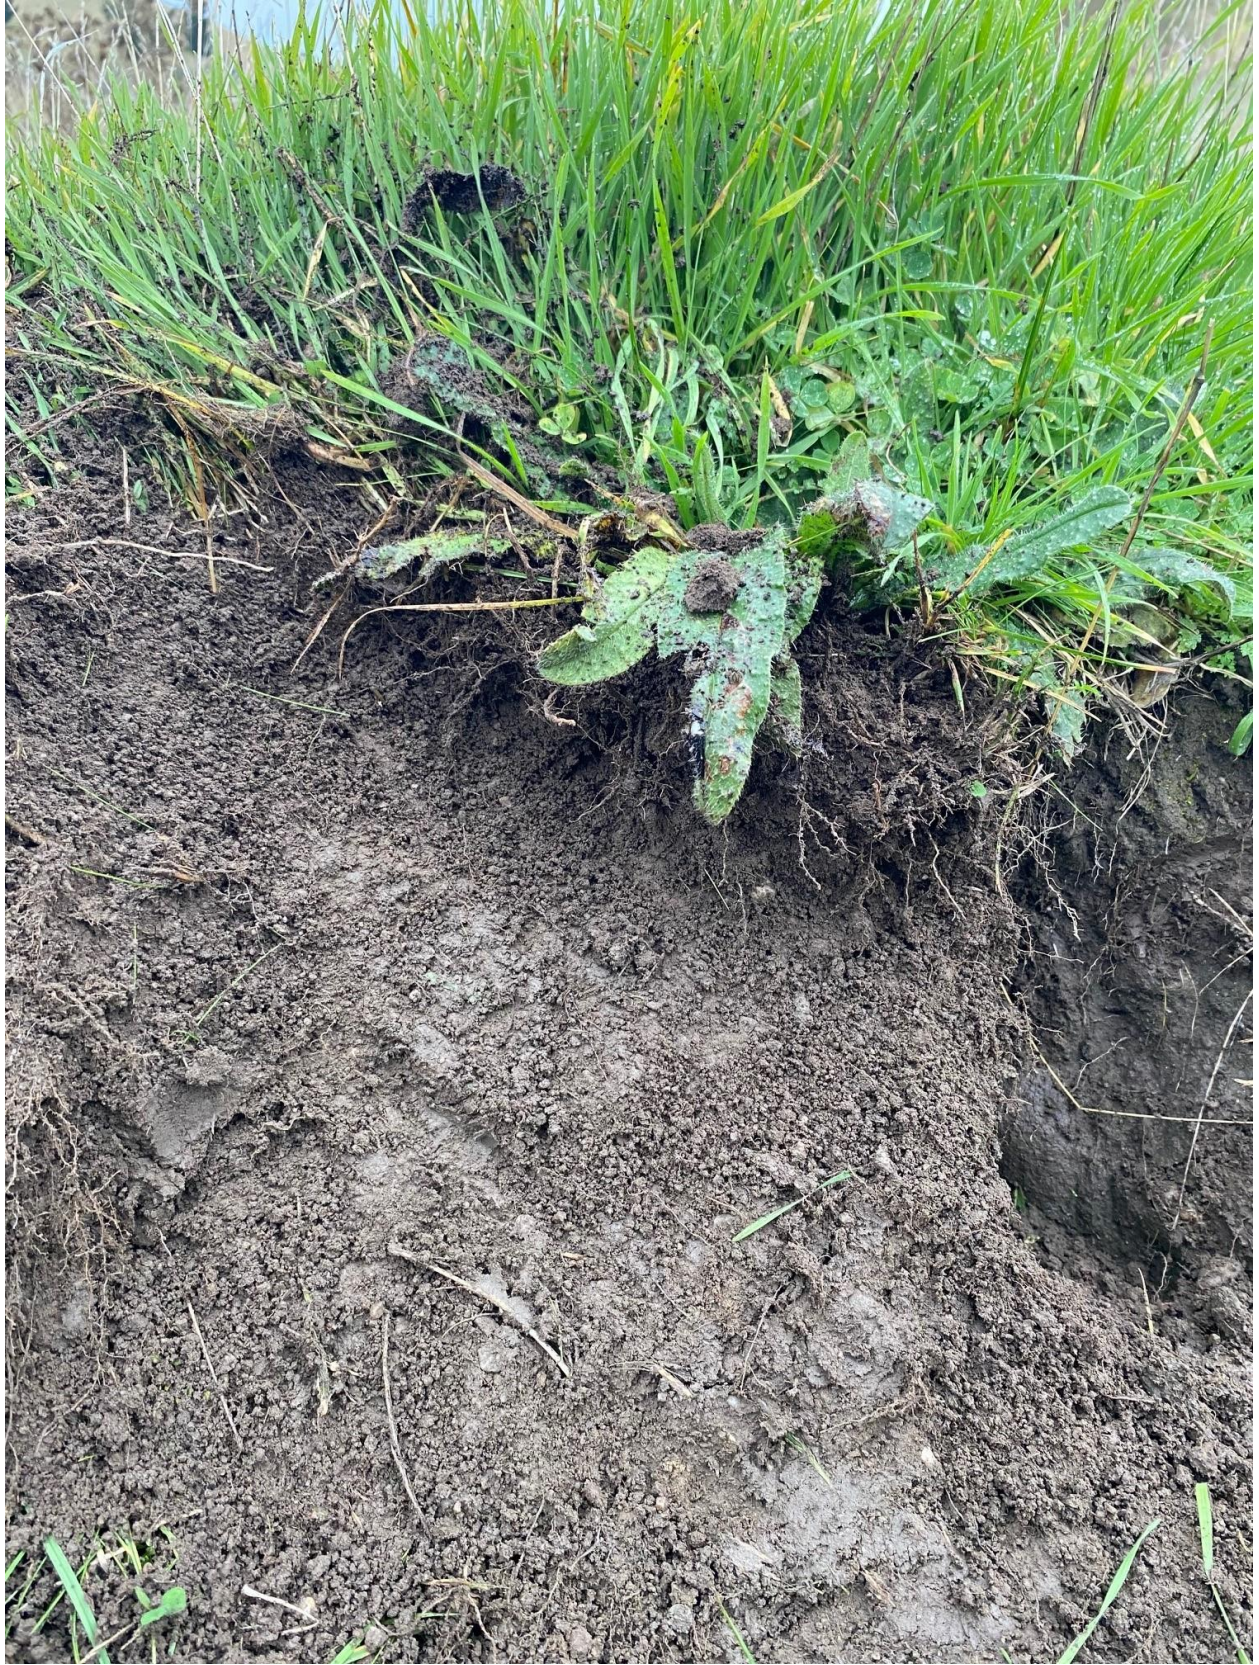
Photo 2. A representative soil assay illustrating shallow rooting depth and Aluminum toxicity at depth.
