BURN COTTAGE ROAD JV LTD - RESOURCE CONSENT APPLICATION FOR SUBDIVISION TO CREATE FOUR RURAL LIVING ALLOTMENTS AND FIVE BUILDING PLATFORMS AT 172 BURN COTTAGE ROAD

Report prepared by Vivian and Espie for Central Otago District Council			
Reviewed and Approved By	Jess McKenzie	Landscape Architect	27 April 2023

GEOTECHNICAL ASSESSMENT REPORT

172 BURN COTTAGE ROAD,
CROMWELL

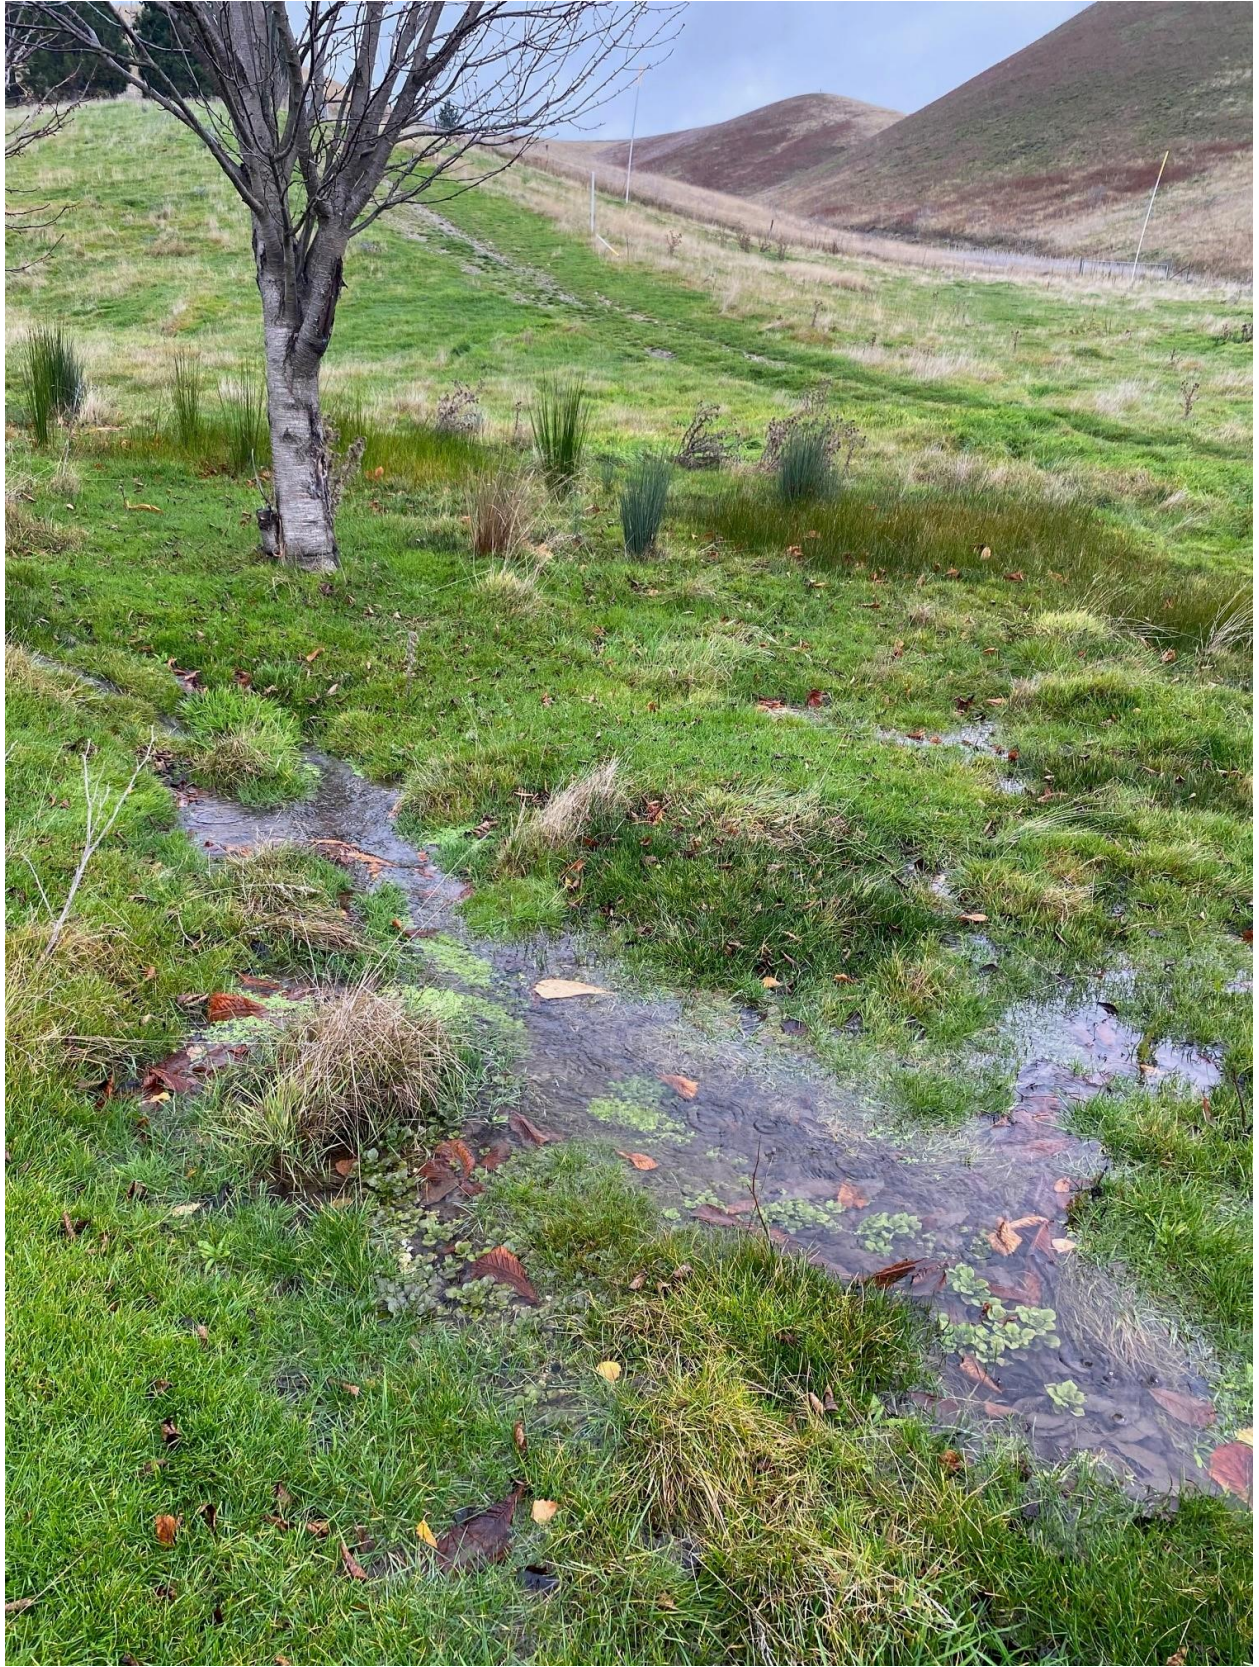
Photo 3. A representative part of proposed lot 4 within LUC 3 land showing a lot of surface runoff and a natural wetland area.
