LANDSCAPE AND VISUAL EFFECTS ASSESSMENT - PEER REVIEW MEMO

CENTRAL OTAGO DISTRICT COUNCIL

RC 230325 TO ESTABLISH AND OPERATE AN ALLUVIAL GOLD MINING OPERATION AT
1346-1536 TEVIOT ROAD, MILLERS FLAT

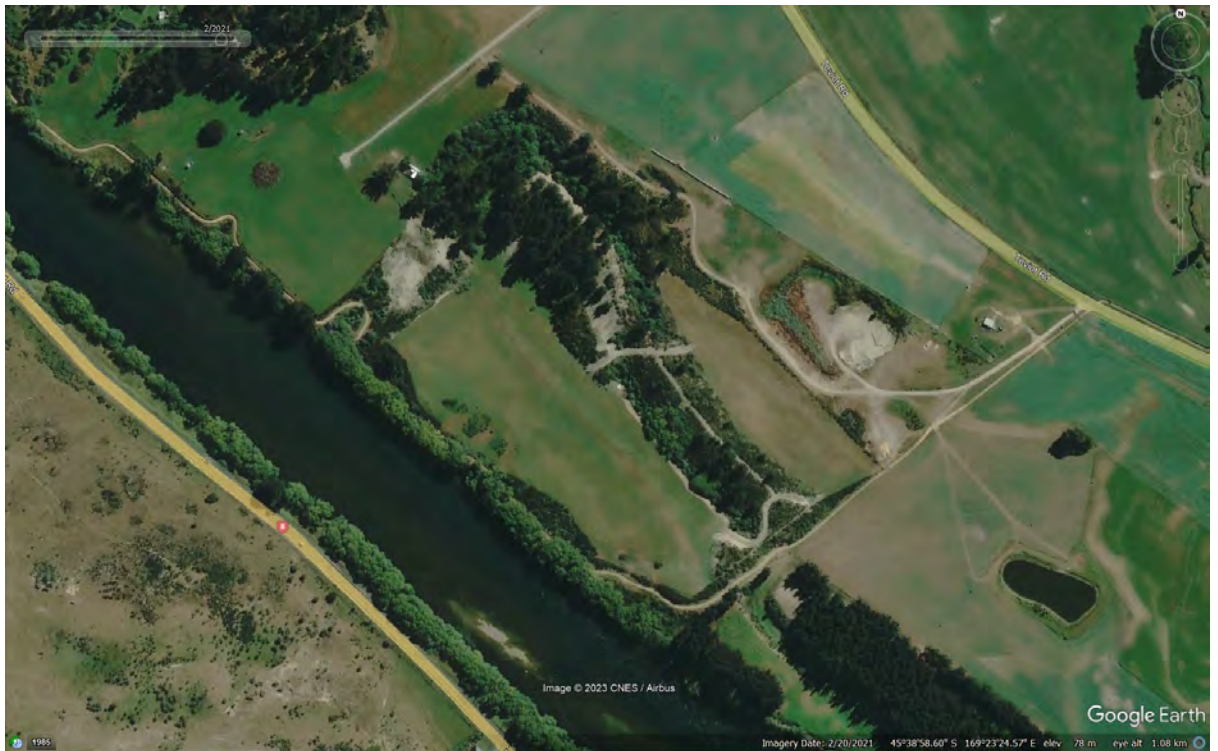
Figure 1: 2021 Google Earth image of the site

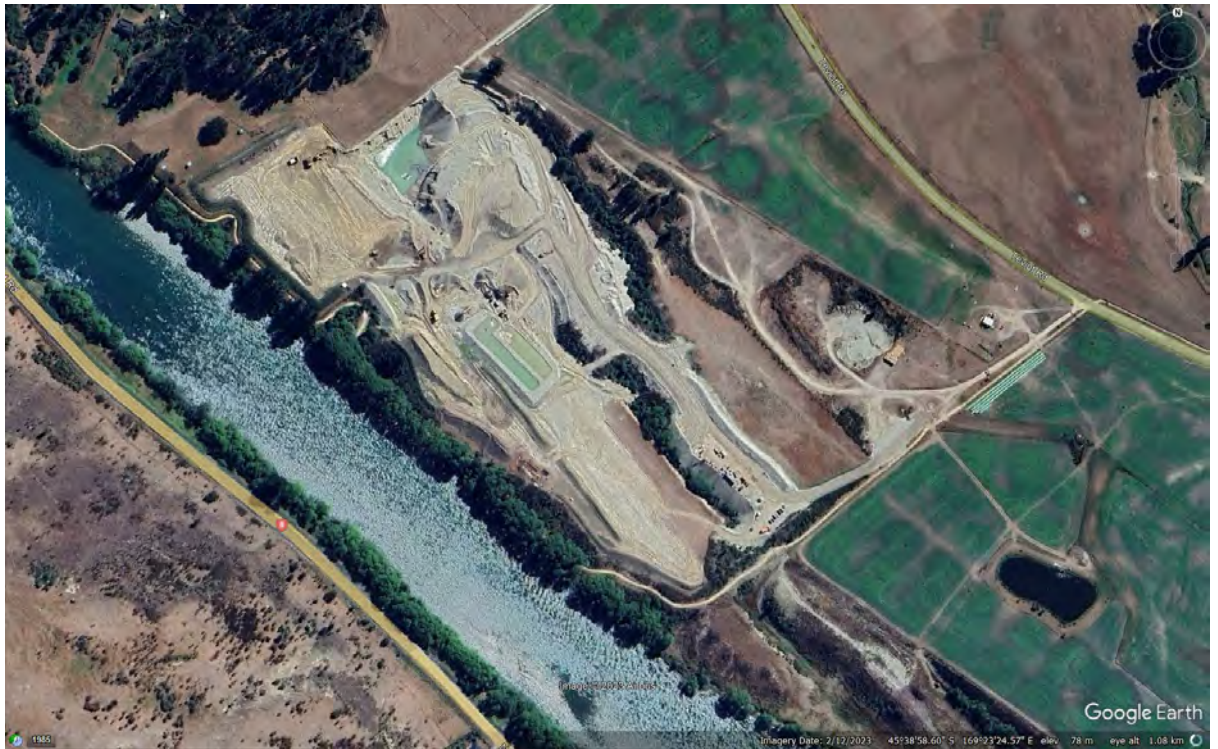
Figure 2: 2023 Google Earth image of the site

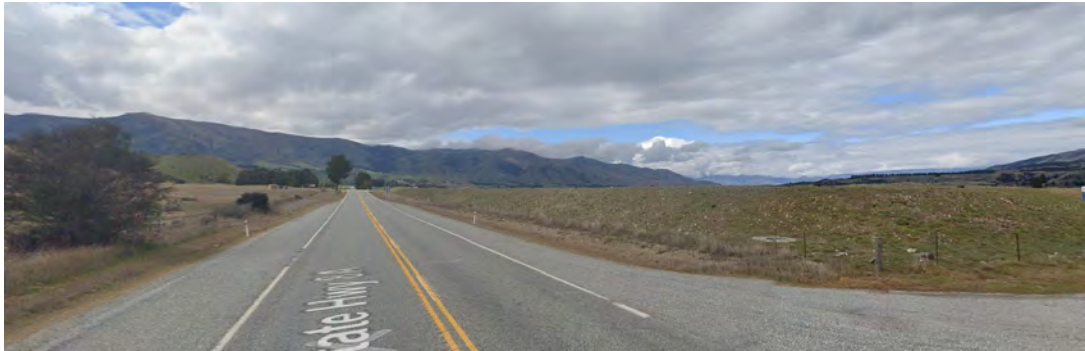
Figure 3: Roadside bunding at the Luggate Quarry

carried out within each stage, and is not removed prior to remediation, to ensure that views of the pit and ancillary activities are adequately screened from public and private locations. Consider lowering the height of the bund to 3m along the road and trail (in locations where this is appropriate for noise), and ensure it is an appropriate gradient to retain views of hills. See image below of suitable bunding screening a similar activity. (Right hand side of the road)

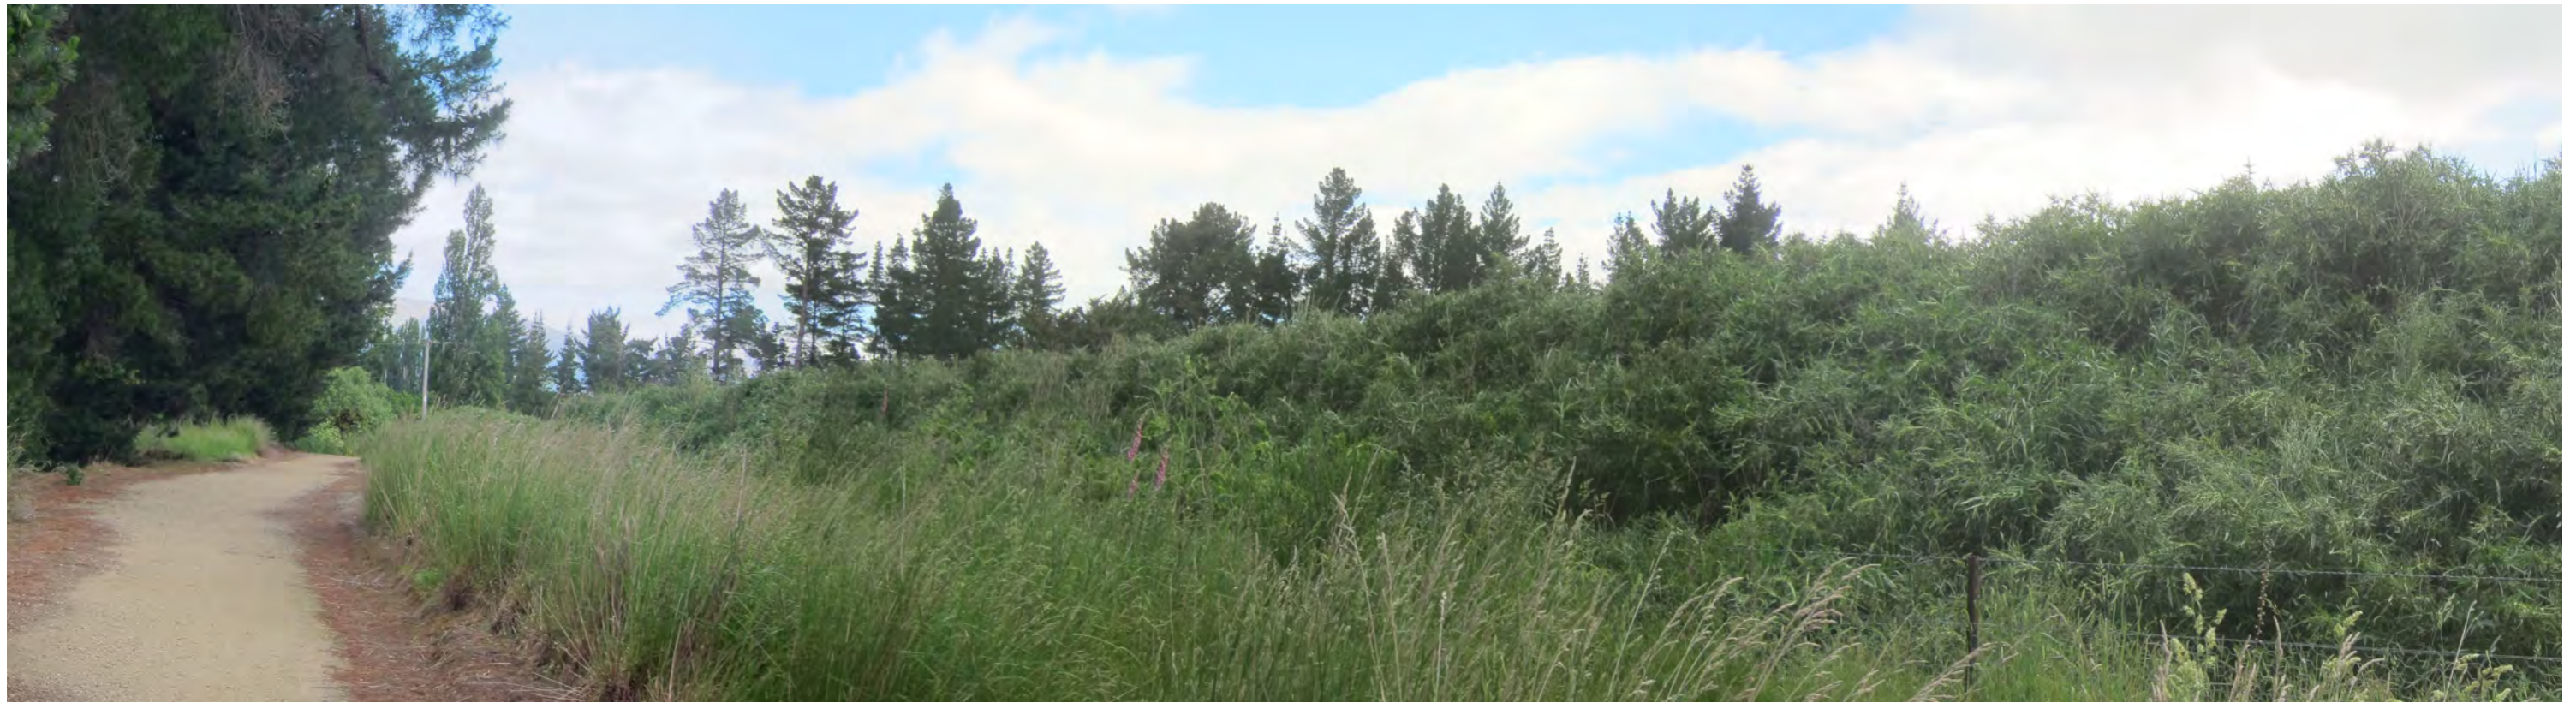
Viewpoint 1 - View from the Clutha Gold Trail adjacent to the subject site. Mining activities are fully screened by mounding.

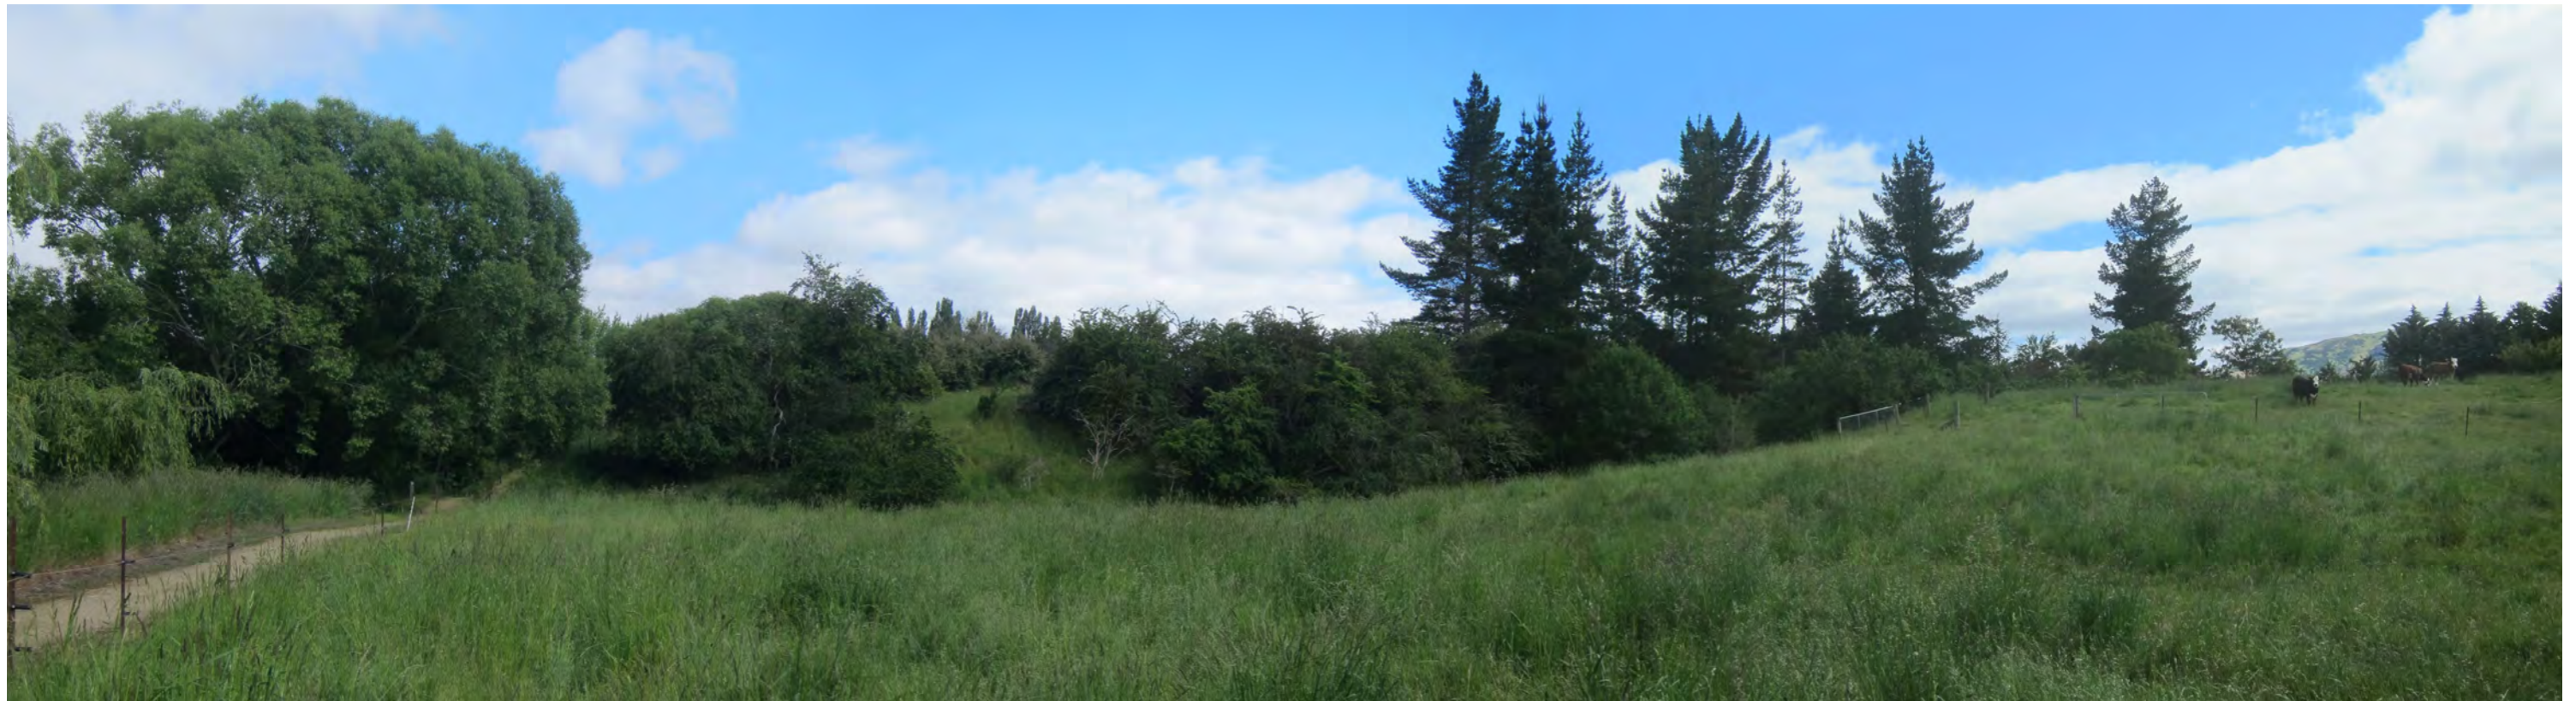
Viewpoint 3 - View from the site looking towards the Clutha Gold Trail adjacent to the subject site.

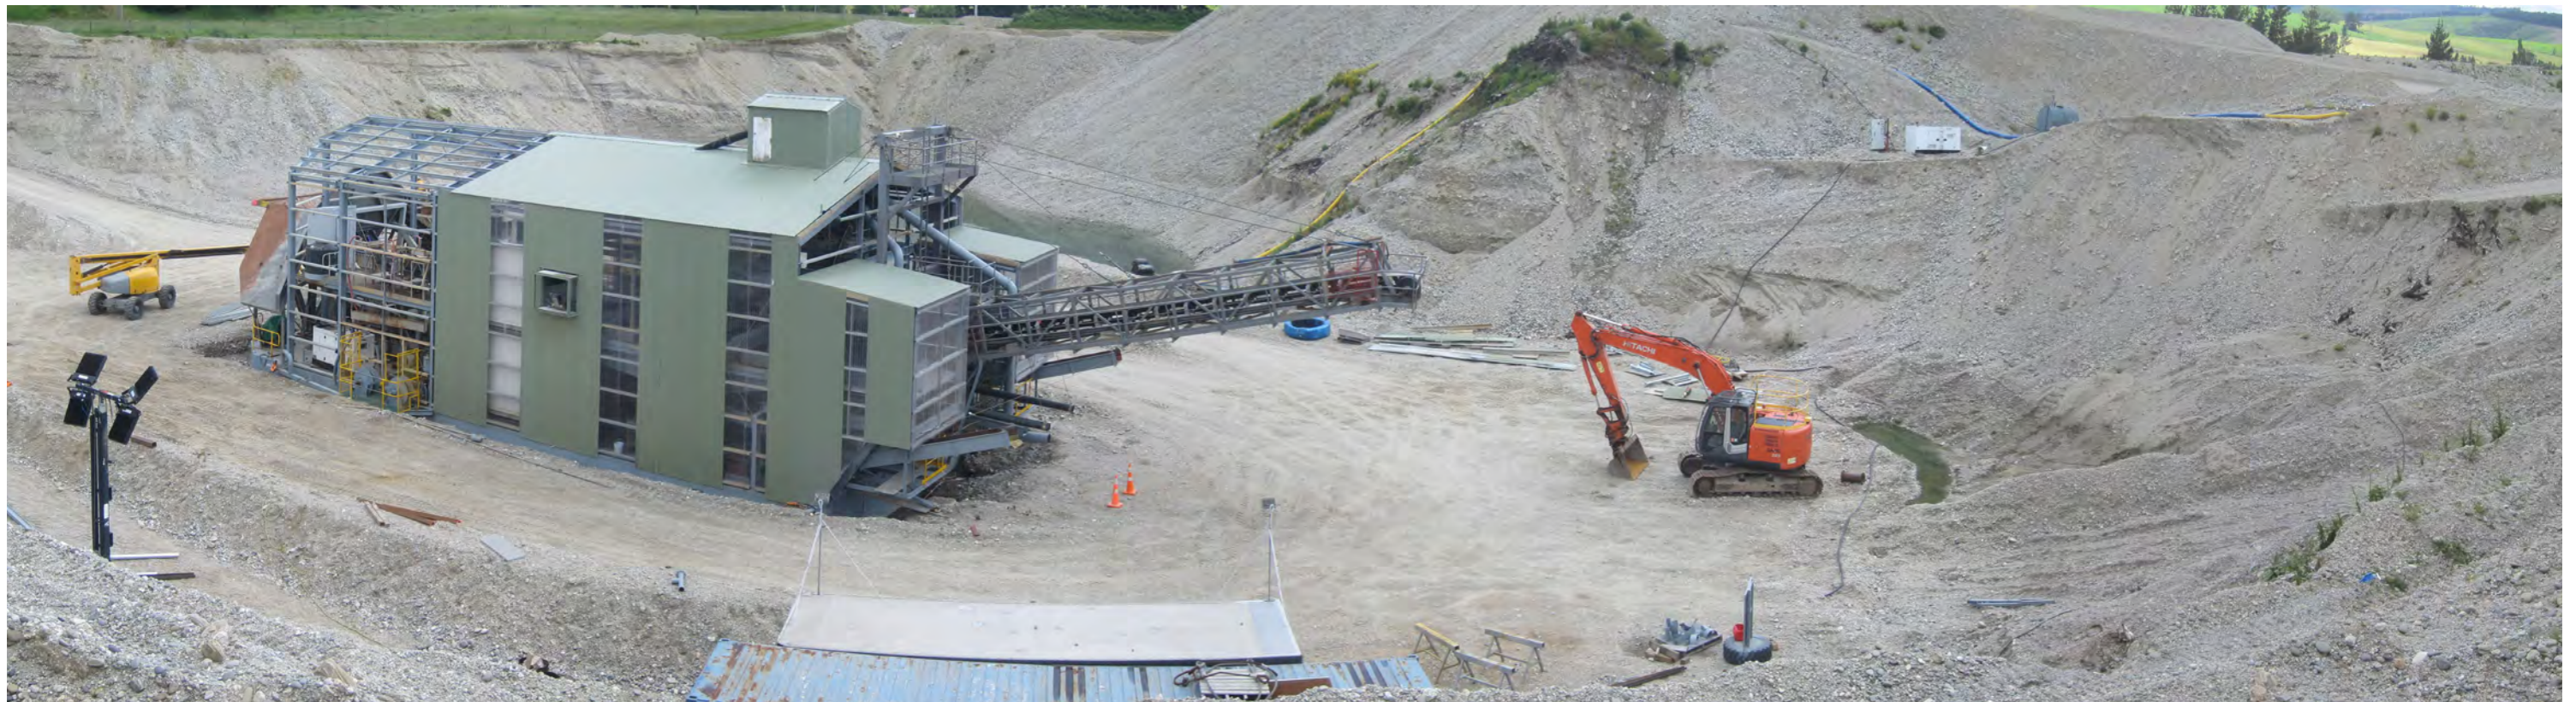
Viewpoint 4 - View of the dredge from within the site, the test pit and stockpiles can be seen behind the dredge.

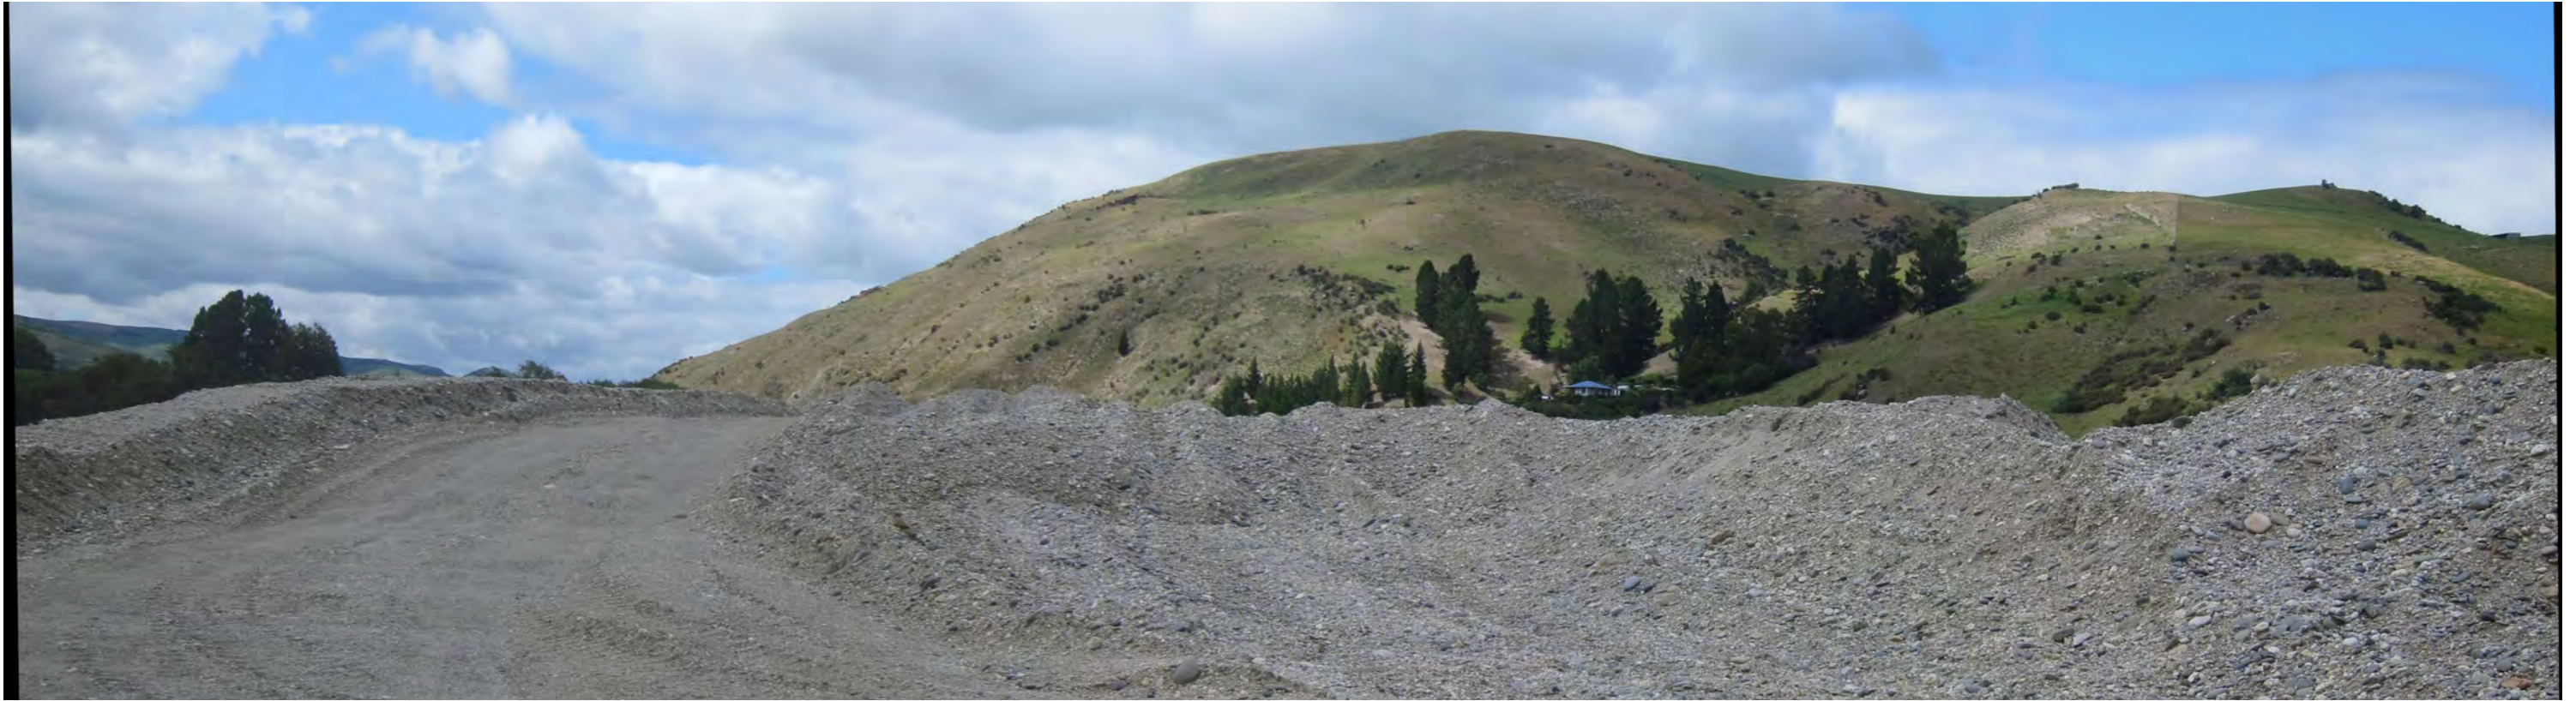
Viewpoint 5 - Looking towards 5474 Ettrick-Raes Junction Road (SH 8) which overlooks the subject site from on top of the stockpiles within the site.

<ul style="list-style-type: none"> - 5474 Ettrick-Raes Junction Road (SH 8) is a rural living allotment located approximately 500m west of the site, on an elevated hillside, overlooking the site. Details regarding timeframes, layout and outdoor storage and stockpiling within the operation area nearest this property are vague and offer little certainty regarding duration or degree of adverse effects on views and visual amenity. As such, the degree of adverse effect on views and visual amenity from this property could be up to a high degree. Again, conditions regarding screening, setbacks and location of storage areas could lower the the degree of adverse effects. - Once rehabilitation of the site is complete there will be no lasting effect. There is also potential to encourage a positive effect through conditions regarding rehabilitation.
<p>Effects on landscape character</p>	<ul style="list-style-type: none"> - <i>Adverse effect will be high while operational.</i> - <i>Proposed mitigation measures will limit the scale of impacts</i> - <i>Degree of adverse effects on openness, naturalness and rural amenity ranges from high to low-moderate.</i> - <i>Long term effect nil – positive.</i> 	<ul style="list-style-type: none"> - We agree that the adverse effect on landscape character while the mine is operational. We agree of adverse effects on openness, naturalness and rural amenity will vary depending on location and staging of the activity. However, a lack of detail around duration and mitigation makes it difficult to assess how proposed mitigation measures will limit the scale of impacts. - Again we agree that once rehabilitation has been undertaken there will be no lasting effect and visual effects will be neutral. We consider that insufficient information has been provided in the application regarding the rehabilitation process to determine that there will be a positive effect. However, we acknowledge that there is potential to encourage a positive effect through conditions regarding rehabilitation.

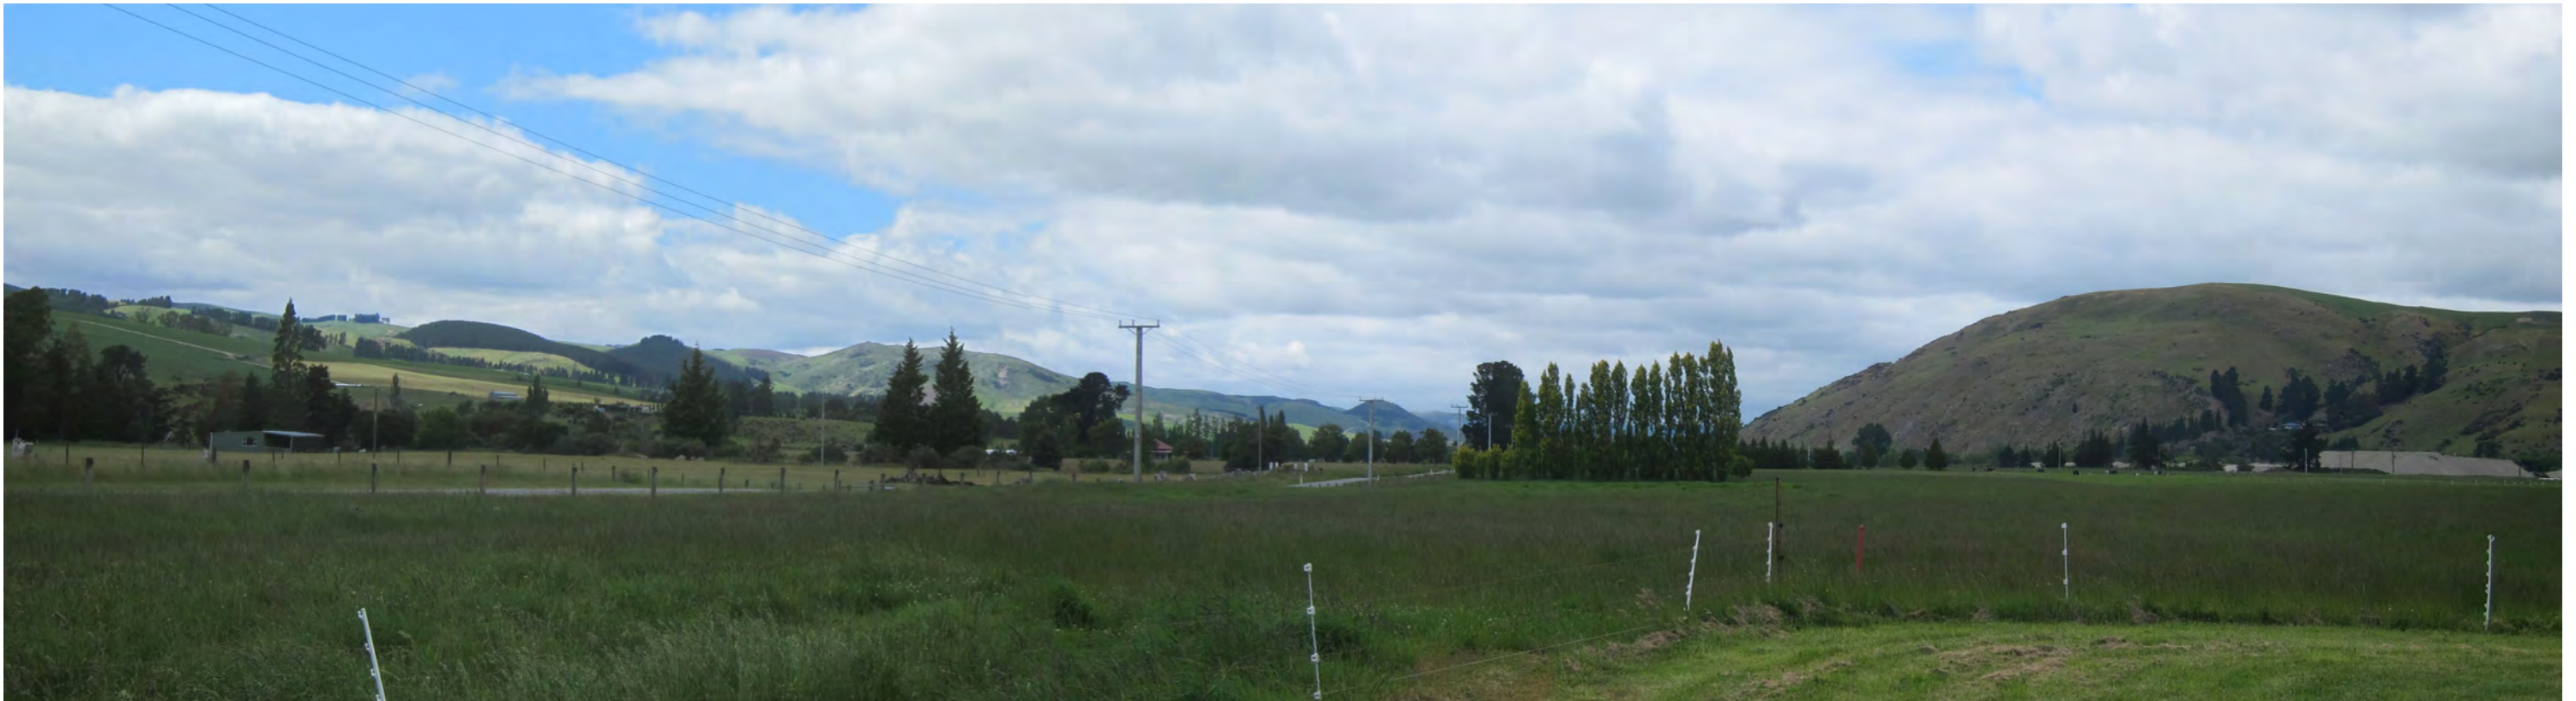
Viewpoint 6 - Looking towards the test pit and stock pile area from 1346 Teviot Road which forms part of the subject site.

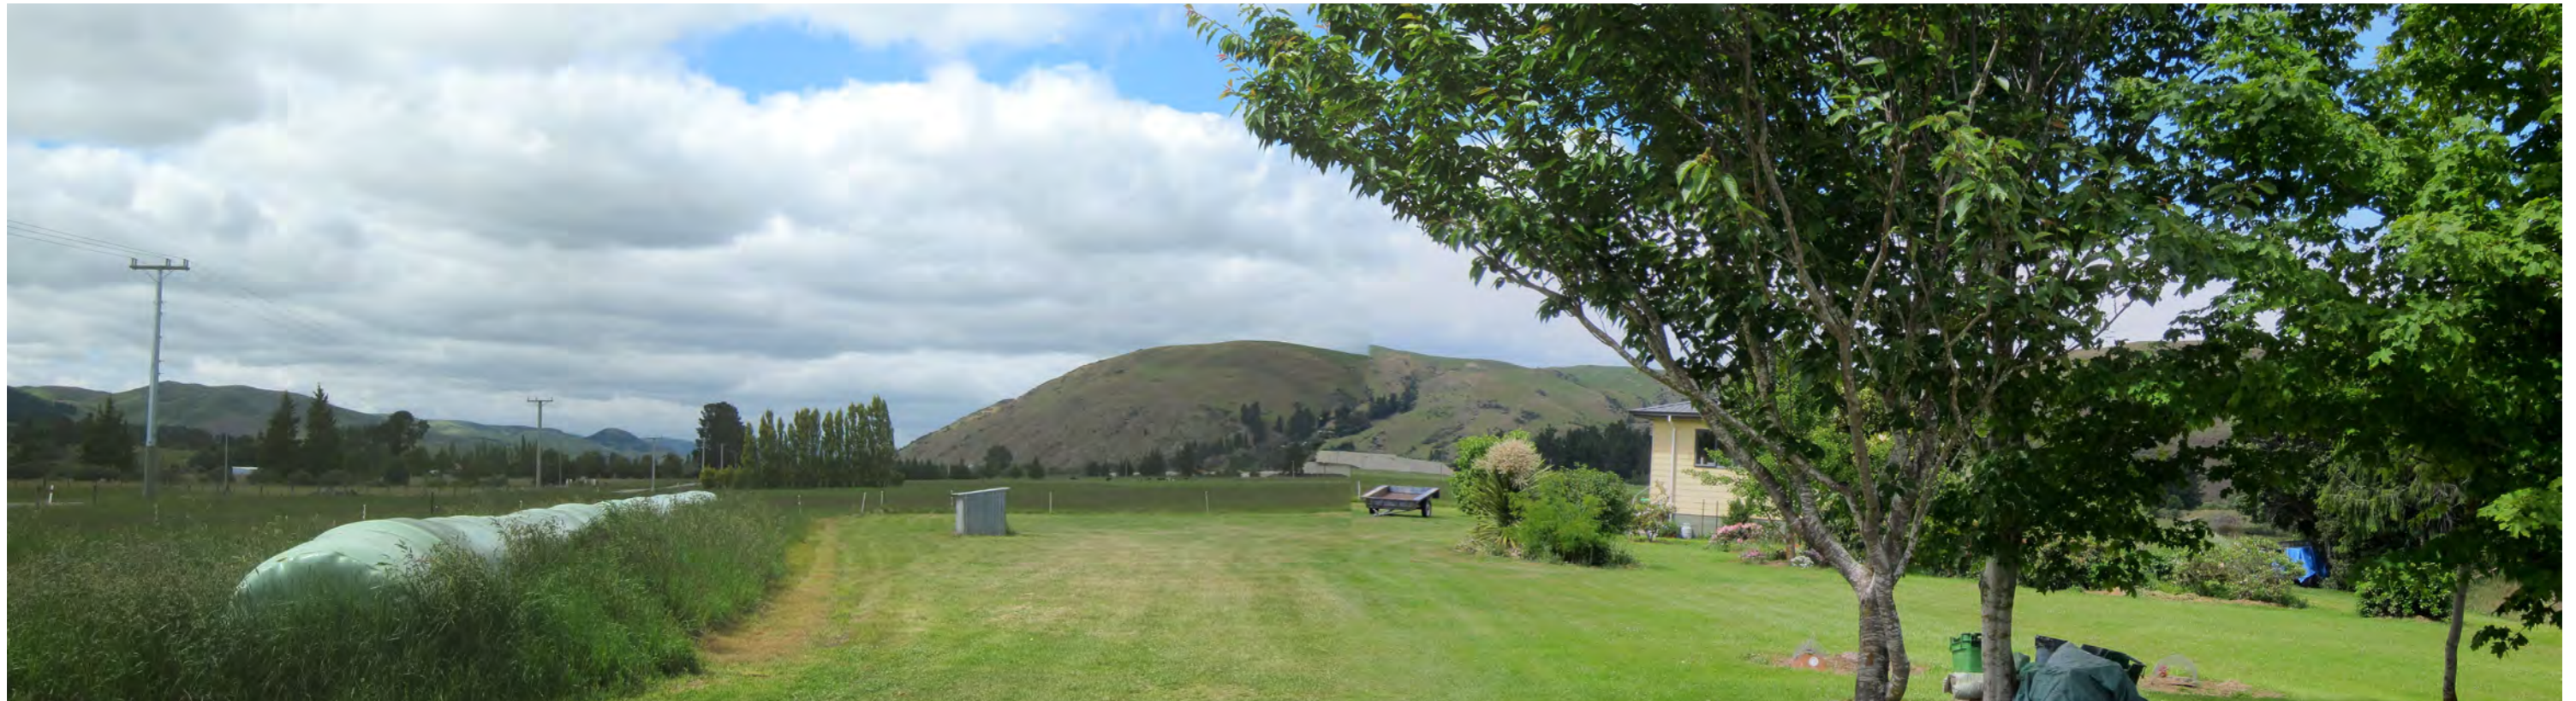
Viewpoint 8 - Looking towards the test pit and stock pile area from 1346 Teviot Road which forms part of the subject site.

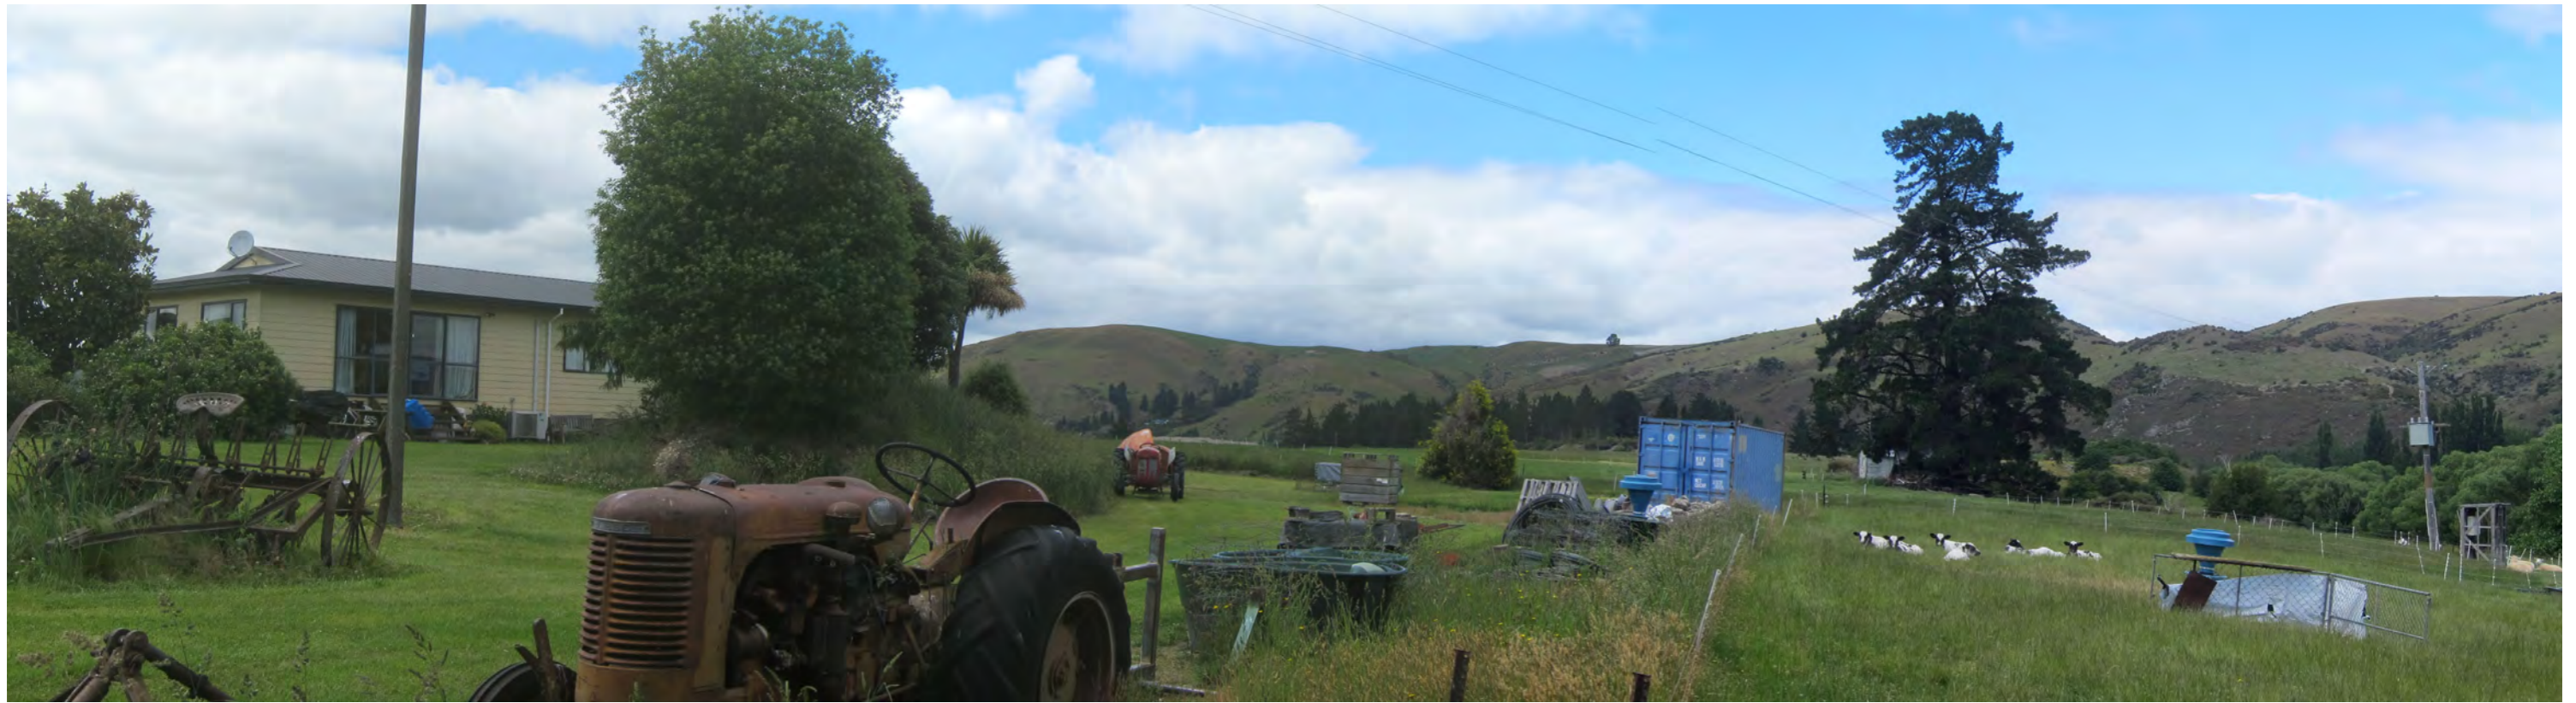
Viewpoint 9 -Looking towards the test pit and stock pile area from 1346 Teviot Road which forms part of the subject site.
