Agenda Paper

Vincent Community Board

Wednesday, 13 February 2019

- RECOMMENDED that the report be received.
- 19.1.6 **Mayor’s Report** **65**
- RECOMMENDED that the Mayor’s report be received.
- 19.1.7 **Alexandra Suspension Bridge Piers (PRJ 04-2002-01)** **66 - 233**

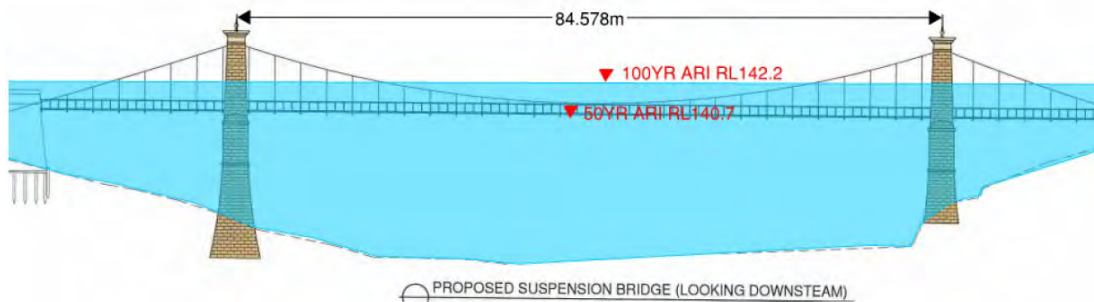
Figure 1: Bridge Reconstruction Adopting Original Deck Height

Beca found that construction of a bridge within the piers is possible. Coming up with a design that gives flood clearance and enough height so that people can safely walk/cycle through the arches may present some challenges. See Figure 1 illustrating flood levels on original deck height.

Prior to proceeding with Stage Two, the ASBWG reviewed design detail to date. They noted the bridge deck would need to be considerably higher than the original level because of the 100 year flood level. This higher deck level would then require a steep access approach on the northern side of the bridge. This would also require a large access area to accommodate the approach to the bridge.

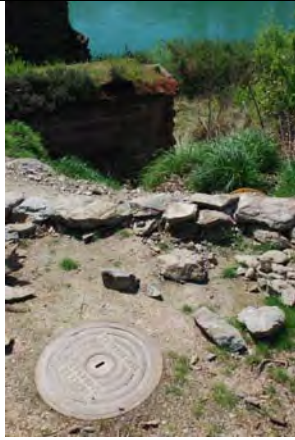
Inspection chamber constructed above the anchorages

- The principal threats to the remaining south bank structures are considered to be the discharge of water from SH8 above the structures and the encroachment of the bank/path and vegetation (see photographs below).

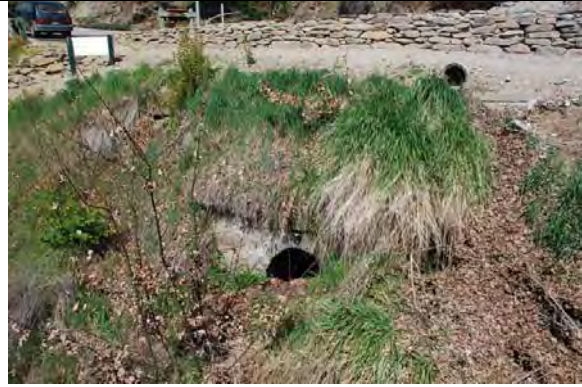
Surface water outlet directly above one of the anchorages – leaves indicate the main flow of water from the outlet

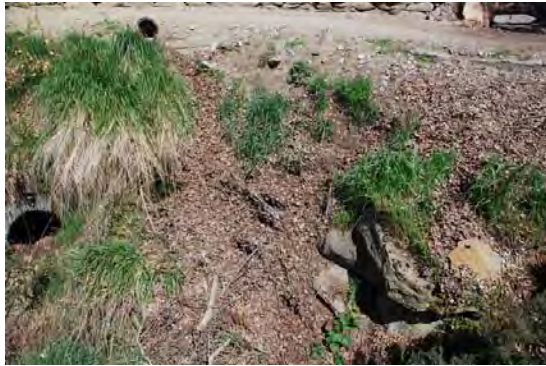
Water flows between the anchorages, which are likely to be clogged by debris. Remaining cables are likely to corrode more quickly.

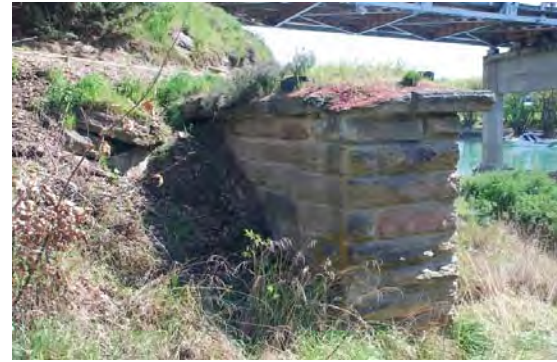
The bank is spreading and building up behind the small south pier/abutment.

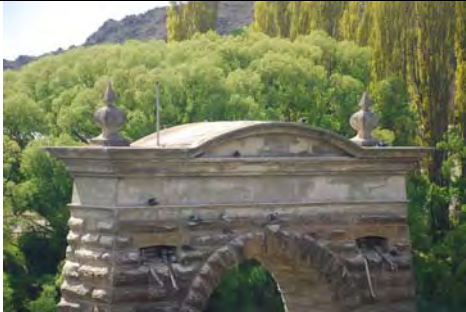
Ref:	Element	Significance	Photograph	Comment/Vulnerability
1.0	South Pier and Tower			
1.1	<p>Pediment, including entablature</p> <p>Classically-styled pediment with segmental/curved head. Entablature comprising cornice, plain frieze and architrave.</p> <p>Two urns or finials.</p>	<p>High</p> <p>Except for galvanised steel pipe projecting for the masonry adjacent to the west finial. The pipe is intrusive.</p>

<ul style="list-style-type: none"> ▪ The projecting galvanised steel pipe will corrode and damage the plaster/masonry in the long-term. ▪ The construction of the finials should be checked, together with the method by which they are affixed to the structure. ▪ Bird control wires are loose and fixings may have

<p>damaged the plaster/masonry.</p> <ul style="list-style-type: none"> Any surviving evidence of decoration/painting of the plaster/render should be recorded.

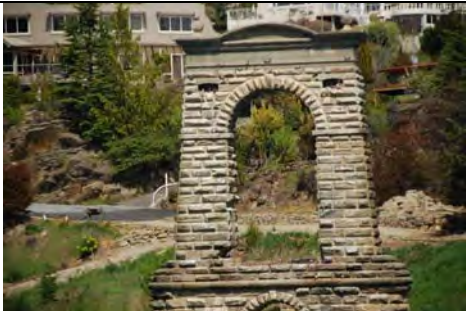
1.2	<p>Second stage</p> <p>Rusticated ashlar schist pillars with semi-circular arch, schist voissoirs, keystone and string course at the springers. Two cable channels with remaining iron cable arms. Channels have single stone lintels with tooling to mimic mortar joints.</p>	High

<ul style="list-style-type: none"> A chase has been cut in the inner face of the base to the east pillar and is thought to have formerly housed a water pipe. There is staining to the masonry both from water runoff and pigeon guano. Scars of the former deck and railings are visible to the inner faces of the pillars and should be retained.

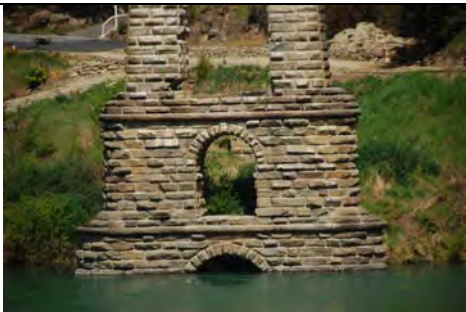
1.3	<p>First stage</p> <p>Rusticated ashlar schist stonework pierced by arch with semi-circular head, schist voissoirs and keystone. Bolection mould/bullnose string courses above and below the arch.</p>	High

<ul style="list-style-type: none"> The masonry to this stage is typical of the exposed stonework to the pier and appears generally to remain in good condition, where visible. It seems that there has been some erosion of isolated blocks, but this may be the result of some blocks being face-bedded. The presence of iron/steel reinforcement to the whole pier is not known but, if present, would be a vulnerability to the masonry and structure due to the

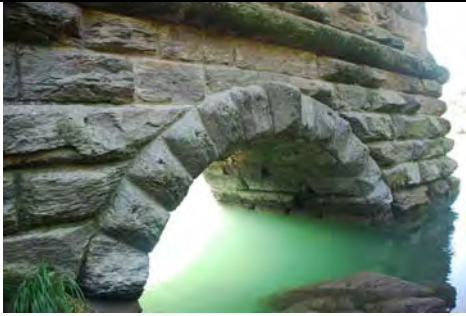
1.4	<p>Base</p> <p>Rusticated ashlar schist stonework pierced by arch with semi-circular head, schist voissors and keystone.</p>	High

<p>effects of corrosion.</p> <ul style="list-style-type: none"> ▪ A substantial part of the base was submerged at the time of inspection and, following construction of the Roxborough Dam, remains so throughout the year. Whilst understood from the recent diver survey to be in good condition the submerged masonry will be prone to erosion.

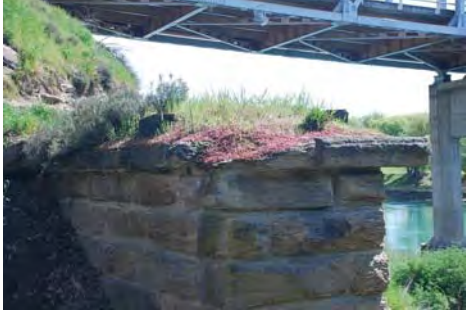
2.0	Small South Pier/abutment			
	<p>Masonry capping with remaining timber bearer to the top and bitumen/asphalt finish to part.</p> <p>At the west end there are the remains of a concrete footing.</p>	High

<ul style="list-style-type: none"> ▪ Vegetation growth is impinging on the pier. Some minor growth may act as a protective soft capping to the masonry, but it should not cover the timber bearer or the timber will decay more rapidly. Larger roots may disturb individual stones. ▪ The adjacent footpath bank is likely to continue to push and spread against the masonry and may be the cause of the dislodged stone at the west end.

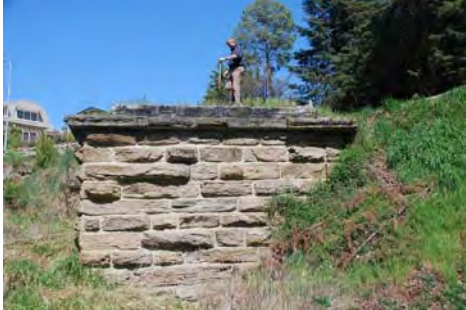
<p>Ashlar stonework</p> <p>Rectangular in shape with stonework of regular courses and partially rusticated style.</p> <p>At the foot of the pier, there is a section of cable that has been cut with a cutting torch.</p>	<p>High</p>

<ul style="list-style-type: none"> ■ The adjacent footpath bank is encroaching upon the structure. ■ A surface water drain discharging from the new bridge highway has been constructed so as to disperse water out of the bank above/behind the pier. This will erode the ground around the pier and may undermine the masonry in the long-term.
<p>3.0</p>				
<p>South anchorages</p>				
	<p>Masonry tunnels built into the bank.</p> <p>Sections of the wire-braid cables remain.</p>	<p>High</p>

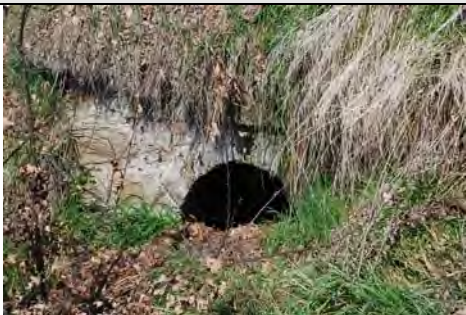
<ul style="list-style-type: none"> ■ The adjacent footpath bank and its vegetation are encroaching upon the structure. One of the anchorages can no longer be seen. ■ A surface water drain discharging from the new bridge highway has been constructed so as to disperse water out of the bank above the structures. This will erode the ground around, water and debris are likely to fill the tunnels

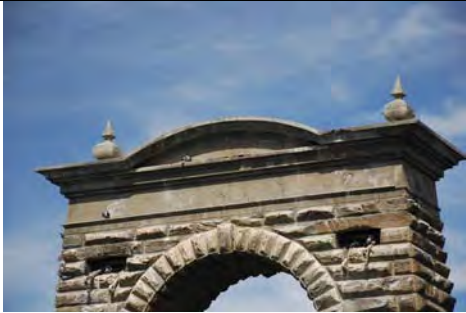
4.0	North Pier and Tower			
4.1	<p>Pediment, including entablature</p> <p>Classically-styled pediment with segmental/curved head. Entablature comprising cornice, plain frieze and architrave.</p> <p>Two urns or finials.</p>	High

<ul style="list-style-type: none"> ▪ The construction of the finials should be checked, together with the method by which they are affixed to the structure. ▪ Bird control wires are loose and fixings may have damaged the plaster/masonry. ▪ Any surviving evidence of decoration/painting of the plaster/render should be recorded.

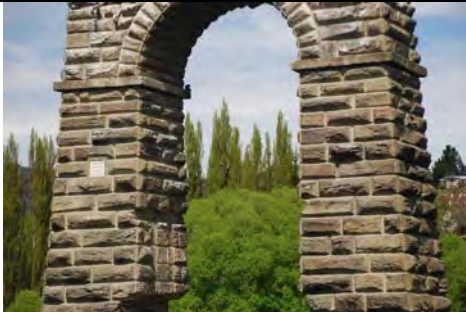
4.2	<p>Second stage</p> <p>Rusticated ashlar schist pillars with semi-circular arch, schist voissiors, keystone and string course at the springers. Two cable channels with remaining iron cable arms. Channels have single stone lintels with tooling to mimic mortar joints.</p>	High

<ul style="list-style-type: none"> ▪ The east pier has a small plaque recessed into the face of the stonework. It gives the date of opening of the bridge and the names of the engineer and builder. ▪ A chase has been cut in the inner face of the base to the east pillar and is thought to have formerly housed a water pipe. ▪ There is staining to the masonry both from water run-off and pigeon guano. ▪ Scars of the former deck and railings are visible to the inner faces of the pillars and should be retained.

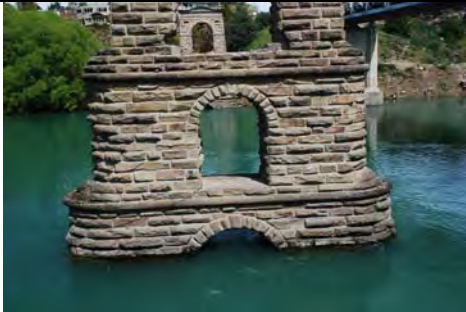
<p>4.3</p>	<p>First stage</p> <p>Rusticated ashlar schist stonework pierced by arch with semi-circular head, schist voissoirs and keystone. Bolection mould/bullnose string courses above and below the arch.</p>	<p>High</p>

<ul style="list-style-type: none"> ■ The masonry to this stage is typical of the exposed stonework to the pier and appears generally to remain in good condition, where visible. It seems that there has been some erosion of isolated blocks, but this may be the result of some blocks being face-bedded. ■ The presence of iron/steel reinforcement to the whole pier is not known but, if present, would be a vulnerability to the masonry and structure due to the effects of corrosion.
<p>4.4</p>	<p>Base</p> <p>Rusticated ashlar schist stonework pierced by arch with semi-circular head, schist voissoirs and keystone.</p>	<p>High</p>

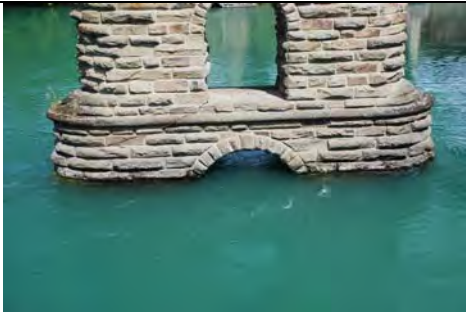
<ul style="list-style-type: none"> ■ A substantial part of the base was submerged at the time of inspection and, following construction of the Roxborough Dam, remains so throughout the year. Whilst understood from the recent diver survey to be in good condition the submerged masonry will be prone to erosion.

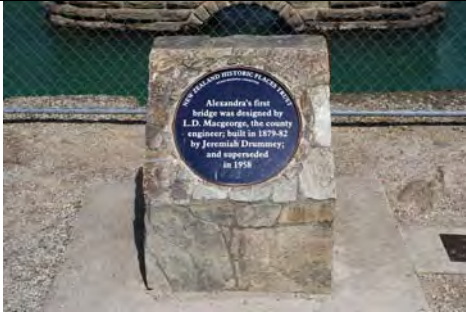
5.0	North abutment			
	<p>Upper surface</p> <p>Gravel and concrete surrounded by galvanised steel frame and mesh fencing.</p> <p>'Blue' NZ Historic Places Trust plaque and smaller recessed plaque indicating the level of the 14th October 1978 flood.</p>	<p>Low</p> <p>Fencing - intrusive</p>

<ul style="list-style-type: none"> Whilst of low significance, the plaques should be removed, but should be retained and incorporated in any proposed alterations to the abutment. It may be that they can stay in their existing positions during future alterations to the bridge structures.
	<p>Masonry walls</p> <p>Coursed stonework.</p> <p>Limited inspection - only the east face was readily visible/accessible.</p>	<p>High</p>

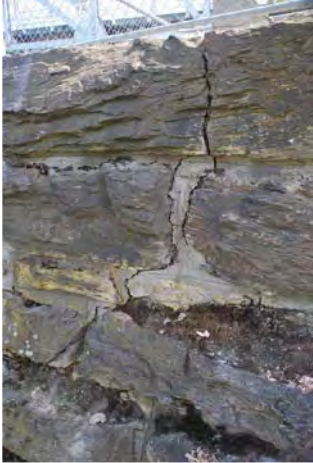
<ul style="list-style-type: none"> There is fracturing in the east face, which has cracked through repointing work done. Historical research indicates that the abutment was built upon a timber platform and piles. Their decay could result in movement/settlement of the masonry. See also Hadley & Robinson report. Some recent repointing has been carried out in a hard, modern cement mortar. It is intrusive and out of keeping with the character of the masonry to the abutment.

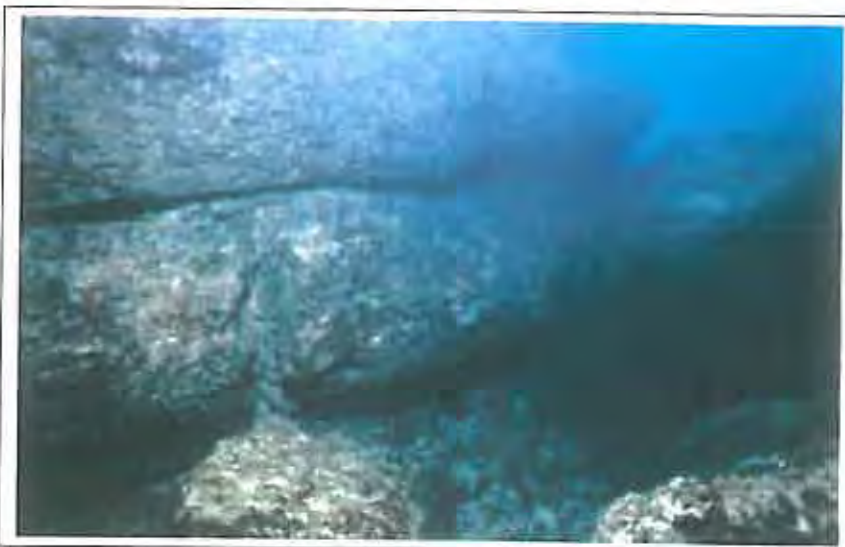
2.. Upstream corner (bank side) of true left pier showing rocks on bottom adjacent to river bed.

Some depression of joints evident along with elevated block faces. No significant scouring of faces noticeable. Note large block size.

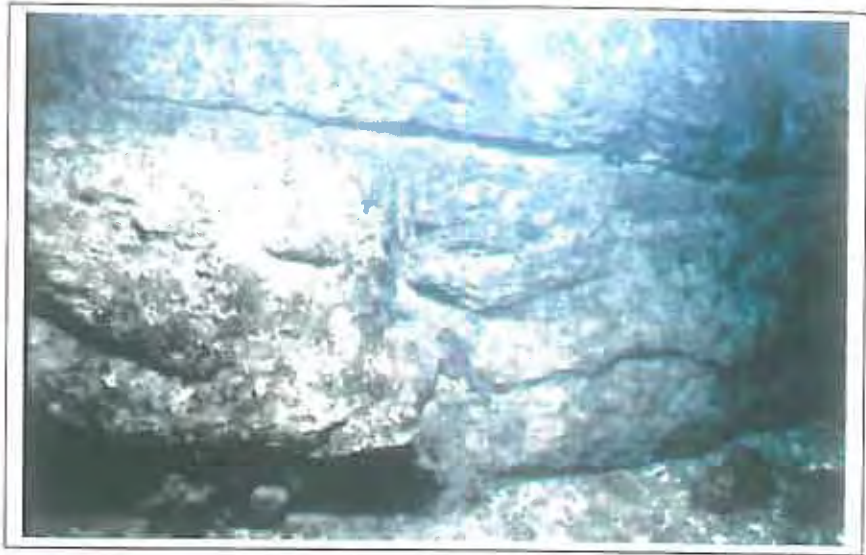
4.. Downstream end
of true left pier at
river bed level.

Joints tight and faces
probably as per
quarrying. Blocks
here are quite large.

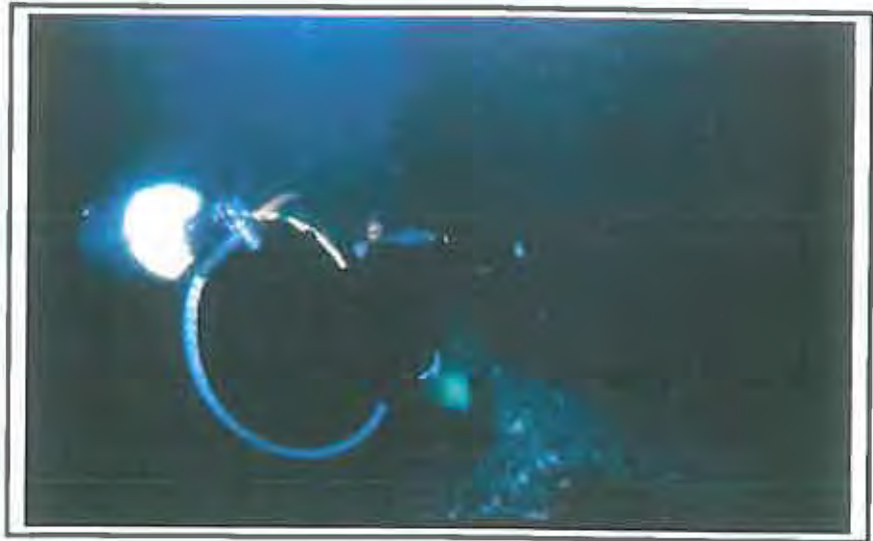
5.. Diver at bottom
rear of true left pier.
Note accumulation of
gravel coming around
from exposed river
side of pier.

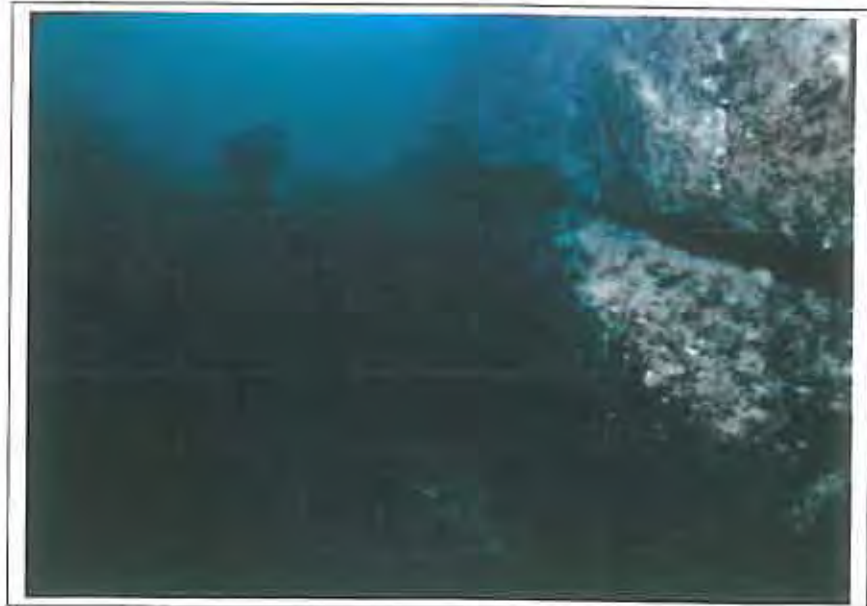
6.. View upstream
along bottom of true
left pier at river-bed
level, outer or river
channel side.

Joints evident but not
worn, faces
moderately elevated,
note algae on rock
surface.

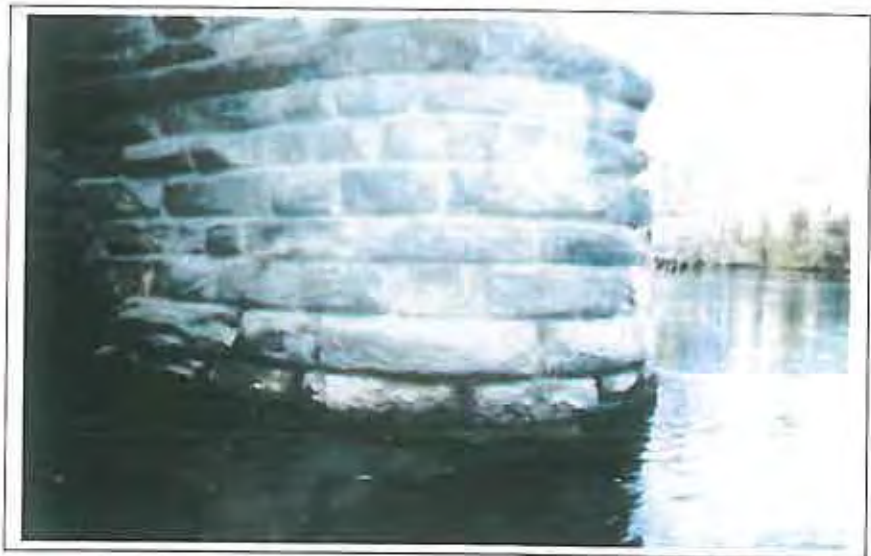
9.. True right pier, downstream end, river channel side.

Joints clearly visible, in good order. Block faces less elevated than those on true left pier (from different quarry?).

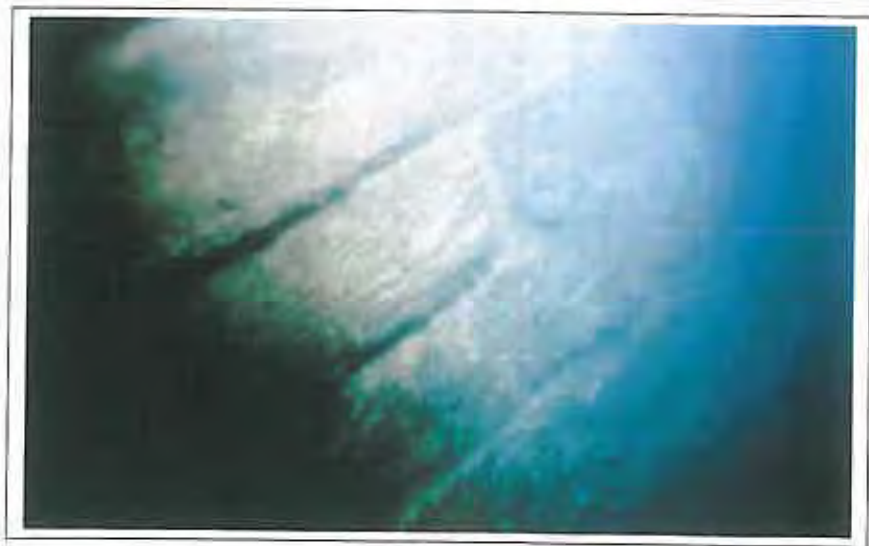
10.. True right pier,
upstream end, river
channel side.

Joints clearly visible
but not scoured.
Block faces more
elevated here. Note
algae on rock surface.

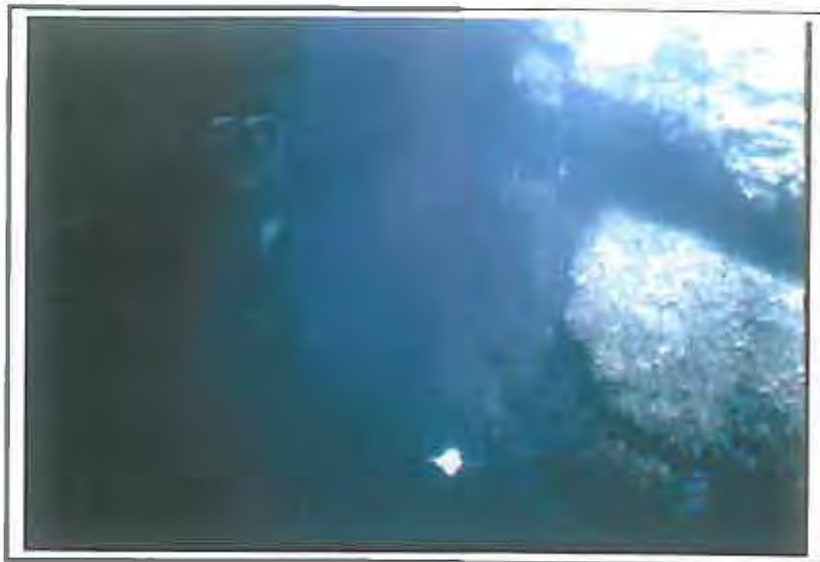
11.. Close-up of
block-work, true right
pier.

Quartzose striations
clearly visible in
stone. Joints appear
in good order.

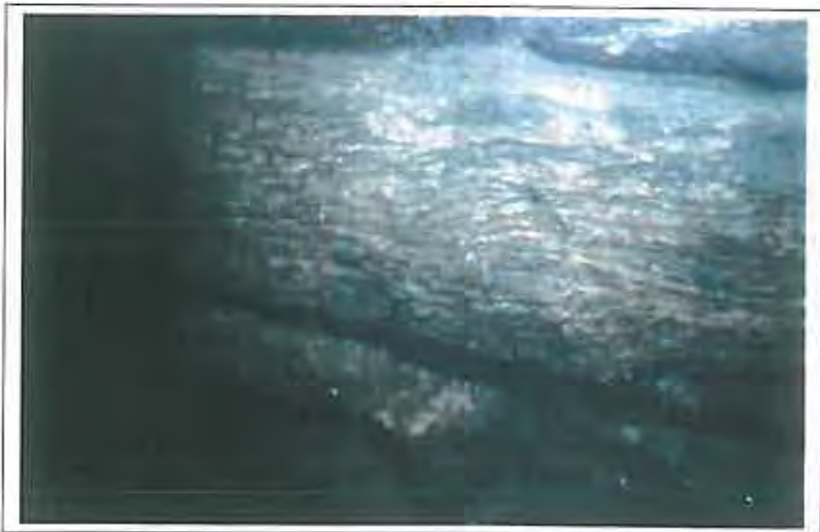
12.. View from within
central portal of true
right pier.

Note elevated faces
on several blocks and
jointing. Most
underwater surfaces
are similar.

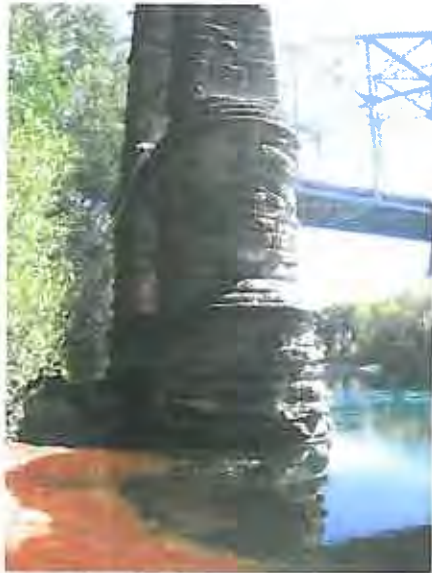
South pier location

The photo of the south pier also shows the extension ladder in position up to the level of the original bridge deck.

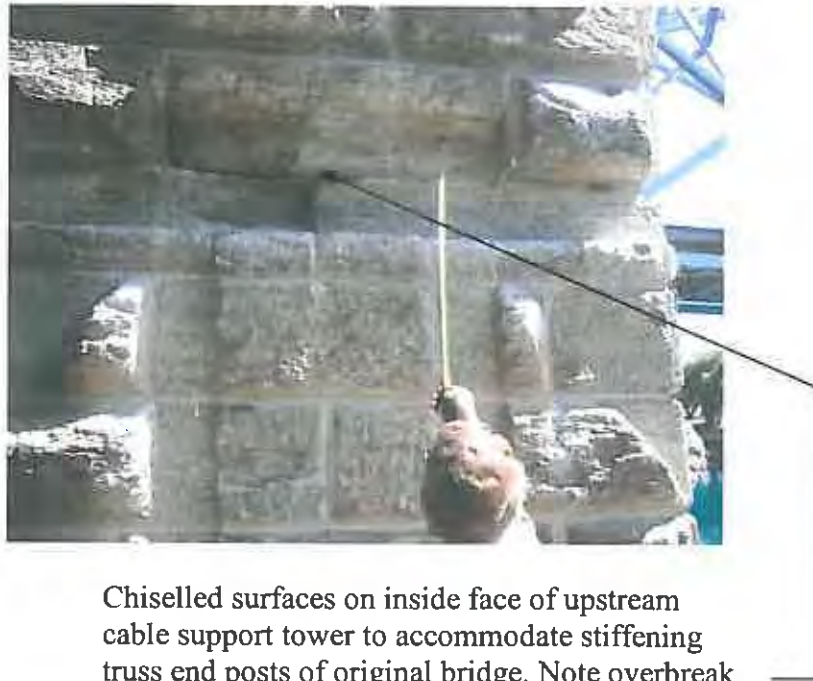
The masonry in the south pier was found to be in excellent condition in all areas which were able to be inspected. The stone blocks showed little or no weathering and no major cracking apart from a localised area on the inside face of the upstream archway at the level of the top chord of the original timber stiffening truss. It is probable that this was caused during demolition when the end post of the timber truss was removed, as can be seen in the following photo.

Chiselled surfaces on inside face of upstream cable support tower to accommodate stiffening truss end posts of original bridge. Note overbreak in region at centre left.

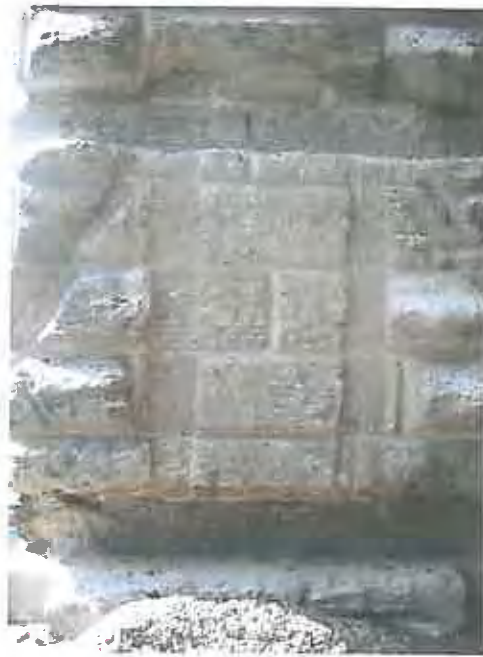
It was noted that a curved rebate has been chiselled out at the base of the downstream cable support tower at the former roadway level of both piers. It appears that this was done at some stage during the 1940's to accommodate a water main which was laid across the bridge to serve the new residential development on the southern bank of the river. This rebate occupies only a small area at the base of the cable support tower and hence is unlikely to have any significant effect on the structural capacity of the tower. The fact that no signs of cracking were detected in the masonry around the rebate during our close inspection, confirms this assumption.

← View of curved recess at foot of
Downstream cable support tower

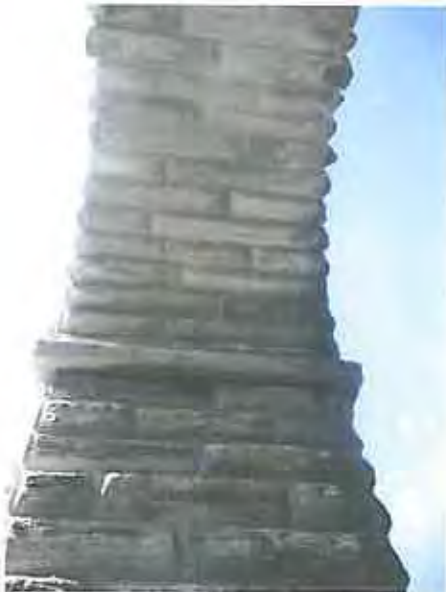
Intrados of upper arch

The intrados stonework in the archways is in excellent condition with no signs of cracking or deterioration.

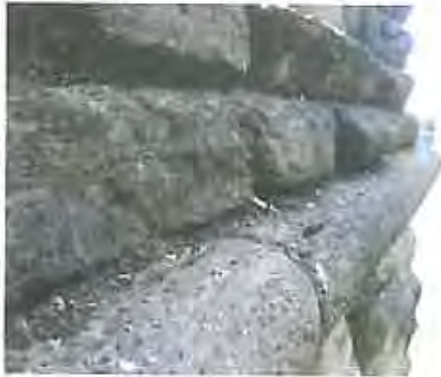
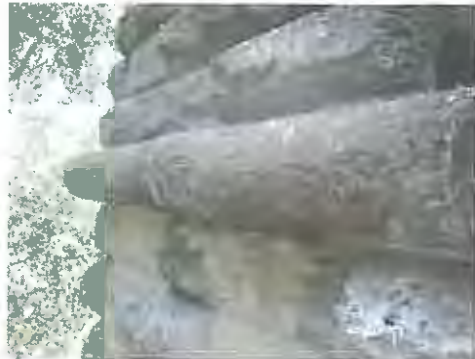
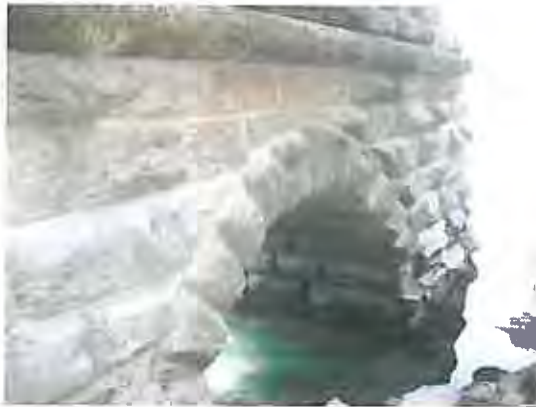
Typical view of masonry in exterior faces of the south pier

The masonry in the exterior faces of both piers showed negligible signs of weathering.

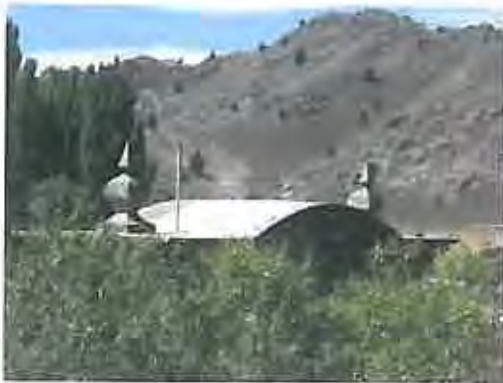
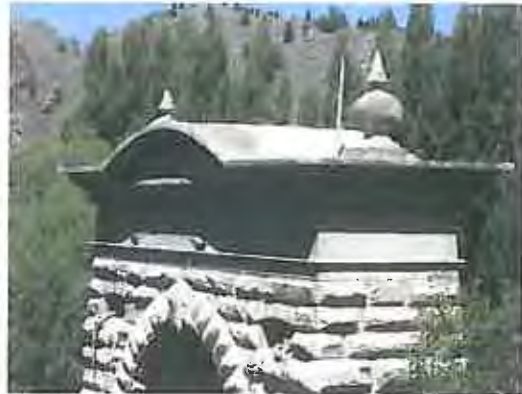
Capital on south pier

The plasterwork on the capitals of both piers exhibited some minor spalling and fretting but generally appeared to be sound. Repairs are not considered to be urgent but should be programmed to be carried out within the next ten years to avoid on-going deterioration.

- At the plastered top sections, carefully inspect all areas of plaster following careful steam cleaning.
- Several areas of the top edge of the upper plaster cornice to both piers has broken away due to cracking of the plaster at this thin edge, allowing water to enter the cracks and freezing over the winter months, causing spalling.

- Carefully repair the decorative urns atop the piers with plaster to match the existing, including the missing pinnacles.
- Once all cleaning and repair work has been carried out, install Ace Birdproofing pigeon spike stripping to the outer edges of the tops of both main piers and to all ledges on which pigeons tend to roost. This spike stripping is fixed with gum or adhesive.

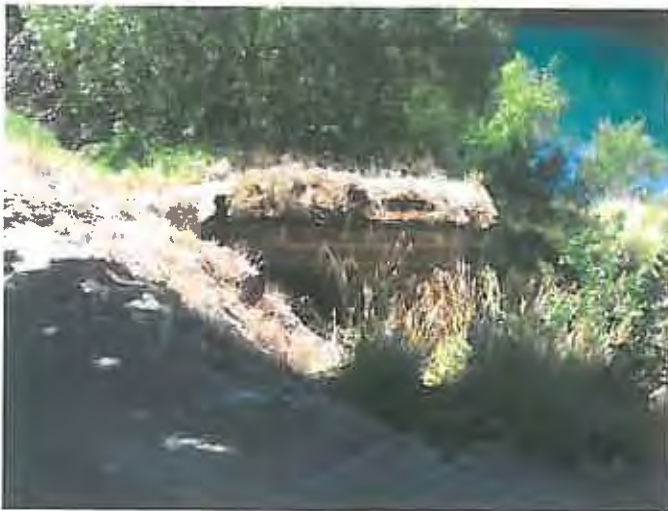
An intermediate support pier exists between the abutment and the main pier and was formerly adorned with masonry side pillars as seen in historical photos. The masonry of this intermediate pier appears to be sound

View of intermediate support pier between old abutment and main pier on Roxburgh side of river. It may be possible to restore this pier including the replacement of the original masonry pillars on each side

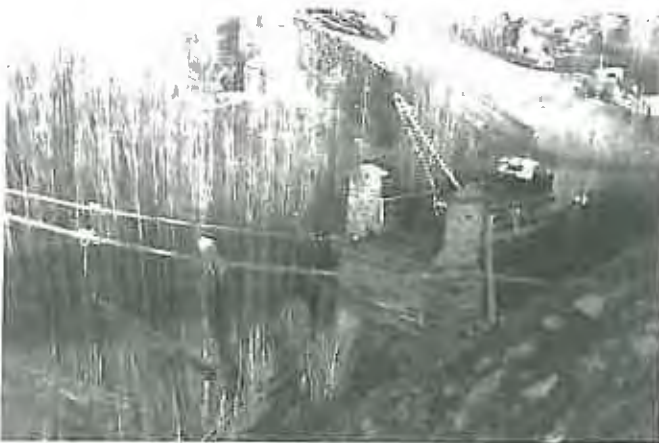
Historical photo of intermediate pier. Note former masonry pillars on each side of pier.

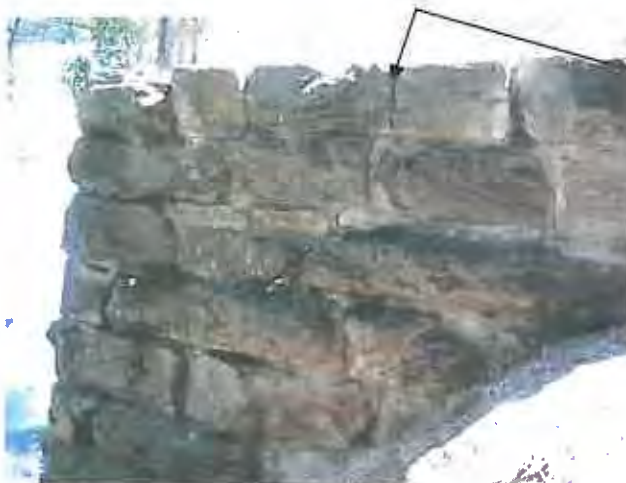
The Alexandra abutment is in reasonable condition but there is a vertical crack, approximately 10 mm wide, in the masonry of the downstream face which indicates that some settlement has taken place. This is not a fresh crack and it is probable that the settlement has occurred over a long period of time. Further investigations and monitoring of the settlement are recommended to understand the cause of the cracking and whether it is an on-going problem.

View of vertical crack in downstream face of Alexandra abutment.

This matter could be checked as part of the further investigations and monitoring recommended above.

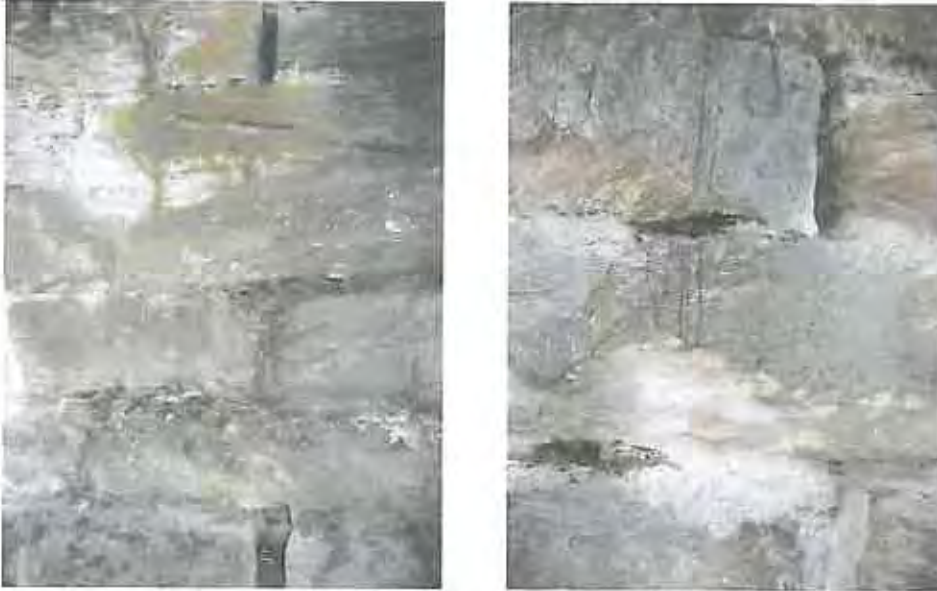
Slots between blocks in front face of Alexandra abutment

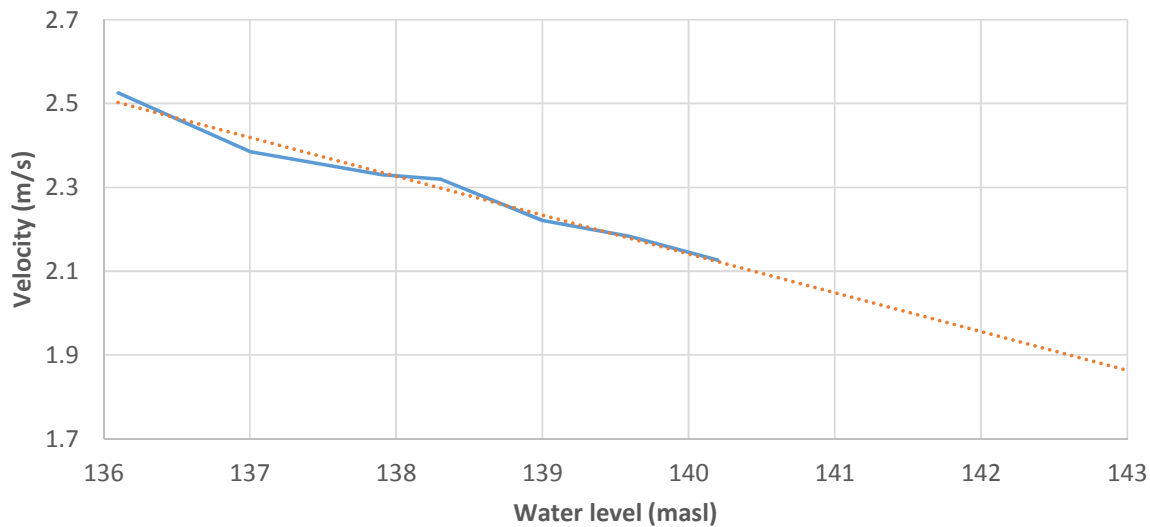
142.2 masl (100 year ARI): 1.9 m/s

Figure 3: Inferred flow velocity at Alexandra Bridge from MWH (2007), with dashed orange extrapolated trend line

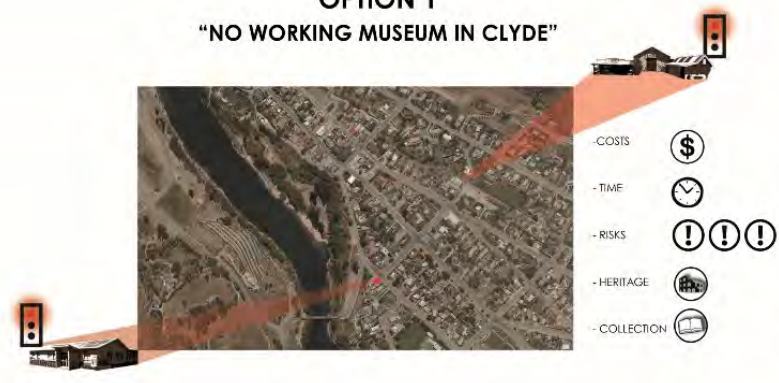
OPTION 1
"NO WORKING MUSEUM IN CLYDE"

- BOTH MAIN MUSEUMS TO BE CLOSED
- NO CHANGE TO RAILWAY STATION MUSEUM ROOM
- NO CHANGE TO HERITAGE PRECINCT OR TOWN CENTRE
- HERITAGE BENEFIT DEPENDS UPON FUTURE ADAPTIVE REUSE OF THE BUILDINGS
- COLLECTION DISPERSED

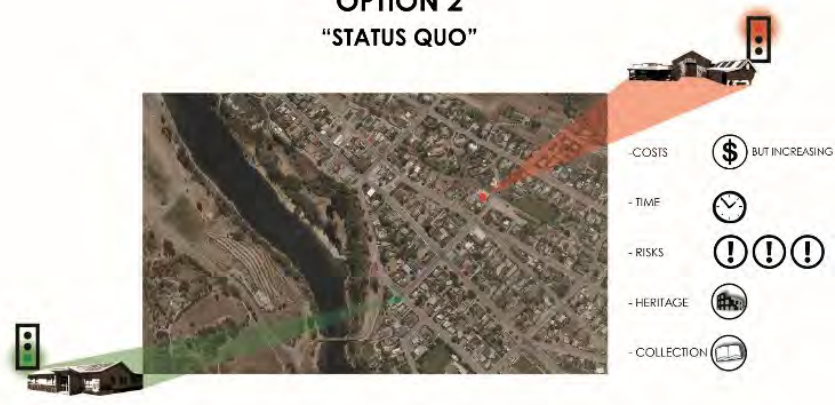
OPTION 2
"STATUS QUO"

- DO NOTHING OPTION
- NO BENEFICIAL INVESTMENT OR REPAIR OTHER THAN RISK MITIGATION
- FUTURE COMPLIANCE WORKS WILL BE REQUIRED BY BUILDING CONSENT OR NEED
- HERITAGE BENEFIT UNCHANGED
- COLLECTIONS AT RISK

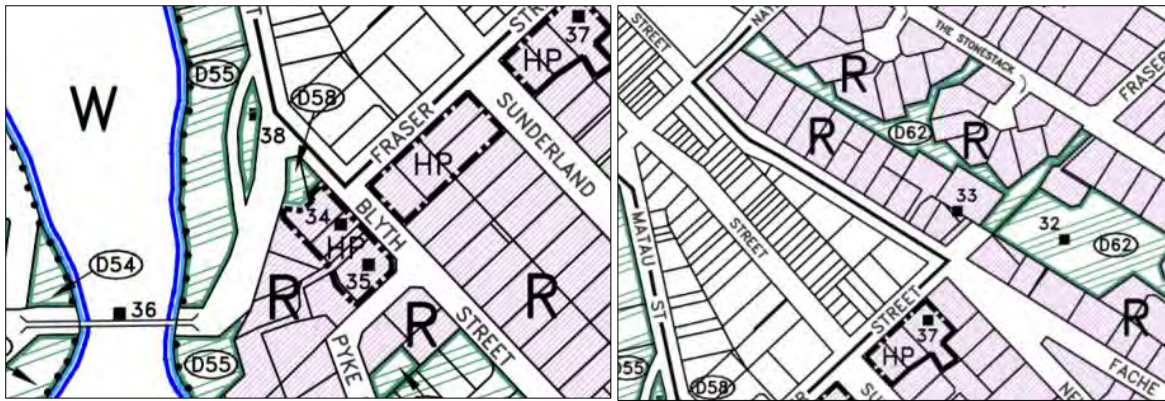
Figure 7: Extracts from Map 9 of the Central Otago District Plan (2008)

Blyth Street Museum: The museum site is included in the CODP as part of a Heritage Precinct, as identified on Map 9, Clyde (Figure 7). No. '34' refers to the former Clyde Courthouse and '35' the former Police Sergeant's House; 'D58' refers to the museum reserve designation.

Briar Herb Factory Museum: The museum site is included in the CODP as Heritage Building no. 33 on *Schedule 19.4: Register of heritage buildings, places, sites & objects and notable trees* of the District Plan (Figure 7). The Register entry names the "Briar Herb Factory" and so is thought to extend to only the factory building and not the other buildings within the museum site. The museum site also lies within the Clyde Residential Resource Area (identified 'R' on Figure 7).

Clyde Railway Station: The station building is included in the CODP as Heritage Building no. 32 on *Schedule 19.4: Register of heritage buildings, places, sites & objects and notable trees* of the District Plan (Figure 7). The museum site also lies within a Local Purpose Reserve (recreation and accessway) designation (identified 'D62' on Figure 7).

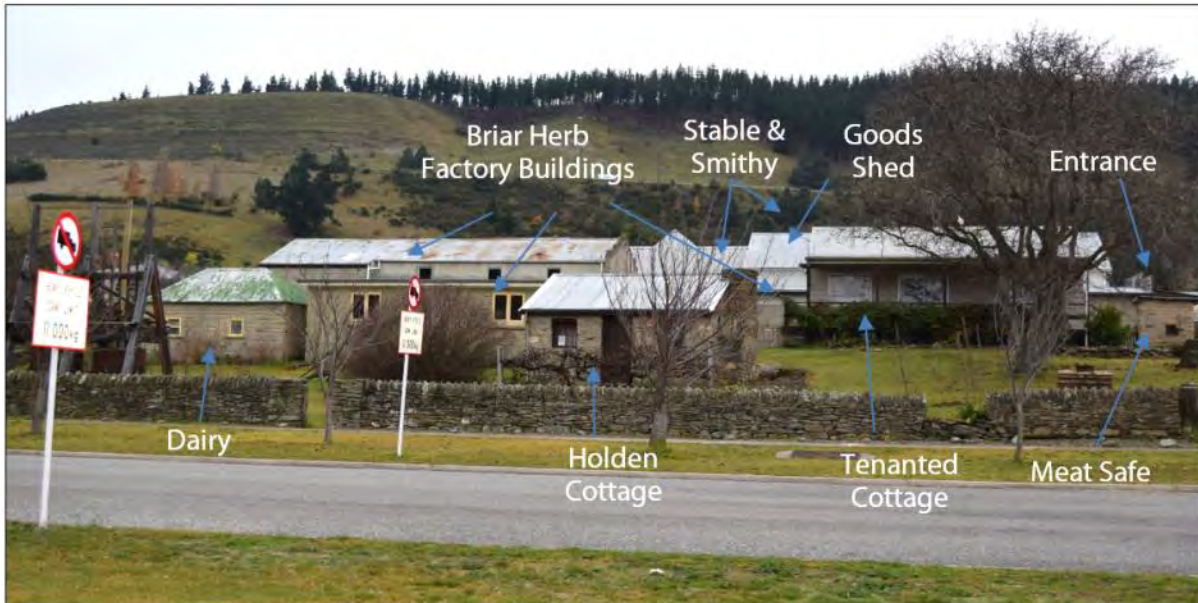
Figure 12: The Briar Herb Factory Museum site viewed from the south from Fache Street with the main buildings identified.

During 1990, the CHM invested considerable time and money creating new display areas and renovating the buildings in advance of the museum opening on 21st October 1990 (Figure 12 and 13). Over the next three years a number of new buildings were added to the museum complex and in 1991 the CODC constructed a new concrete block public toilet just outside of the museum frontage on Fraser Street. In 1995 the Department of Conservation agreed for the return of the McNichol stamper battery and dredge tender (boat donated by the Harliwick Family) to the museum (the associated winch and Pelton wheel were lost) from its yard in Alexandra. Also in 1995, CODC purchased the northern section of land (part Section 12) for a museum extension and the toilet block land for \$22,000 from NZ Housing Corporation. In 1996 the theatre display was constructed, in 1998 the museum was broken into and various items stolen, and in 2001 the shoe shop display was completed. In 2009, the dredge tender was covered by a structure erected and donated by the Otago Goldfields Heritage Trust.

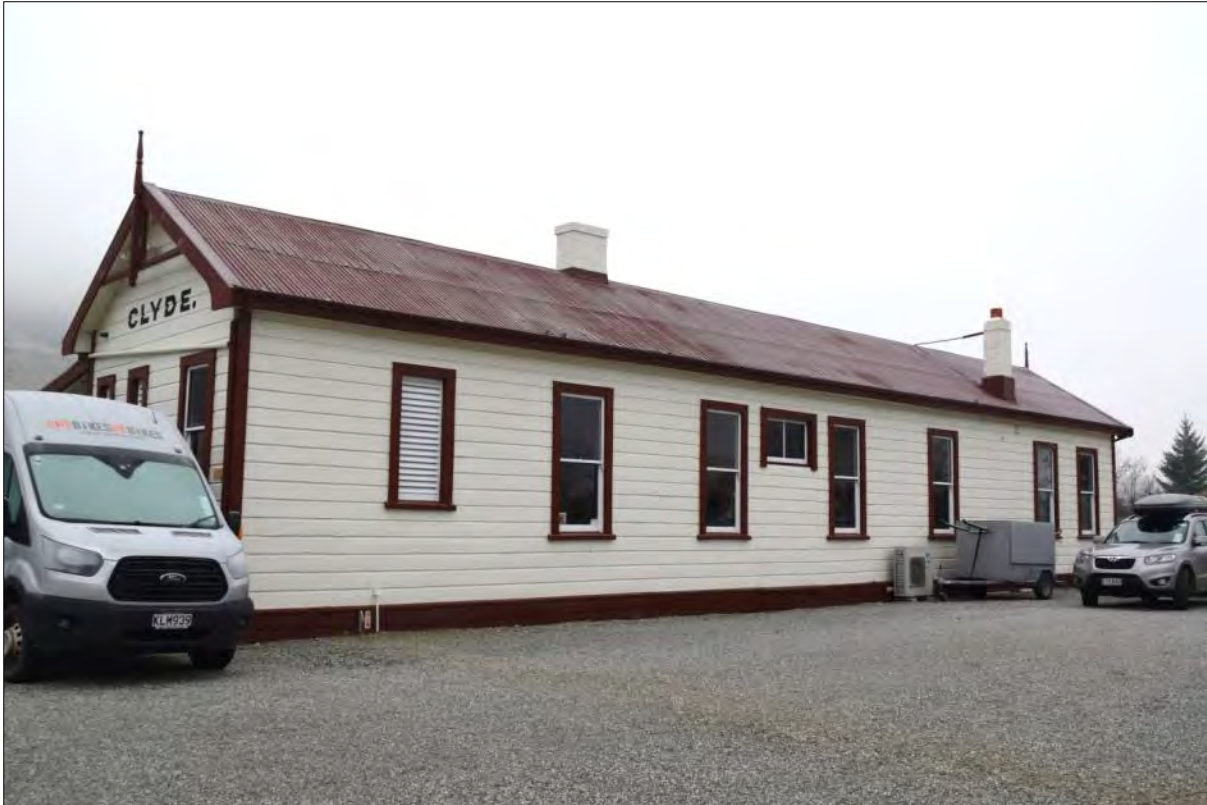
Figure 15: The rear elevation of the station facing onto the car park.

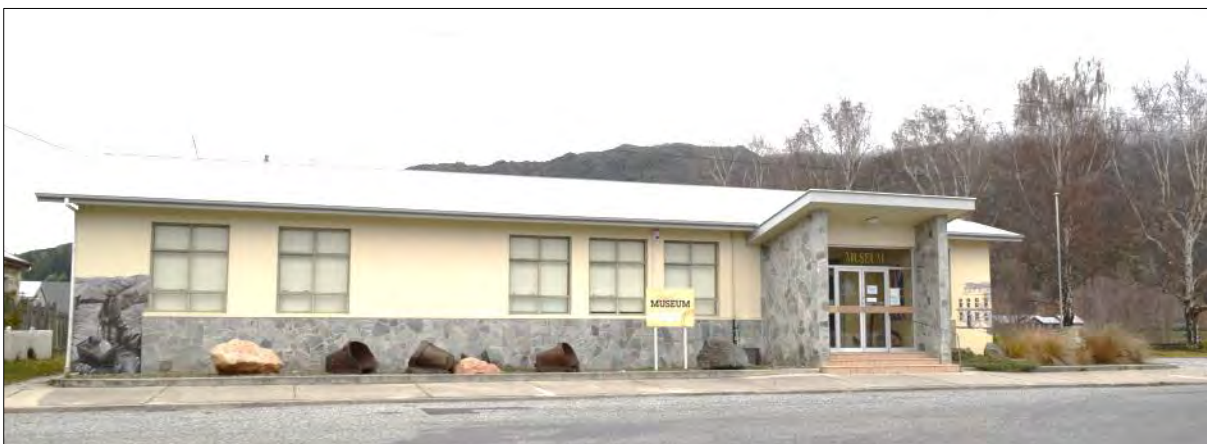
Figure 16: The Blyth Street Museum (north-east entrance elevation) with the former Courthouse just in view to the left.

The museum building is constructed in shuttered concrete covered with a cement render; along the north-western front elevation, a facing of local schist stone extends along the lower half of the building (Figure 16). The museum is covered with a corrugated galvanised iron-clad steel roof and features steel-framed glazing

throughout. The entrance is covered with a square, solid canopy roof and the interior lobby is accessed via three steps covered with ceramic tiles; a pair of aluminium glazed doors with fixed sidelights leads into the interior.

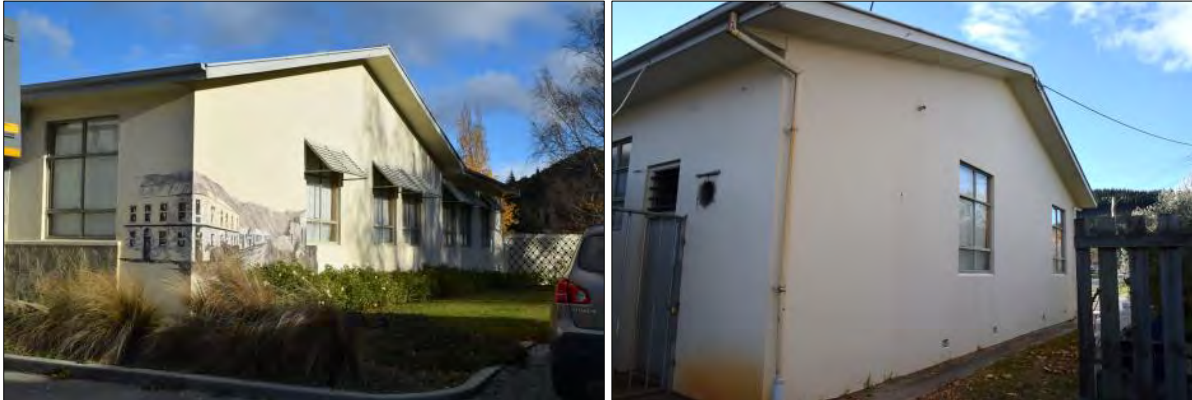
The north-west and south-east elevations are plain rendered; a mural painting extends from the front elevation around the north-west side, which features historic vignettes from Clyde's gold mining past (Figure 17). The rear of the museum building features a western wing that forms a small open courtyard with the two adjacent outbuildings, and the south-west elevations are rendered (Figure 18). Garden beds run along the north-west side of the building, concrete paving and gravel beds slabs along the front elevation, and rough, gravel and asphalt around the south-east and rear areas of the museum. A modern steel gate restricts access the rear courtyard area.

Figure 17: The north-west elevation of the museum with the Clyde mural c. 2007 (left); the south-east elevation (right).

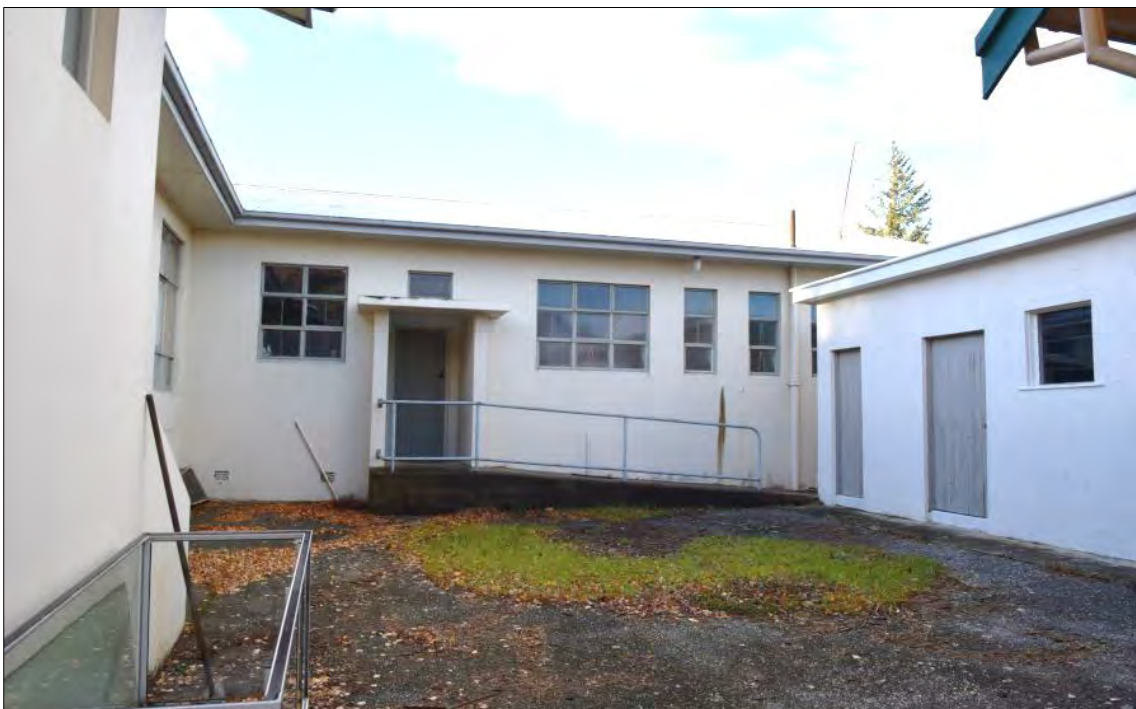
Figure 18: The rear, south-west elevation with the Ablution Block to the right of view (c.1965) and the return west wing to the left.

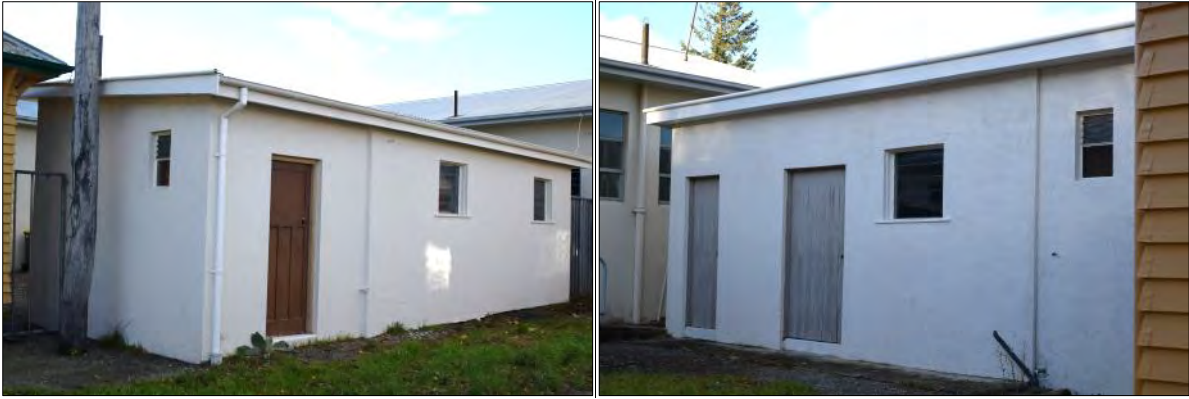
The outbuildings comprise a rectangular plan, cement rendered, timber framed Ablution Block covered with a mono-pitched, corrugated galvanized iron-clad roof that formerly housed toilets and additional office space (Figure 196). It has two louvre glazed windows and a timber door in the south-east elevation, a single louvre window in the south-west wall and two further louvre windows and two timber doors in the north-west elevation. The building is contemporary with the 1965 VCC office/museum building and is currently used as store rooms.

Figure 19: The Ablution Block, south-east elevation (left) and north-west elevation (right).

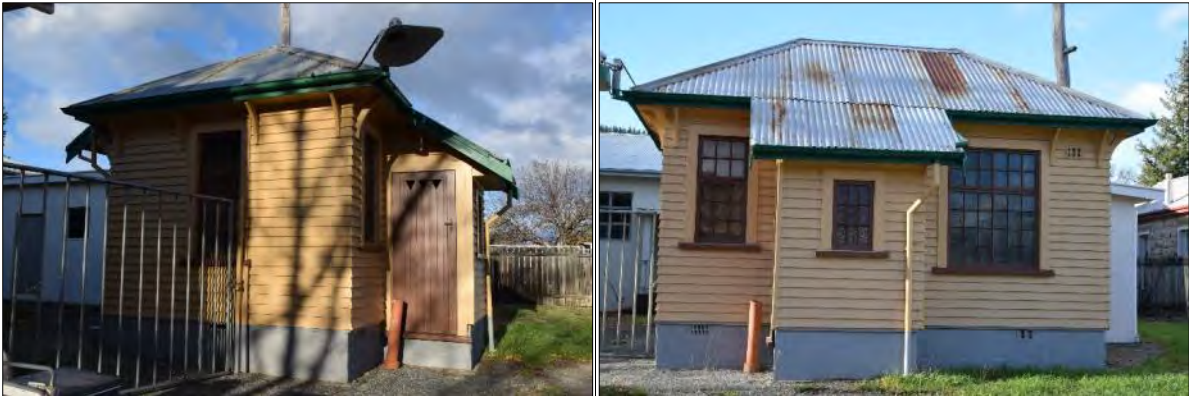
The former police lock-up building is a weatherboard, timber structure, with a timber roof clad with corrugated galvanised iron sheeting (Figure 20). The lock-up features large, timber and glazed windows and a timber door in each of the south-west and north-east elevations. The building was constructed c.1938 and subsequently relocated first to the rear of the adjacent Courthouse (1960s) and then to its present position in 1999 (Jackie Gillies & Associates 2014). It is currently used for storage.

Figure 20: The former police lock-up building (c.1938) in its current location to the rear of the museum building.

- The Police Lock-up building is currently used for casual storage and considerable effort has been invested previously by the CHM and CODC for its relocation and repair. If the future use of the site changes from its current museum function, the Lock-up will become vulnerable both in terms of its compatibility of any future use and if a reduction in public access is involved.
