Agenda Paper

Vincent Community Board

Wednesday, 13 February 2019

- RECOMMENDED that the report be received.
- 19.1.6 **Mayor’s Report** **65**
- RECOMMENDED that the Mayor’s report be received.
- 19.1.7 **Alexandra Suspension Bridge Piers (PRJ 04-2002-01)** **66 - 233**

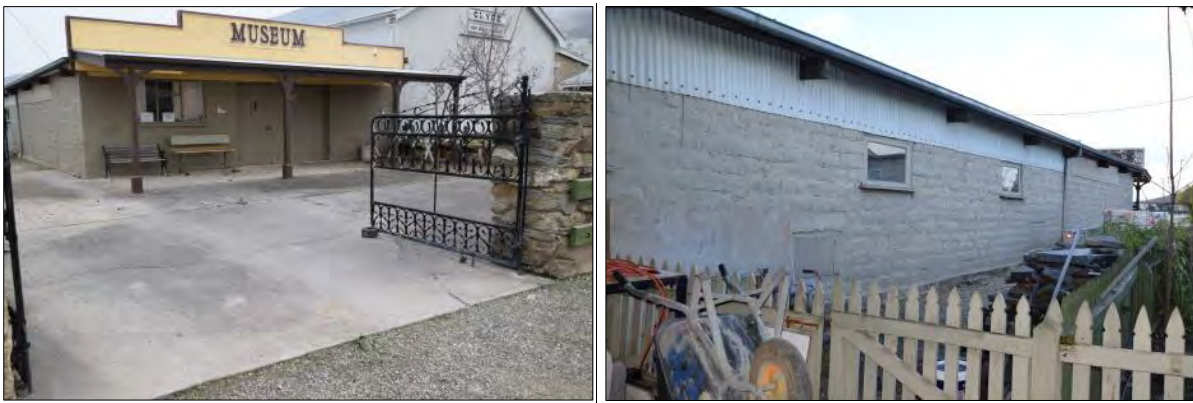
Building A: A long shed structure constructed in different phases with a timber post and truss frame, mud brick walls, corrugated galvanised iron roof cladding and a concrete slab floor. The building provides the main entrance to the museum from Fraser Street and is divided into a number of bays containing themed museum displays, free standing machinery and other historic vehicles. A room at the south-east entrance provides an office space with an enclosed 'theatre' room adjacent. A door at the south-western end connects into the covered yard area that leads to the adjacent Building F. The factory building formed part of the original Briar Herb Factory complex. It was partly raised with a new roof in 1980 by the CHM with assistance from the local PEP (Project Employment Programmes) scheme.

Figure 24: The museum entrance (left) from Fraser Street and the south-west mud brick elevation (right).

Building A – Factory building: A long narrow building of piecemeal construction, some of which is built ad hoc. Whilst the main framing is serviceable for its present purpose, much of the rest of the building requires repair and improvement. The piecemeal and irregular nature of the construction means that the building is not considered to provide suitable long-term museum accommodation.

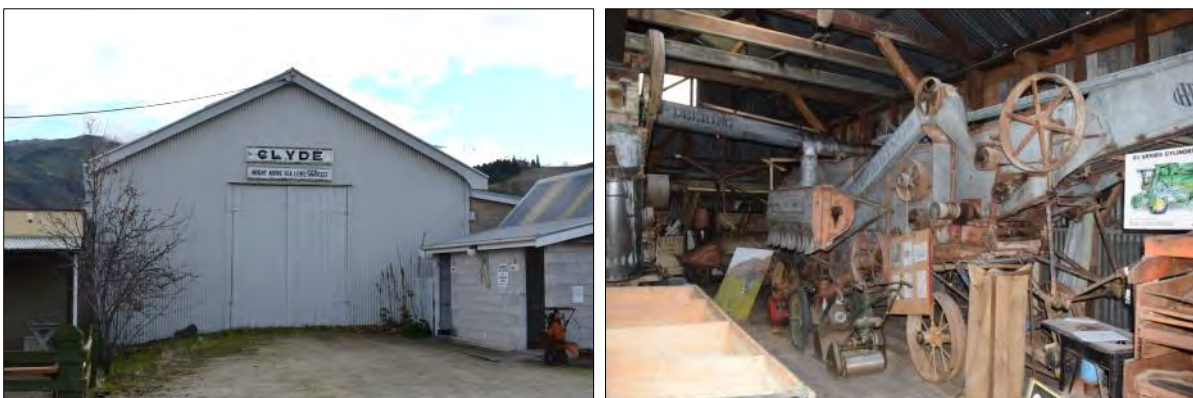
Building B – Goods Shed: A substantial, gabled-roof timber post and truss framed building clad with corrugated galvanised iron and floored with timber planks; relocated to its present site from the north side of the Clyde Railway Station site. The Goods Shed contains large machinery and other industrial equipment displays, two internal 'room' display areas and connects the main museum building (A) with the Blacksmith's display (C) to the north. Full height doors in the eastern end open out onto the car parking area shared by the Clyde Railway Station. The shed was originally constructed c.1907 and relocated to its present site in 1982.

Figure 25: The front, south-east end of the Goods Sheds (left) and a view of the interior, looking west (right).

Building B - Goods Shed: The structural condition of this building is of serious concern. In addition to inadequacies raised in the seismic assessment, the framing of the building is deformed and there is decay evident in some of the externally exposed framing. Only a limited inspection of the building could be made due to the machinery in it and the two rooms formed in the east end of it. The junction of the Goods Shed with the Stables has been poorly designed creating roof/gutter areas that could not be inspected and which are difficult to maintain. Leaks have occurred in the past between these two buildings and have caused mud brick failure in the Stables. There is the risk of further damage/defects being concealed here; the cause of the slope in the floor adjoining the Stables is unknown and requires further investigation.

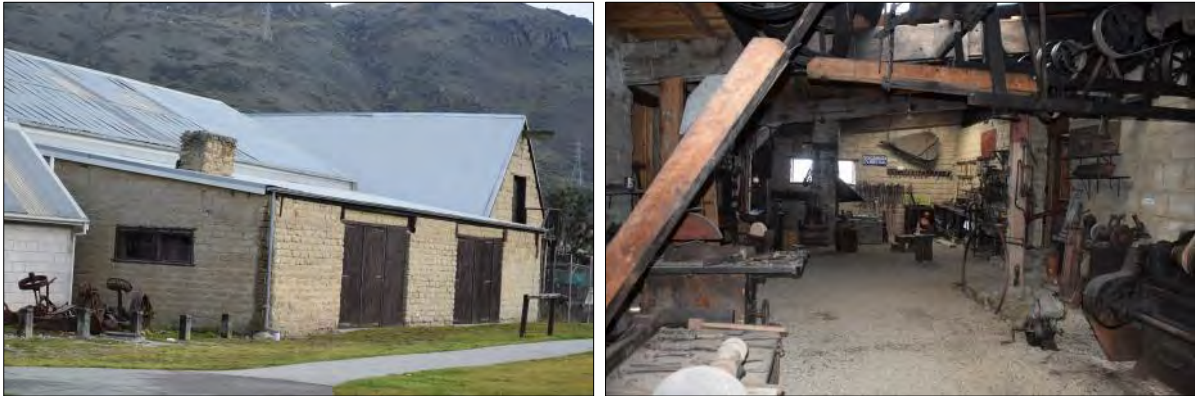
Building C – Black Smiths: A long and narrow mud brick building with a post and beam, lean-to roof built up against the north side of the Goods Shed. The 'Smithy' has two pairs of large barn doors along its northern elevation and contains two schist forges, the south-east one rising to a stone flue above the roofline. The floor is covered with gravel and the roof is clad with corrugated galvanised iron. The interior

display is set out as a Blacksmith's with the forges, other heavy equipment, anvils, benches, and numerous iron and steel tools and horseshoes. It was constructed by the CHM with assistance from the local PEP (Project Employment Programmes) scheme in 1982.

Figure 26: The Blacksmiths building exterior (left) and an interior view looking east (right).

Building C - Blacksmiths: This building has been constructed on an ad hoc basis and is understood not to have been issued with an approved building permit when constructed. Whilst the external mud brick walls are solidly built, the overall structural adequacy of the building is of concern. A particular issue is the lean-to roof/post structure, which appears to be the cause of (or at least contributing to) structural movement in the adjoining Goods Shed wall frame. The south wall mud brick cladding is buckling/slumping and is a further risk. Further/more detailed investigation is likely to reveal more faults and inadequacies. Overall, it is

doubted whether the building can be economically and practicably repaired and upgraded for future museum use; planning for demolition and re-construction to meet current NZ building consent requirements is considered more practicable.

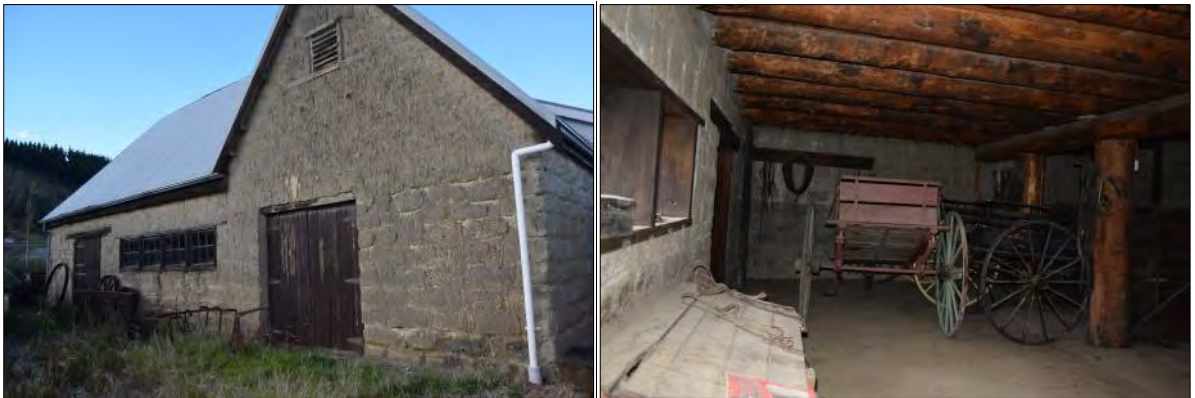
Building D – Stables: A two-storey, gabled building constructed with mud bricks and containing an earth floor, large timber posts supporting the timber floor of the loft space and glazing along the north-west elevation. Access is provided by a side door in the south elevation, a pair of barn doors in the north-west elevation and a door to the first-floor loft accessed by an external flight of timber stairs placed along the north-western gable end of the building. The timber roof is clad with corrugated galvanised iron. The form and interior plan of the building is laid out as a traditional stable, with a feed and tack room in the full-height gable bay at the south end, and four horse stalls, further harnesses and three carriages/buggies stored in the northern bay, with a loft above accessed externally and via an internal trap door. It was constructed by the CHM with assistance from the local PEP (Project Employment Programmes) scheme between 1982-85.

Figure 27: The Stable north-west facing front elevation (left) and interior view of the horse stalls and carriages in store (right).

Building D - Stable: A substantially-built, pseudo-historic building which has been unconventionally-constructed in mud brick. Damp and decay of the mud bricks, particularly just above ground level and to the east wall are an issue for the building. The mud brick gables are poorly restrained, the design of the roof junction with the Goods Shed/Blacksmith's is poorly considered, and the first-floor external stair is decayed and dangerous. Again there is a question mark over the permit status of this structure and it appears to have deviated from the original design drawings submitted to Council in 1982.

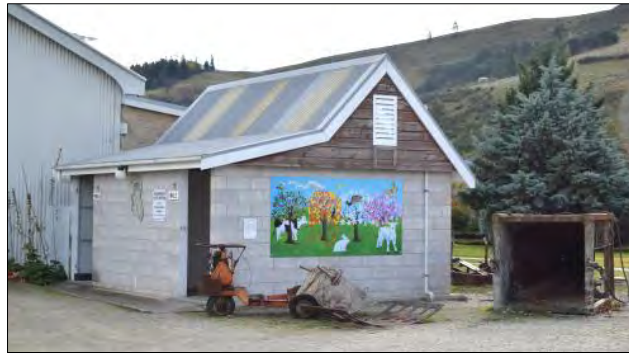
Building E – Public Toilets: Modern concrete block construction separated into two bays for male/female conveniences, concrete slab floor, and covered with a timber and corrugated galvanised iron and plastic roof. They were constructed by the Council in 1991.

Figure 28: The concrete block public toilets located to the east of the Goods Shed and Blacksmiths.

Building E - Toilet Block: A modern detached toilet block in reasonable condition.

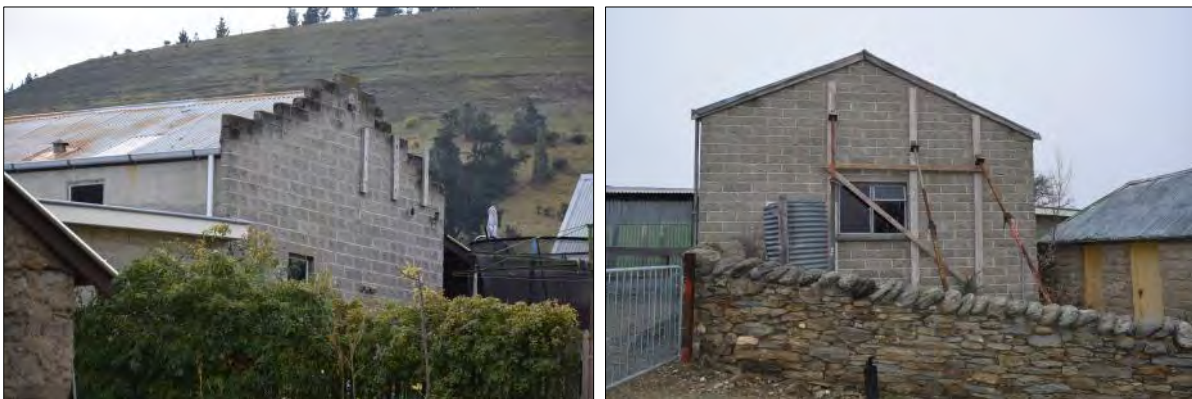
Building F: A tall, single-storey building constructed in concrete block with a timber and corrugated galvanised iron roof, concrete slab floor, and windows in the gable ends and north elevation. A door in the north elevation leads into the adjoining covered yard area and the main door access leads into a short corridor off which is an enclosed room containing a large collection of glass slides and other photographic material. The factory building formed part of the Briar Herb Factory complex and interconnects with a smaller, mud brick, lean-to structure along its south-western side. It currently contains several pieces of machinery belonging to the former factory and an interpretive display about its history. It dates to c.1955-56.

Figure 29: The Briar Herb Factory building (F) east elevation (left) and west elevation (right) with modern propping in place.

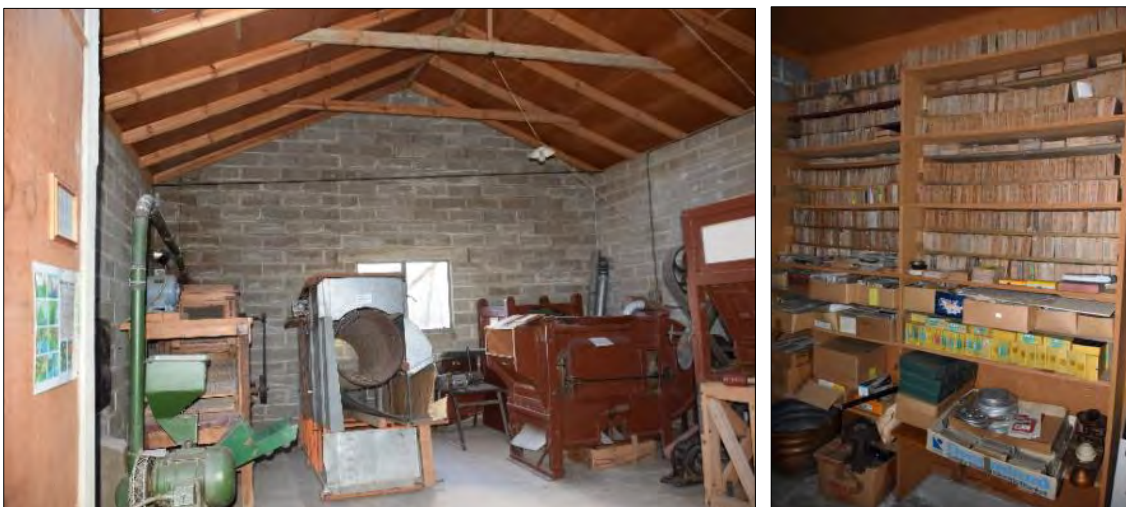
Figure 30: The interior of the factory building looking west (left) and the glass photographic negatives store in the eastern end of the building (right).

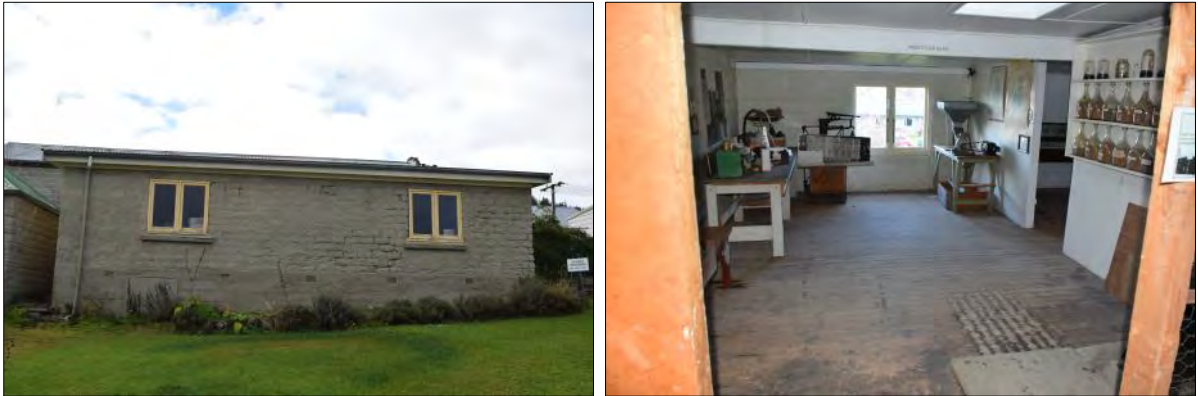
Building G: A single-storey, lean-to building constructed of mud brick on a shuttered concrete foundation, with timber flooring, timber partition walls and a timber and corrugated galvanised iron roof. The small

building interconnects with the larger Briar Herb Factory Building F at each end along its northern side and a door leads from the north-west elevation down some external concrete steps to access the Dairy (Building H). The small factory building has glazing along the south-west elevation. It dates to c.1952-54.

Figure 31: Part of the Briar Herb Factory buildings (G) with the south-west facing exterior (left) and a view into the east end of the interior (right).

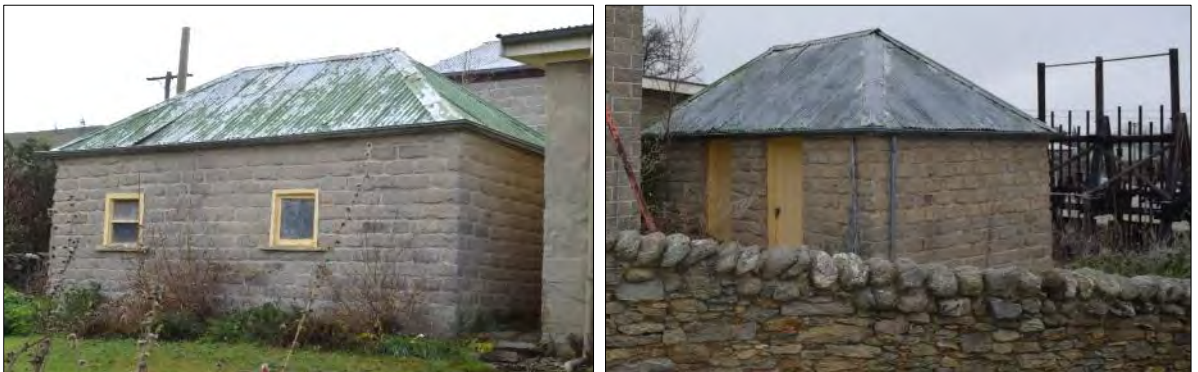
Building H – Drybread Dairy: A small, single-storey mud brick structure divided into two internal bays, each accessed via a door in the north-east elevation. The timber roof is clad with corrugated galvanised iron and the interior roof lining is covered with tongue and groove boards. The flooring is stone and two small windows are set into the south-west elevation. The building was relocated and rebuilt from original materials on the site in 1982.

Figure 32: The Dairy building south-west facing exterior (left) and the north-facing exterior (right) with the stamper battery in view in the background.

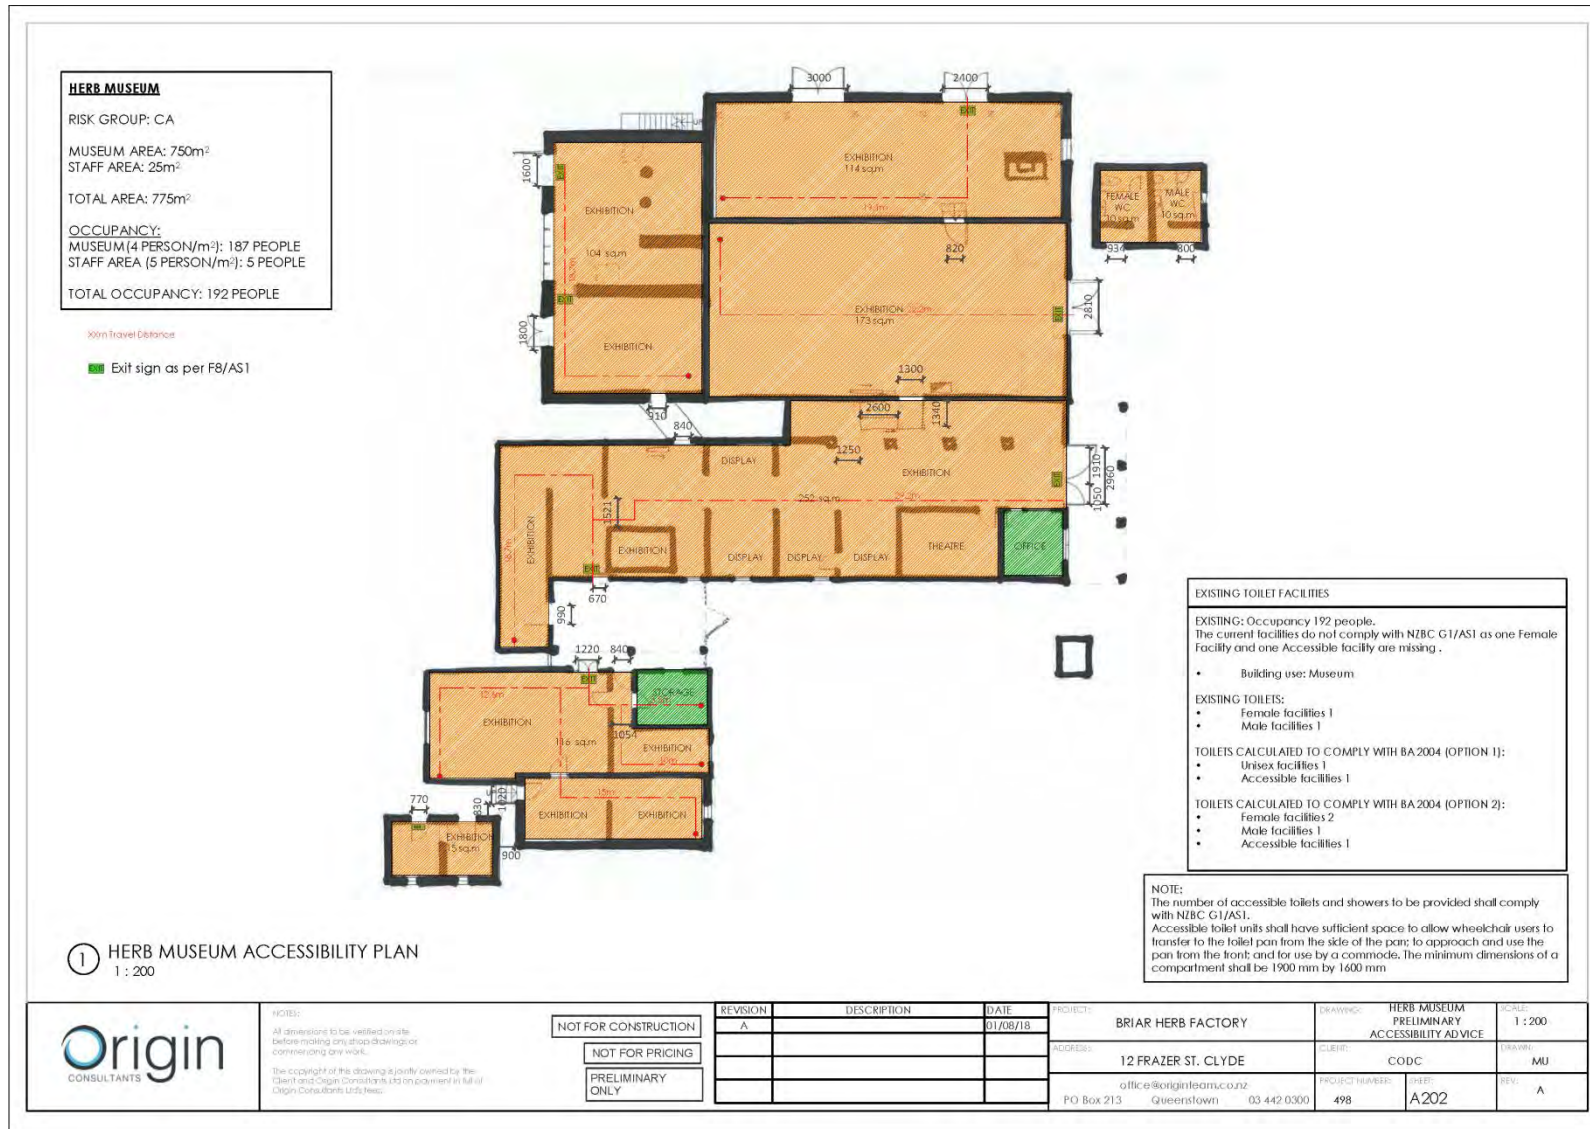
Figure 36: Summary appraisal plan of the Briar Herb Factory Museum site.

- There is no **Fire alarm system** installed in any of the buildings. A Type 2 Alarm System or a Type 18 Alarm system is required to comply with NZBC C/AS Sec 2.2 (TBC by Fire Engineer).
- **Surface finishes to wall linings, ceiling linings & Floor coverings** are not compliant in both buildings. To comply with NZBC C/AS Sec Table 4.1.
- There is no exit **signage** in exit ways. Exit Signs to be installed. To comply with NZBC F8/AS1.
- Visibility in escape routes: No existing emergency lighting. **Emergency Lighting** to be installed in all exit ways if open path travel distance exceeds 20m and in every change of level to comply with NZBC F6/AS1.

- **Accessible car parks** shall be by accessible route and close as practicable to the accessible entrance. Existing carpark in both buildings do not comply with NZBC D1/AS1 10, NZS 4121.

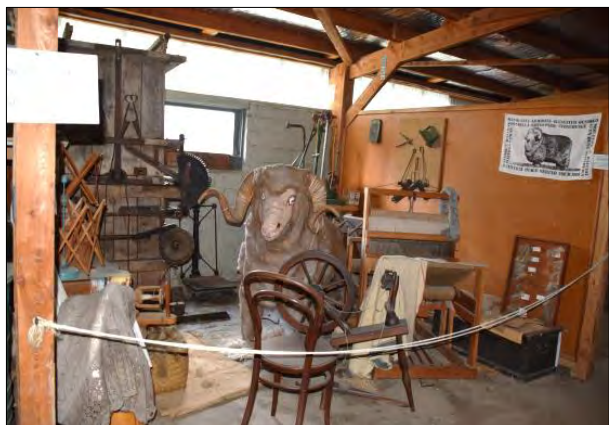
Figure 43. The Wool display.

Wool Display: The Wool Display tells the story of wool from sheep through to clothing (Figure 43). Some of these objects have provenance, with labels/accession numbers attached. It is an important display in terms of showing that Clyde has a multi-faceted story.

- Overall high significance.

6. *Wool display* - Textiles are hard to keep in this environment on open display. These should be displayed in purpose-built cases. Consider sourcing prop woollen blankets and fleece samples for visitor interaction / touching, if deemed necessary. The provenanced blanket needs to be removed and stored in a sealed container in the interim to protect it from further insect and dust damage. Wool samples similarly or wrapped in plastic and sealed. The Float Sheep also needs to be covered, as above.

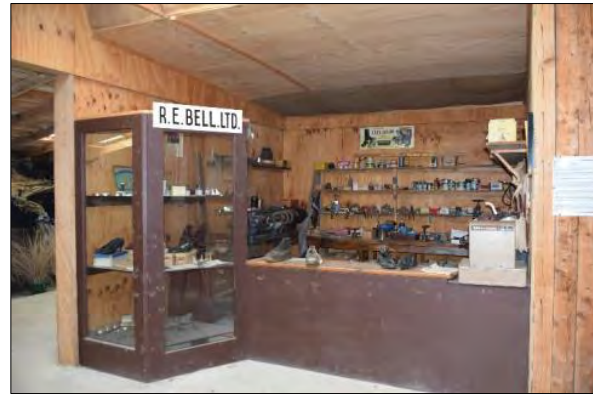
Figure 44: The Bell Shoe Shop Display.

Shoe Shop: The Bell Shoe shop is not from Clyde, rather from Alexandra, but is a good example of a small trade that affected whole area (Figure 44).

Of particular interest is the "Frost Boot" that were specifically designed for the orchard workers in the area. This collection was donated to the museum from R. E. Bell as it was implied that the Alexandra Museum did not want it.

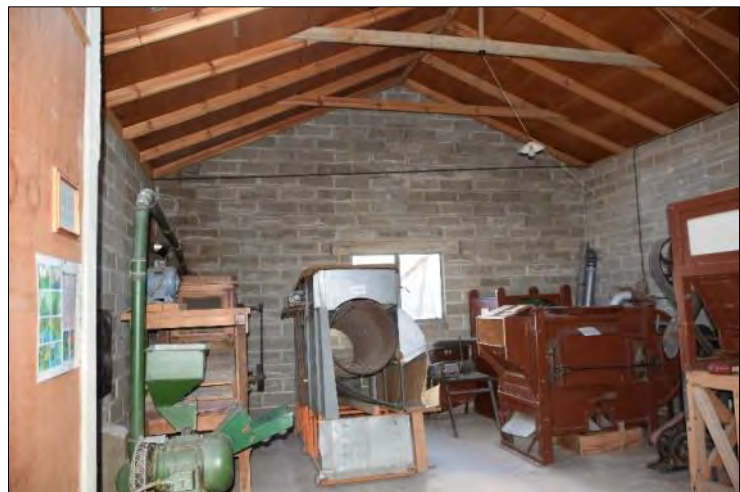
Figure 45: The main display room of the Briar Herb Factory

Briar Herb Factory: The Briar Herb Factory is considered to be the only intact example of a local industry in Clyde (Figure 45). Briar Herb exported internationally. The equipment is a good example of kiwi ingenuity, utilising what was available. Order's and notices pasted on the wall are original but deteriorated.

- Extremely significant.

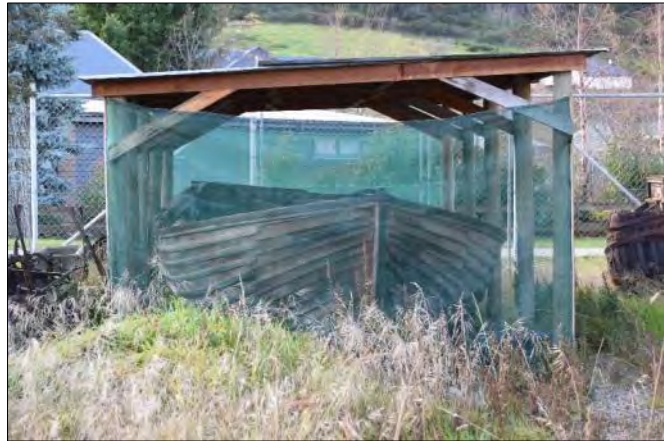
Boat: The coal supply boat is considered to be of high national significance, as it believed to be the only surviving one of its kind in the country. In poor condition due to poor external storage (Figure 46).

Figure 46: The dredging tender/coal supply boat.

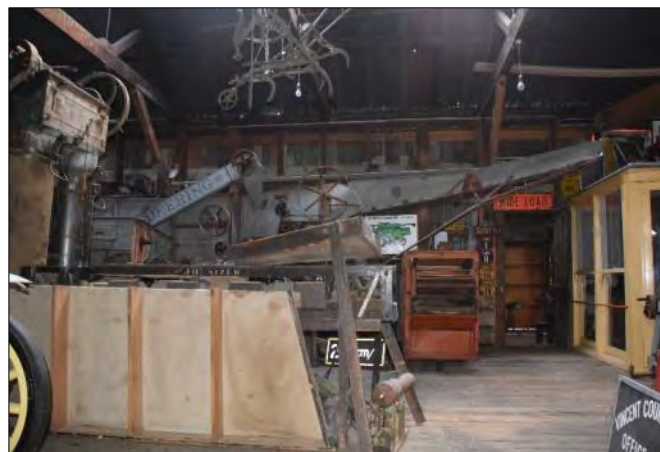
Figure 47: Goods Shed machinery display

Agricultural/Horticultural Material: This is a combination of farming and orcharding material. The grader, orchard sprayer and the nail machine are examples of the fruit growing material in this area, locally significant! The farming equipment is not of high local significance but show the agricultural history of the area. The thresher may be of significance due to its provenance from Drybread/Glassford family and its rarity. Stationary engine: there was a number of these sort of machines used to run local trades, there is very little information known about this one. The petrol pump came from D Hutton in Earnscleugh and is indicative of the era.

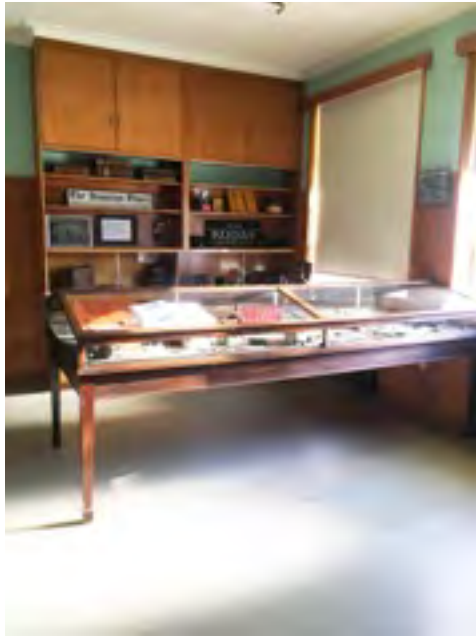
There were several rooms that have large north and west facing windows that throw a high level of UV light into each room and across the collections that are on display. The blinds installed appear to be opened during visiting hours, and shut when the museum is closed. There was no evidence of fire or security alarms installed on site.

Image following: Light raking across display case, as surveyed.

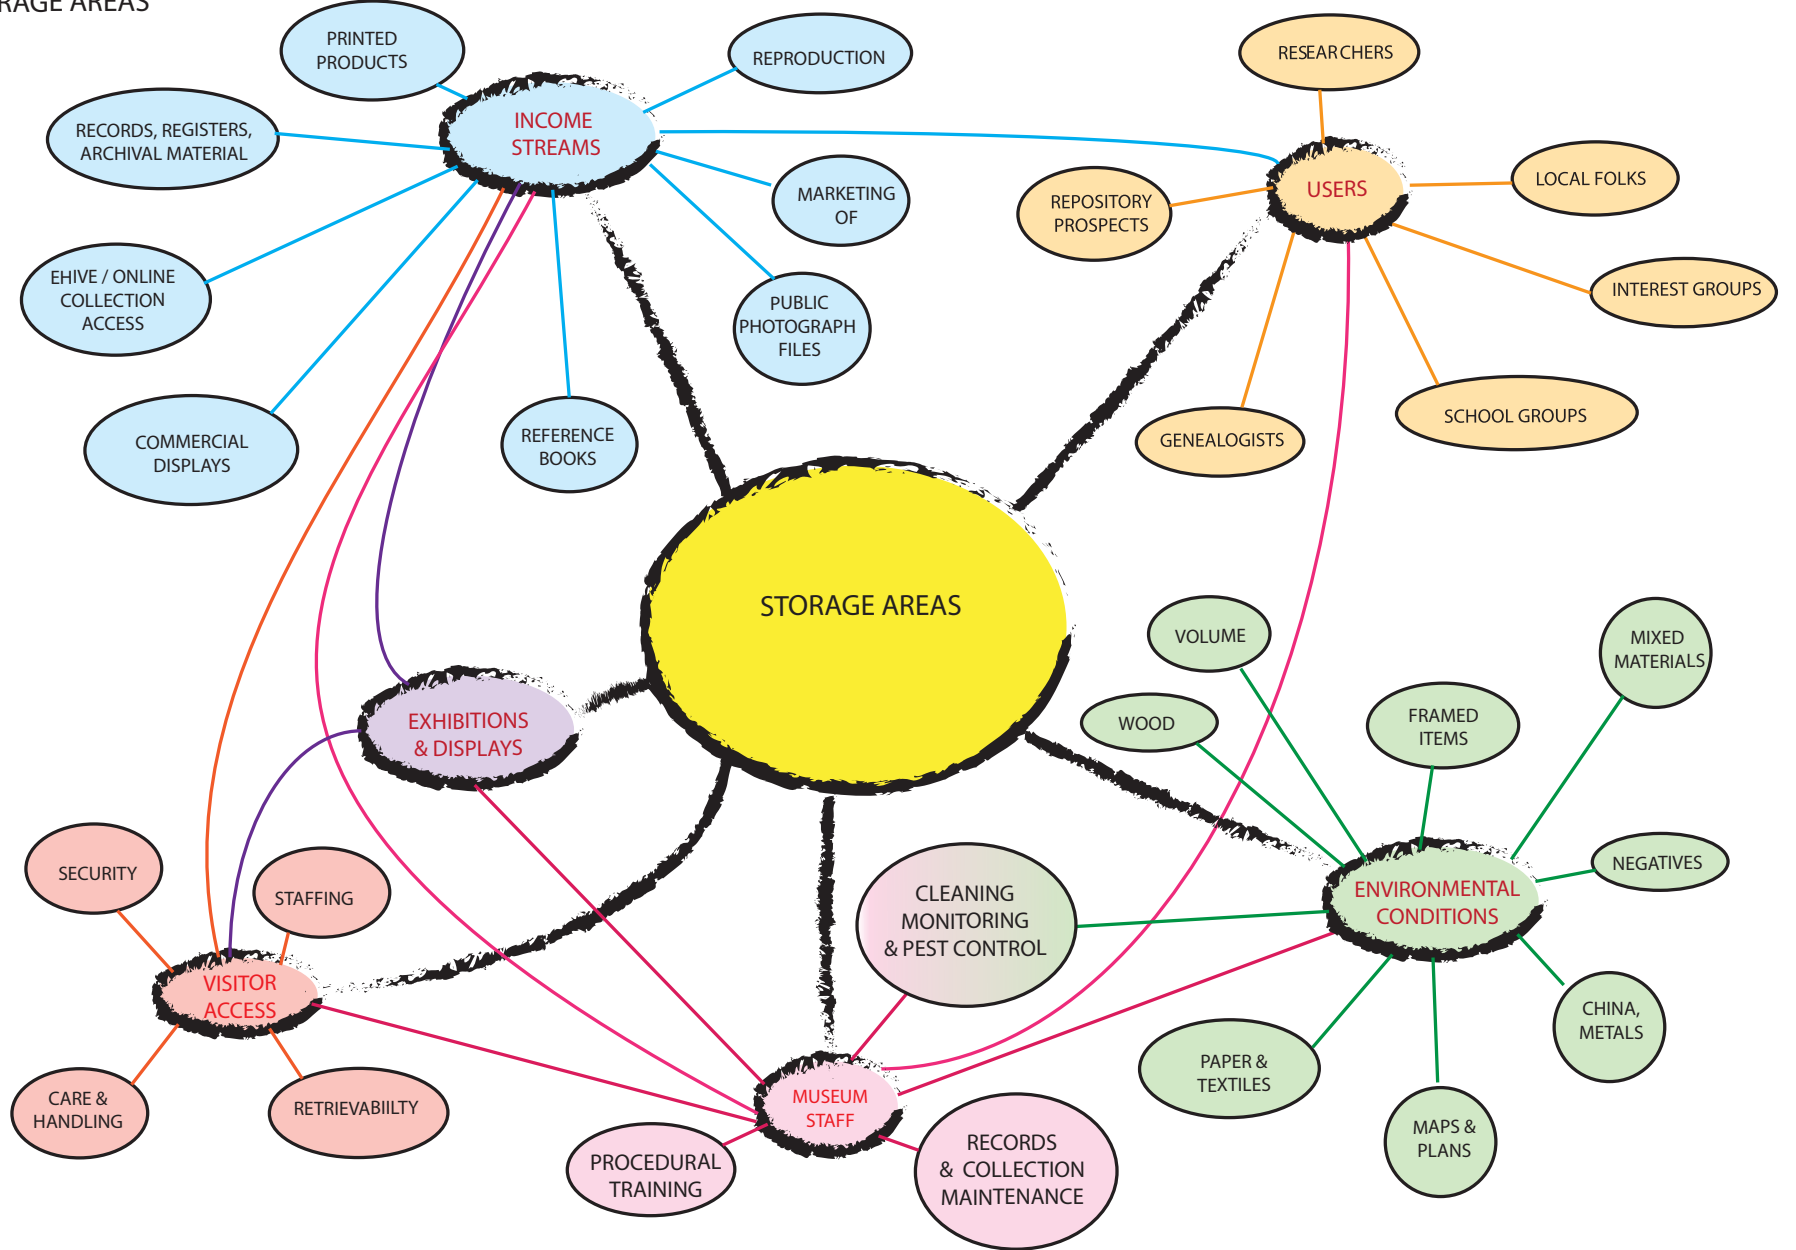
Image: Diagram showing how storage areas interact with museum function

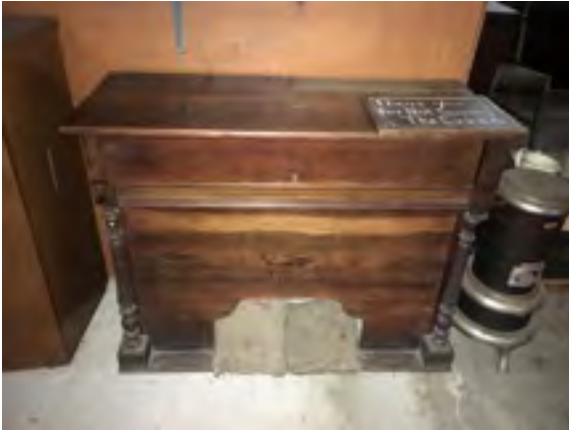
- The french organ, c.1855, has an interesting story with local connections attached. Its presence is not appropriate for the theme or storage conditions of the Briar Herb site, and it needs to be relocated to Blyth Street Museum and stored carefully. In the interim, it would be prudent to encapsulate the organ completely in a dust and insect proof wrap.

Image: French organ, as surveyed.

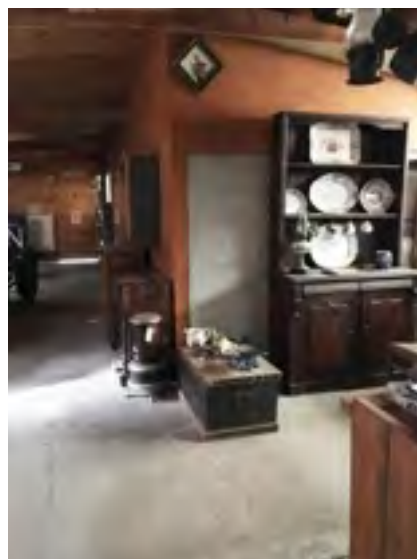
- All objects appear unsecured and are in danger of being damaged or stolen, or injuring visitors in the event of an earthquake or mischievous interaction.
-
- This space has general hands on / education value, in terms of connecting it with local stories. Some objects can be integrated into the sheep and orchard displays, to enhance interpretation of women's roles. Remaining items can be selected to become part of a hands on/education collection, while some poorer condition items can be considered for deaccession.

Image: Unsecured collection items in kitchen display

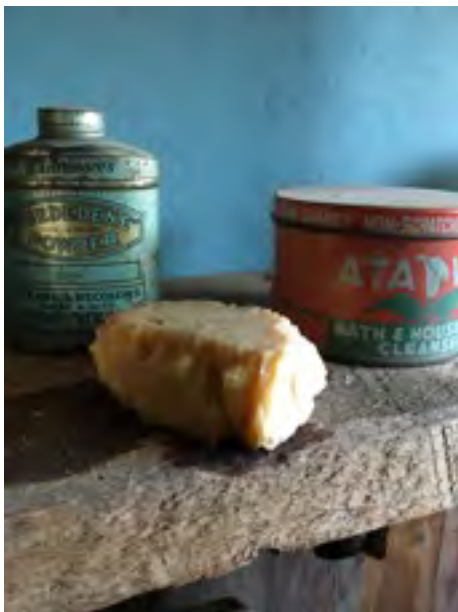
- The Laundry in particular shows signs of silverfish and rat damage - on paper labels, boxes, and soap.
- Borer holes on washboards are not necessarily proven to have occurred on site, but may be previous due to the nature of the material - no evidence is present [after three years of not being attended to]. Needs monitoring.

Image below left: Rodent damage on soap, as surveyed

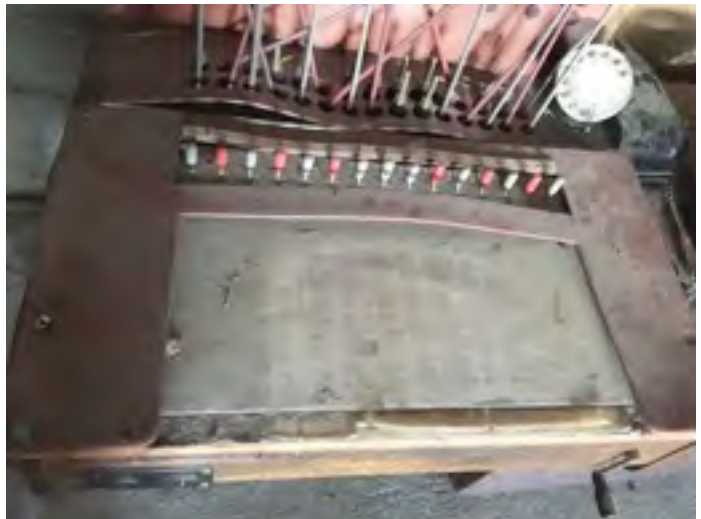
- The telephone exchange is in poor condition and needs to be cleaned and covered. It could be seriously considered for deaccession due to its provenance and condition.

Image above right: telephone exchange, as surveyed.

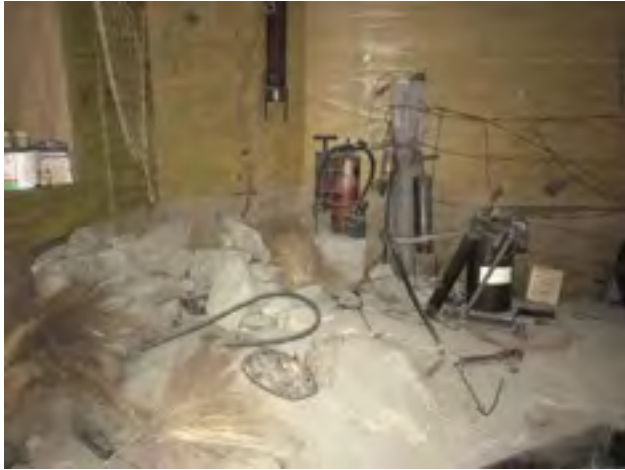
- The main concern in this area is the build up of dust and detritus due to items not been covered over, particularly the stuffed rabbit and organic material. The rabbit should be temporarily removed and kept in a plastic lidded container to protect it from insect and dust damage.
- Open display is an engaging way to present a story, and there is definite between public and display by using the raised tussock/earth areas, however many of the objects still need to be discreetly secured with wire mounts.

Image: Rabbiting display, as surveyed

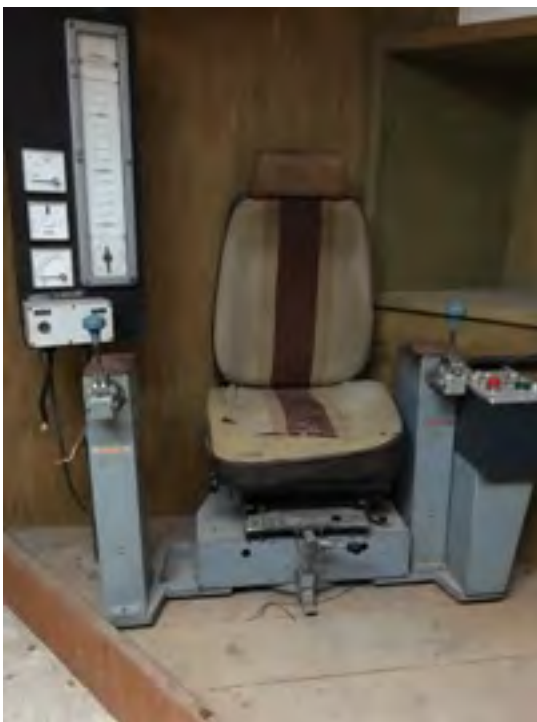
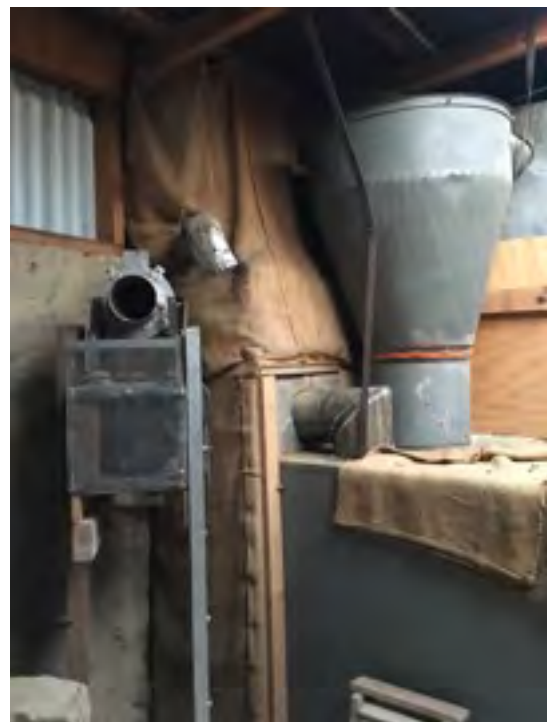
- The crane seat needs conservation. Consider installation of a sympathetic barrier to ensure longevity of this collection item.

Image: Original crane seat, as surveyed.

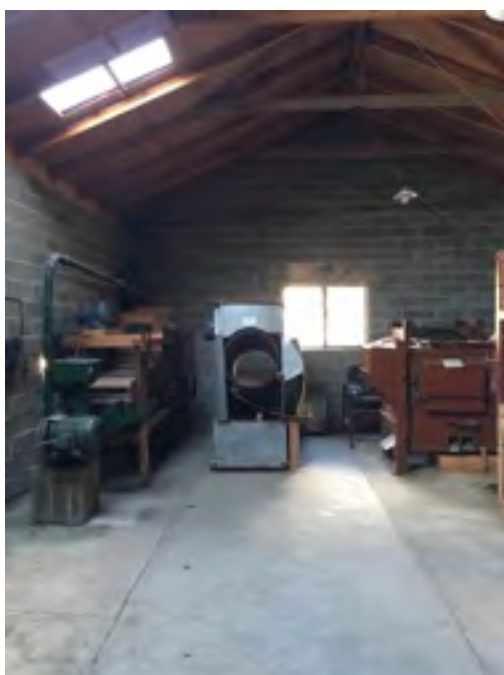
HERB FACTORY MACHINERY ROOM (F)

- Although this building is in need of significant repair it is recommended that it be conserved and reinstated - housing the original machinery etc, as is now, also including the office area with its original wall linings etc. remaining intact.

Images: Left, Machinery room; Right: Silverfish damage, as surveyed

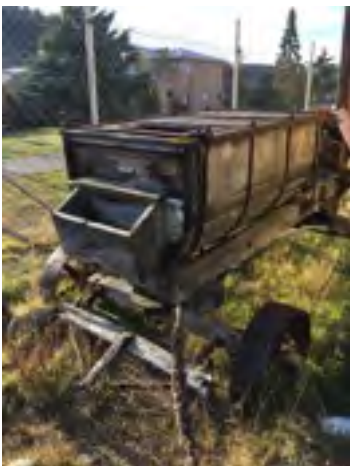
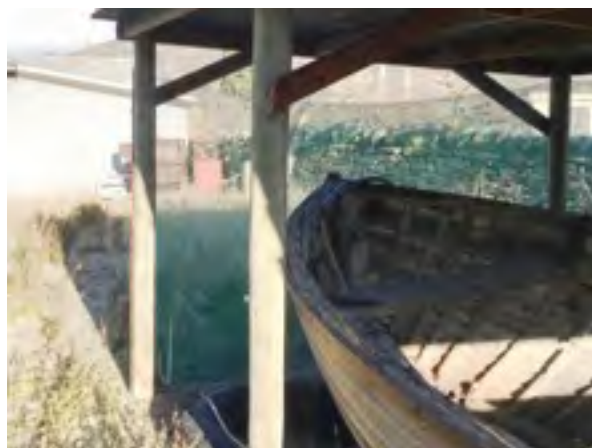
- Two vineyard barrels and an old unidentified portable unit on wheels sit unprotected from the elements. These should be wrapped under tarpaulins, ([including undersides), to protect from weather.
- The shade cloth around the dredge boat needs to be tidied up to ensure the boat is getting the best protection possible from all directions while being kept outside.

Images: Left: portable unit; Right Dredge boat , as surveyed

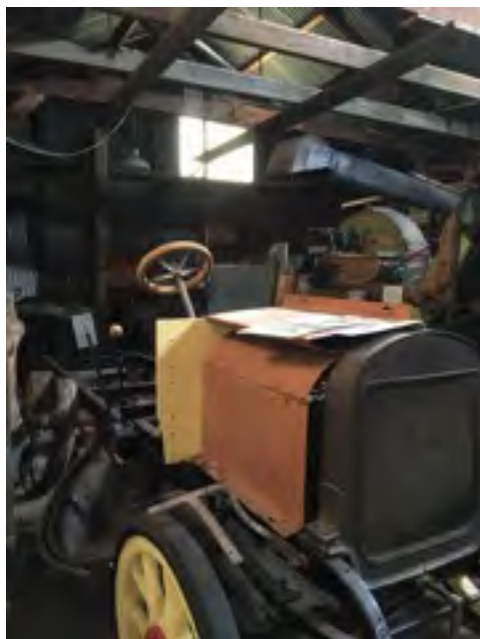
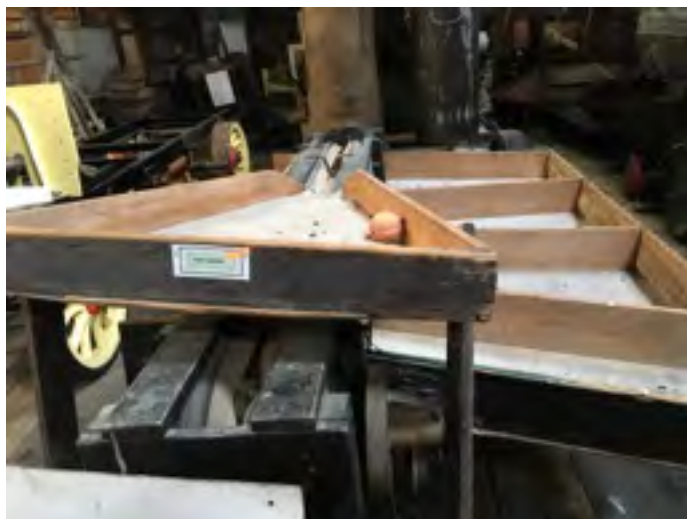
- There is evidence of prevalent pest and rodent infestation. Recommend building maintenance and regular cleaning of this area, along with covering the fruit grader to avoid further staining and pest damage.

Images: Left: Argyll truck; Right: fruit grader, as surveyed

- **It is recommended to retain the large agricultural equipment for its scale, wow factor, and rarity.**

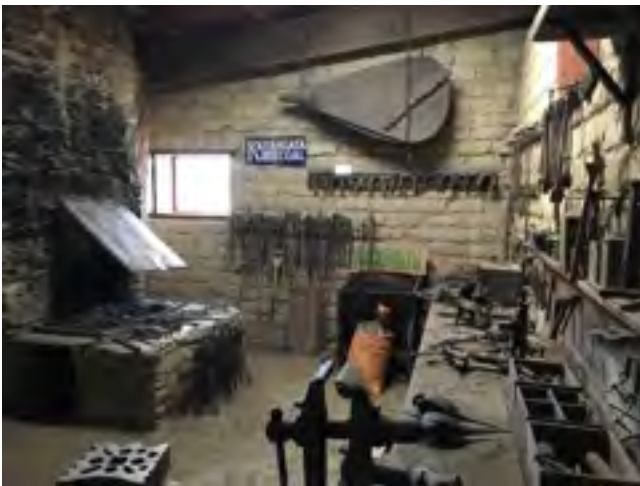
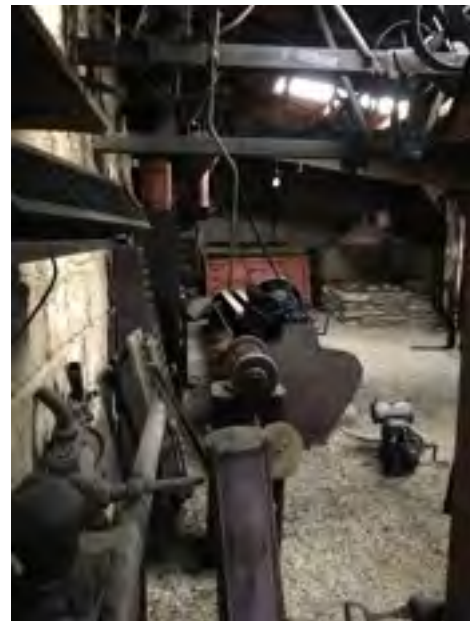
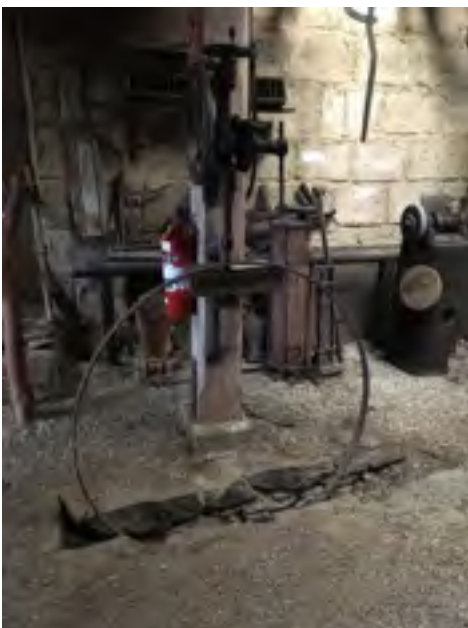
Images: top left: forge area; top right, Lathe and associated collection
Lower left, Wheelwright equipment

- Consolidate and amalgamate the collection, along with gigs, to be incorporated into the Drying Shed (A) where the environmental conditions will be much improved.
- Retain selection of tools and equipment, especially if local provenance, (e.g. wheelwright items and horse shoes referencing gigs/transport, and station/cattle), as appropriate.
- Rehome the lathe and associated collection to another museum or heritage site. (e.g. Hayes Engineering, Cromwell Museum)

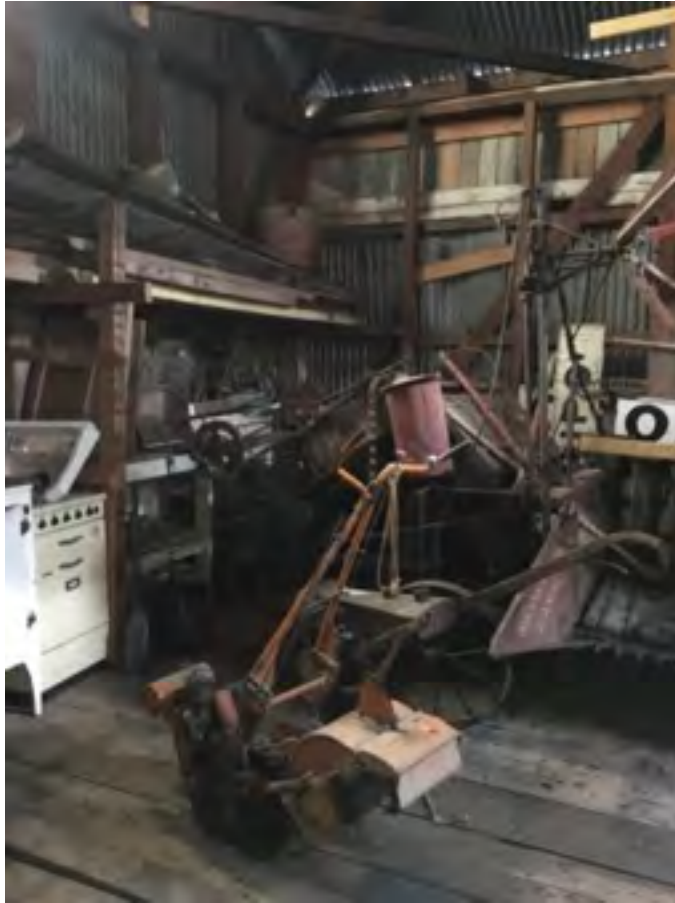
Image: West wall storage shelving, as surveyed.

If stacking large heavy objects up high, ensure they are well secured and not liable to fall.

Box up or cover collection items to protect them while in storage, using dust sheets or curtaining.

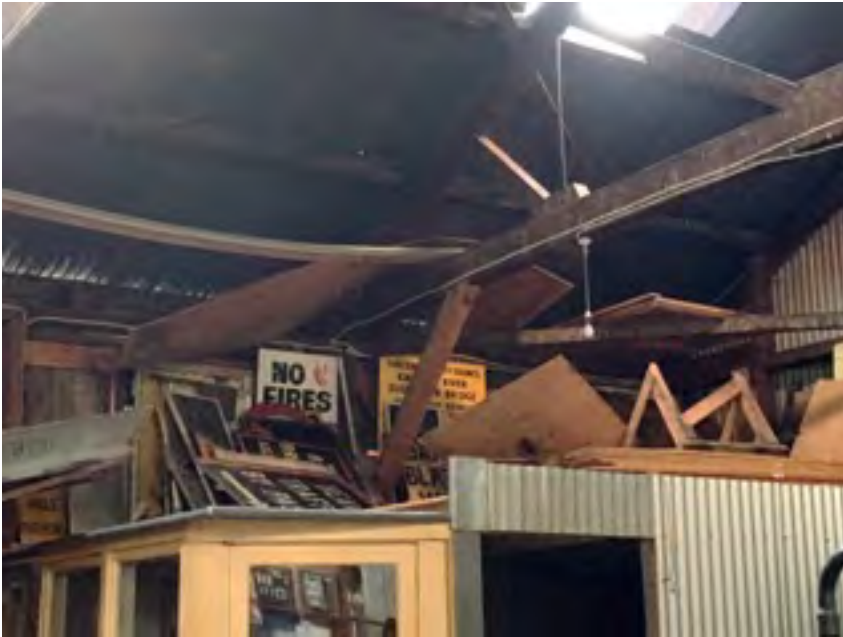
Image: Storage area above the smoko room, as surveyed.

Remove all items in this area, sort out collection items and re-house these temporarily in another area, (suggest unused workshop room).

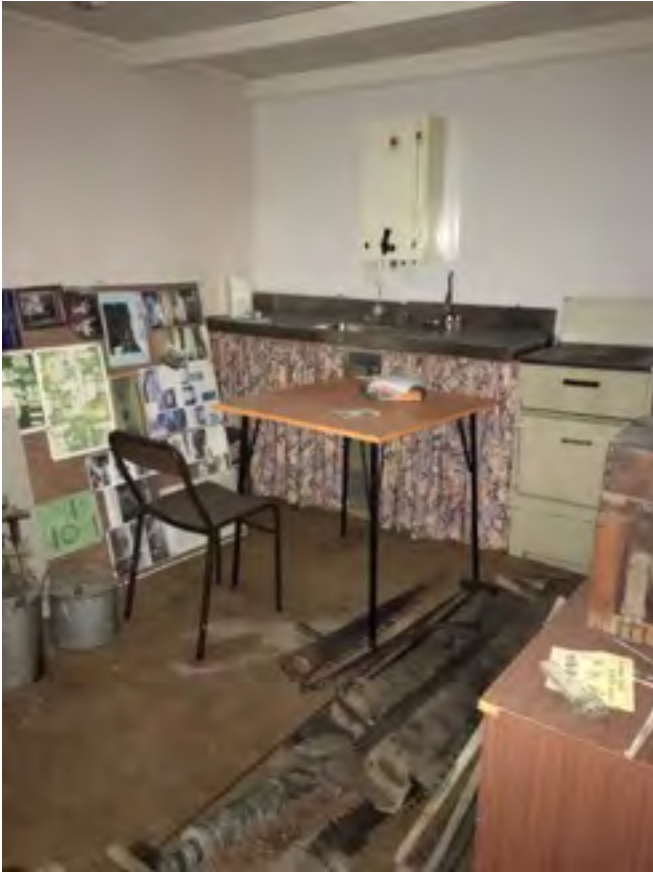
Image: Smoko Room, as surveyed.

Consider whether the redundant signs and other non- collection items stored here need to be retained.

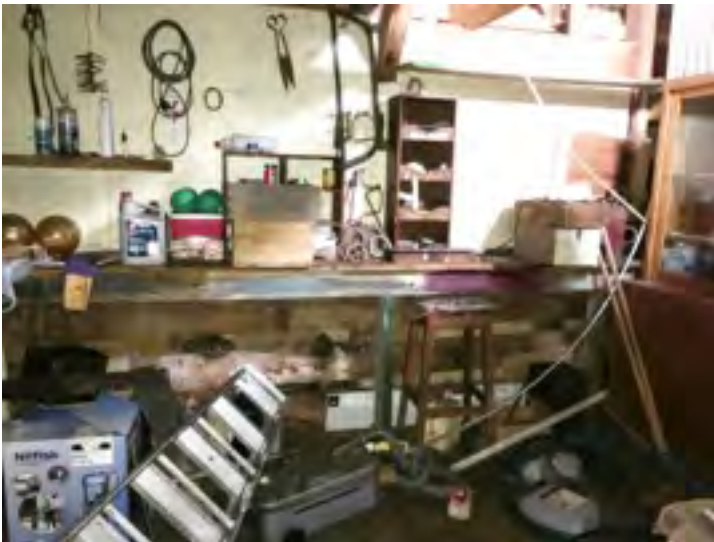
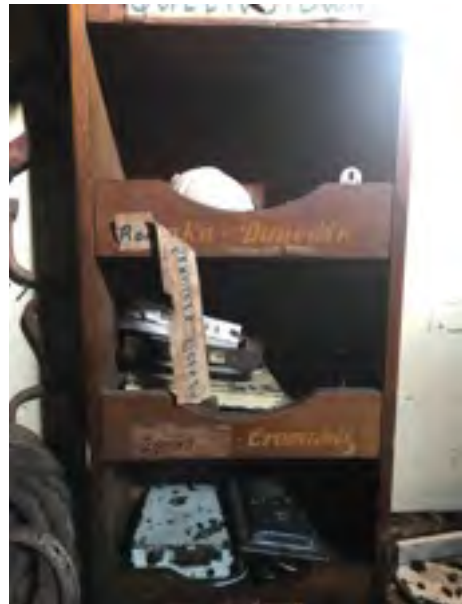
Left: Workshop room, as surveyed. Right: Railways filing box

Box up, or cover collection items to protect them while in storage.

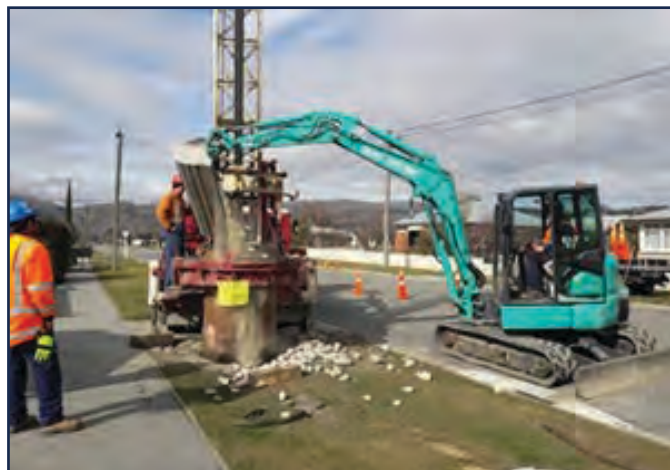
Ventry Street soakpit installation – September 2018
