VALLANCE COTTAGE ALEXANDRA

Conservation Plan

July 2016

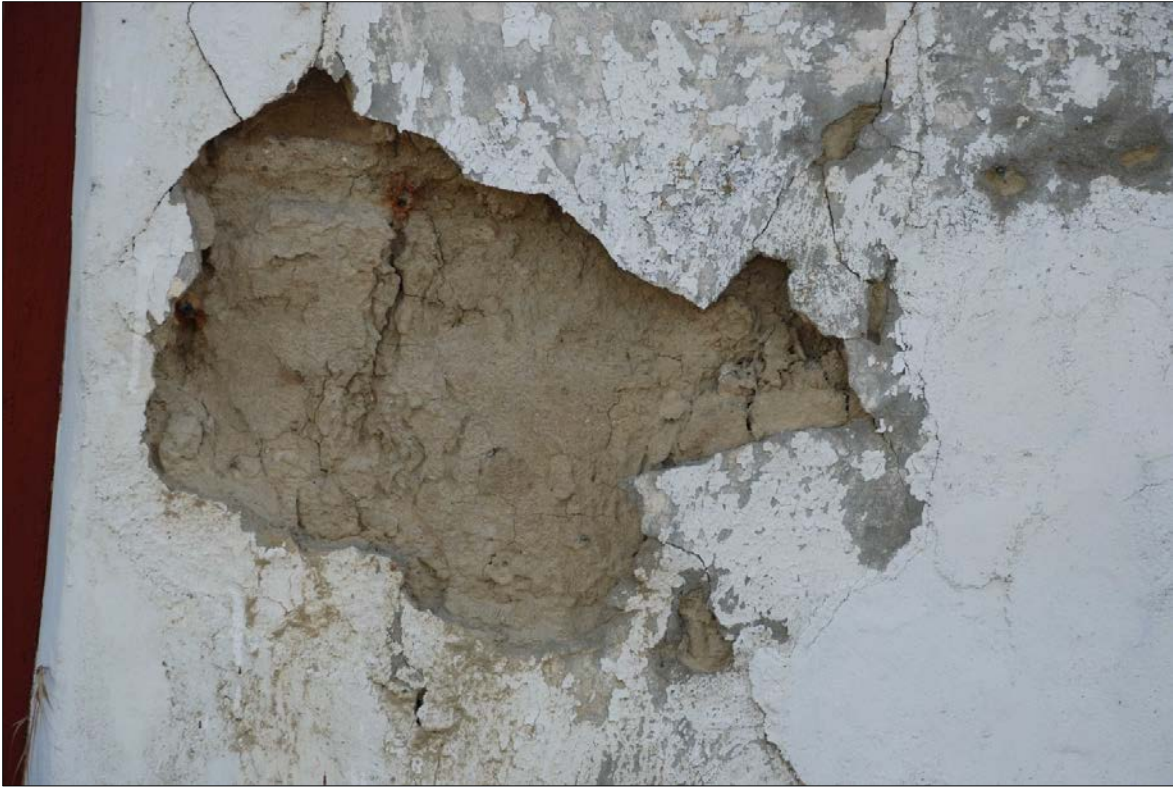
Figure 20: Like Vallance Cottage, the front wall of Peyton's Patch was finished with painted, rough-cast cement render. The side walls however retained their older, smooth render with lime-wash evident beneath the latter paint finish. The photograph shows a section of one side wall where the cracked smooth render had fallen away revealing cob or rammed earth as the principal wall material. *Photograph: Origin Consultants*

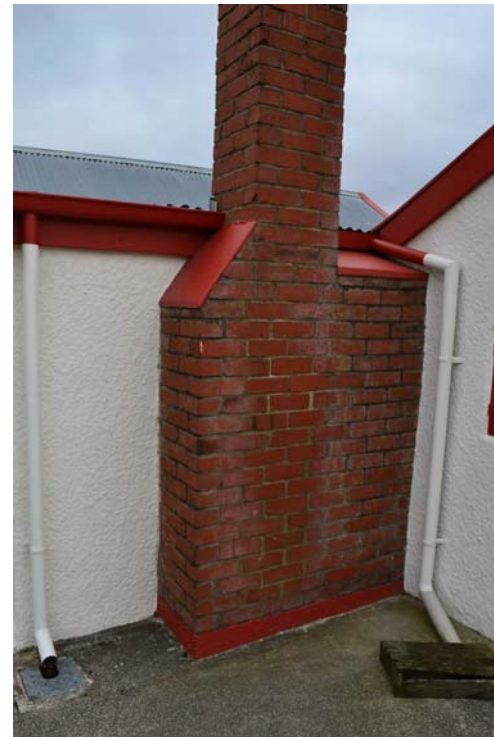
6.
Late 20th Century brick chimney at rear of building cast on a concrete pad with the scullery to the right.

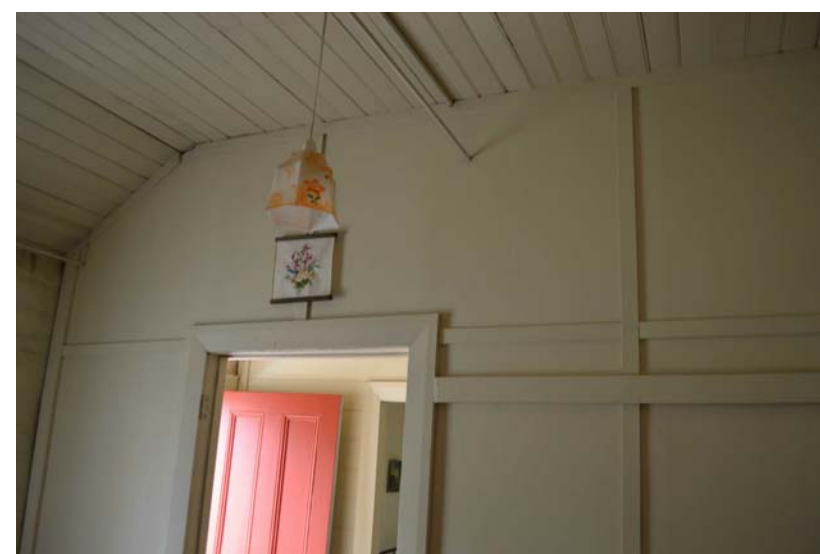
5. Room 2 timber framed internal wall with lining and panelling. Tie rods at high level.

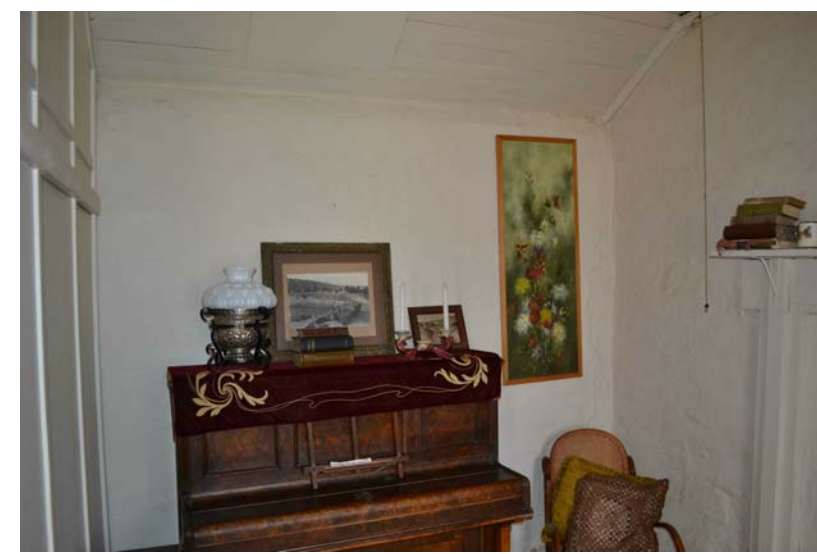
6. Room 2 - view of the rear (south) wall.

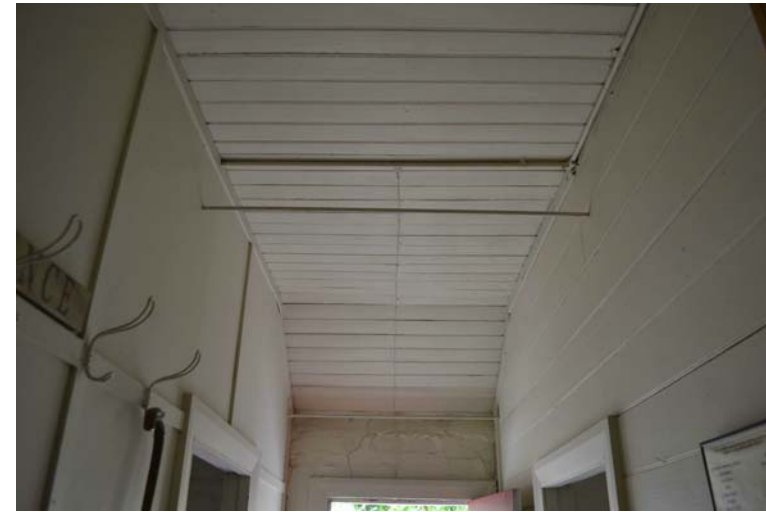
3. Room 5 showing steel tie at high level.

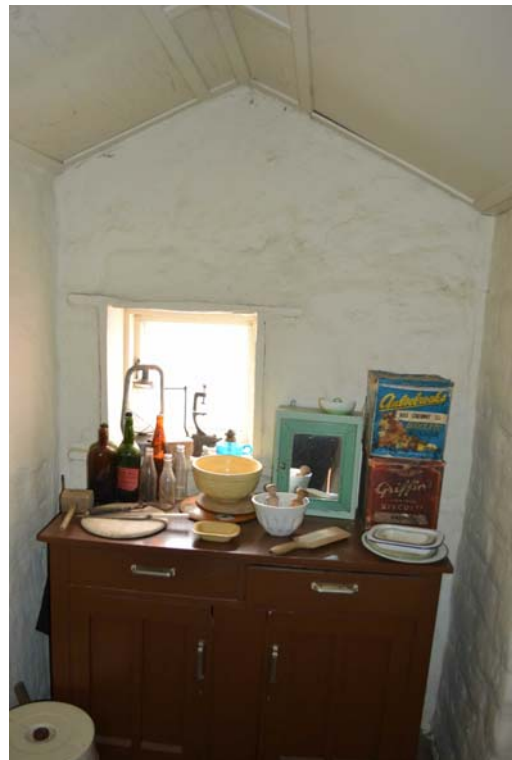
4. Room 6 looking towards the window on the west wall, showing plastered mudbrick wall.

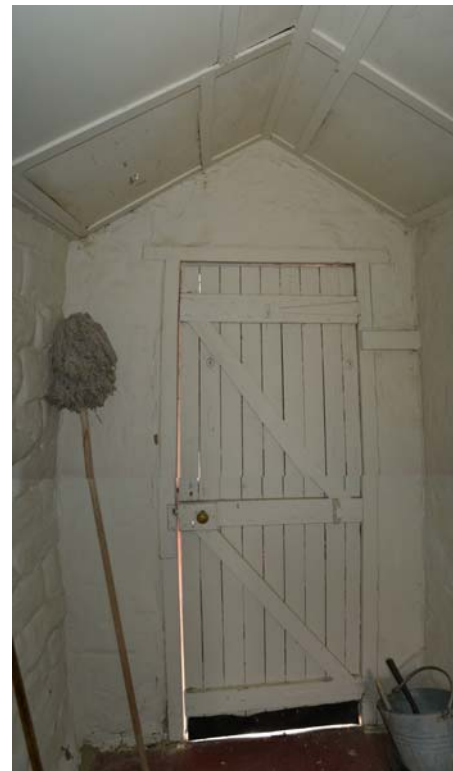
5. Room 6 with cross braced panel door. Note the different wall to the right of the photo.

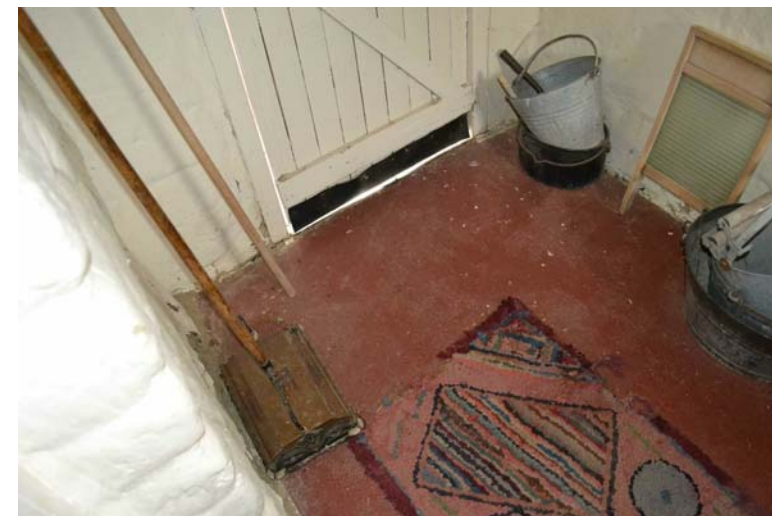
6. Room 6 showing the concrete floor and gaps under at the exterior door.

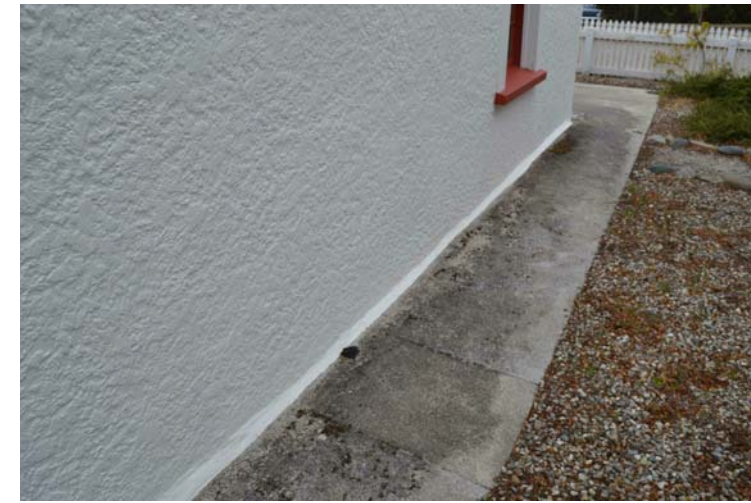
6. Plaster taken right down to ground/path level.
