Review of existing conservation plans for the Clyde Museums Feasibility Study Project

Clyde Railway Station,

Prepared by Robin Miller MNZIBS MRICS

Building: Clyde Railway Station

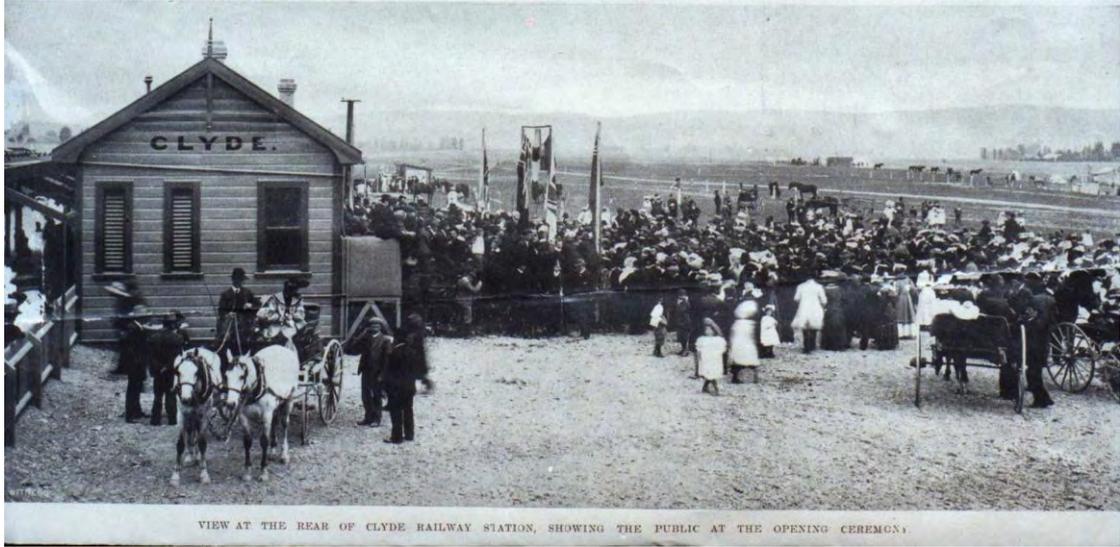
Figure 5 The opening ceremony on 2nd April 1907. Note the rainwater downpipes on the building, the storage water tank at the rear and how low the ground level at this end of the building seems to be compared to the present day.

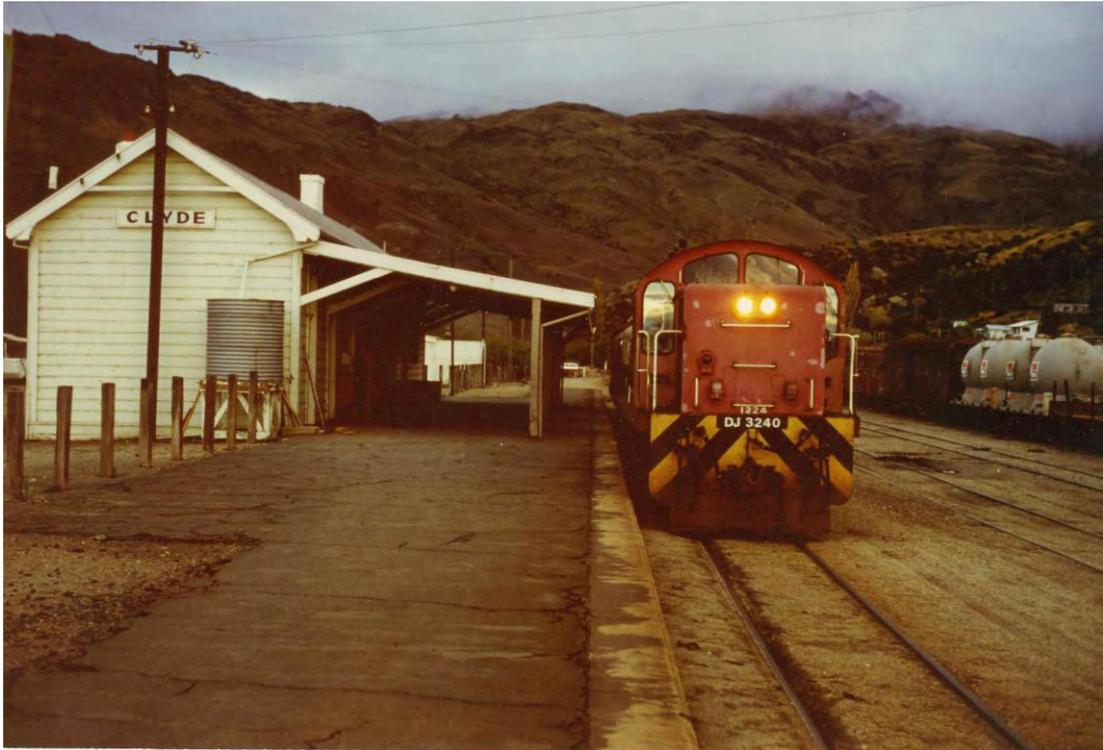
Figure 13 A diesel engine at the station. Note the rainwater fittings on the main building and platform veranda and the water tank against the gable end.

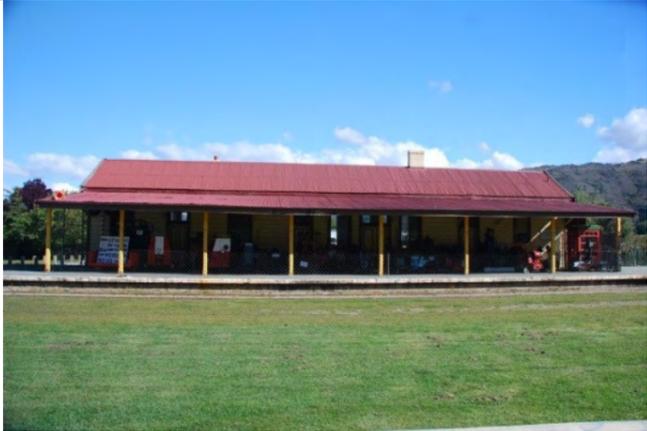
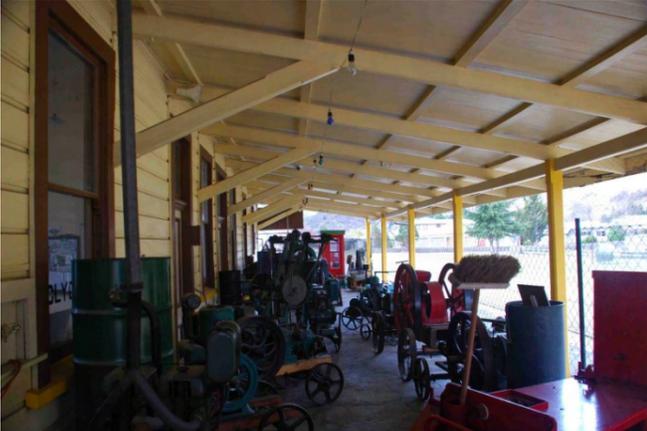
1.0	Exterior			
1.1	North elevation (excluding the platform veranda)

<p>Significance: High</p> <p>The north elevation has altered little since the construction of the building and therefore has high authenticity. The form of the building is original, including the roof, veranda/platform canopy and fenestration of the north wall.</p>	
	<p>Roof coverings and roof level joinery</p> <p>The main north roof slope is clad with short-run corrugated iron with red paint finish and matching ridge capping.</p> <p>A former roof light at the west end of the building has been roofed over.</p> <p>The north eaves are fitted with a painted timber fascia.</p>

<ul style="list-style-type: none"> • The brickwork is in good condition. The durability of the mortar could not be checked above roof level, but mortar joints appear to be in good condition. The stack has previously been painted, although this is not thought to be original. Painting of brickwork with modern masonry paints is generally not recommended. • It should be checked whether the stack has been capped and the flue should be ventilated. No capping was evident from ground level. Old photographs show that the stack originally had at least one chimney pot and consideration should be given to 	<p>B</p>

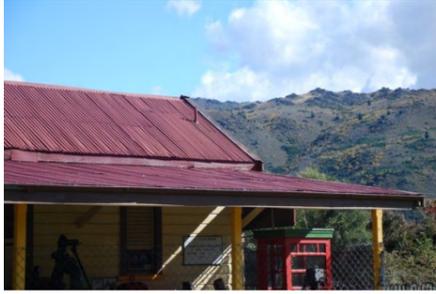
<p>Rainwater fittings</p> <p>There are no rainwater fittings to the main north roof slope. Painted, galvanised steel ogee-pattern gutters are fitted to the veranda/canopy roof. Downpipes are missing and; at the west end of the canopy, a plastic pipe has been fitted to discharge water over the edge of the platform, but this is only a temporary measure.</p>

<p>reinstatement.</p> <ul style="list-style-type: none"> The veranda/canopy roof is slightly shorter than the main roof slopes, which means that, at both ends of the building, there is a small length of roof where water does not flow onto the canopy, but instead discharges down the cladding on the corners of the station building. This is causing timber decay and a short section of traditional guttering needs to be fitted to run the water onto the lower roof. 	<p>A</p>
<p>Walls</p> <p>The north wall of the building is constructed of 4" x 2" timber studs clad with painted, rusticated weatherboards.</p>

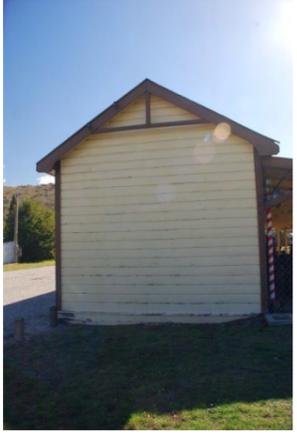
1.2	East elevation		Significance: High

<p>In terms of form and scale, the east gable end remains very similar to when it was built. There have however been a few changes/losses as follows:</p> <ul style="list-style-type: none"> • The finial above the kingpost and name sign have gone, although the collar and kingpost to the gable overhang remain; • An historic photograph (a copy of which is on one of the information panels in the building) shows that a rainwater downpipe from the south gutter originally ran across the gable to discharge into a water barrel, which was positioned adjacent to the north east corner of the building. 			
Roof level joinery	<p>The roof slopes project over the gable end and are finished with bargeboards.</p> <p>The end pair of rafters is joined by a timber collar, which has a vertical kingpost mid-span that aligns with the ridge board.</p>

<ul style="list-style-type: none"> • Within the roof void, the gable framing is in good condition. At the foot of the gable wall the ground level slopes up to cover the baseboard at the north end and at the south end water discharging down the wall from the gutter (downpipe missing) has caused decay in the subfloor structure and weatherboards. Without opening up of the structure, the extent of decay/damage cannot be seen, but the need for repairs to the bearers and joists is anticipated and, possibly, to some of the piles as well. • Decay is also possible in the structure on the north east corner, where there is no gutter and water discharges onto the wall and platform below. • The areas potentially affected by decay and borer should be opened up to establish the extent of the problem. • Save for the decayed areas at low level, the weatherboards are in reasonable condition, although the bottoms of the corner cover boards have warped and deteriorated and should be repaired. • Redecoration of all joinery is required. 	<p>A</p> <p>B</p> <p>B</p>

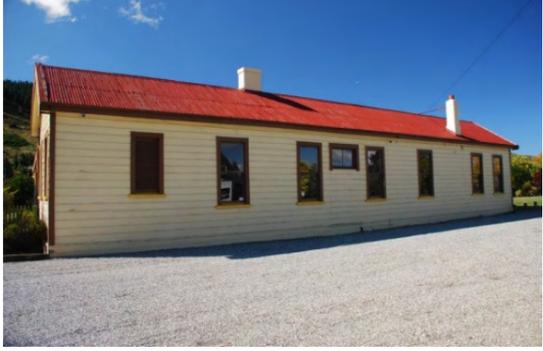
1.3	South elevation		Significance: High

<p>As with the other elevations, the south elevation remains largely authentic, although there have been some small changes, principally the removal and blocking up of the double entrance doors.</p> <p>An old photograph shows that water from the roof used to discharge to a barrel adjacent to the south west corner of the building.</p>

<p>Roof coverings and roof level joinery</p> <p>The main south roof slope is clad with short-run corrugated iron with red paint finish and matching ridge capping.</p> <p>The junction with the lateral chimney stack has been finished with stepped flashings, a back gutter and front apron.</p>

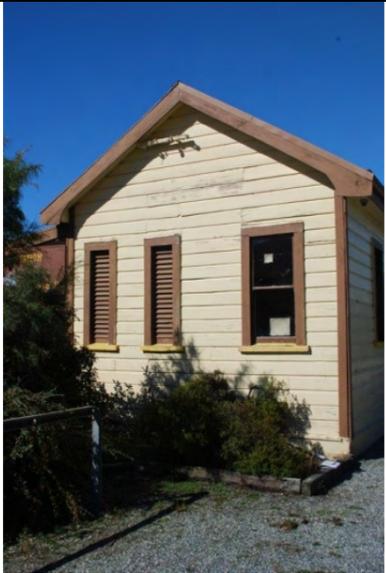
1.4	West Elevation		<p>Significance: High</p> <p>In terms of form and scale, the west gable end remains similar to when it was built. There have however been some changes/losses as follows:</p> <ul style="list-style-type: none"> • The finial, kingpost and collar, together with the station name sign have been lost; • Historic photographs show that a rainwater downpipe from the north gutter originally ran across the gable to discharge into a water barrel positioned adjacent to the south west corner of the building.

<p>Roof coverings and joinery</p> <p>The roof slopes project over the gable end and are finished with bargeboards and coverboards (a metal trim has been fitted over the Southern board).</p> <p>The end pair of rafters has lost its timber collar, kingpost and finial.</p>

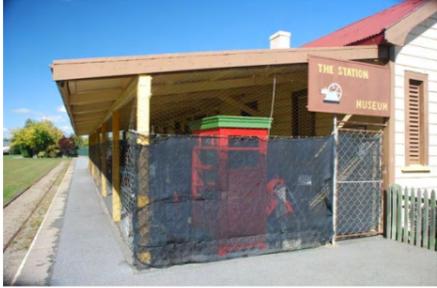
1.5	Platform and canopy		Significance: High

<p>The platform and veranda remain very similar to when they were built. Although there have been some repairs, the veranda retains much of its original framing and has a high degree of authenticity.</p> <p>The present mesh fencing and gate have a negative effect on the heritage values of the building and platform, but they can be readily removed and the need for security for the museum is appreciated.</p>		
Roof coverings and joinery	<p>The shallow-pitched veranda roof is clad with short-run corrugated iron with red paint finish.</p>

<ul style="list-style-type: none"> • Generally the roof covering is in good condition. At the time of maintenance to the main North slope, the opportunity should be taken to overhaul the Veranda covering replacing loose/missing nails and undertaking redecorations. • Decayed sections of the fascia board require renewal. • There are loose nails to the metal trim over the ends of the roof. 	<p>B/C</p> <p>B</p> <p>B</p>

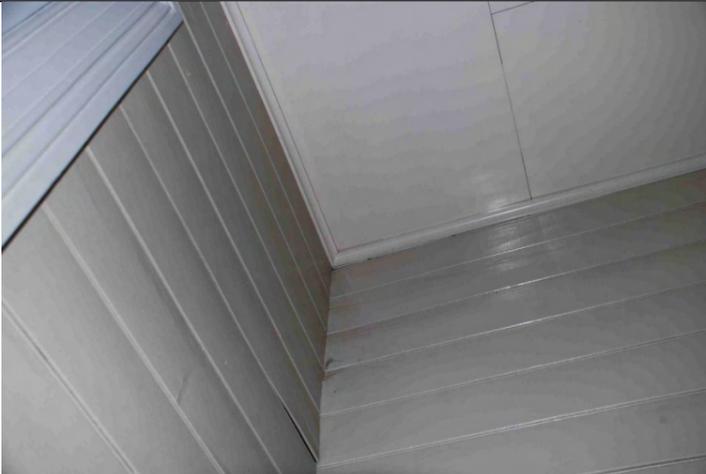
<ul style="list-style-type: none"> The modern ceiling finish is in good condition. The upper face of the original lining is visible in the roof space. Generally, it appears to be in good condition, although fixing of the modern lining to the underside will no doubt have caused some disturbance to the latter face. A small area of charring/fire damage was apparent to the upper surface in the roof void. Further damage to the ceiling and walls, etc may be revealed if the modern linings are removed.

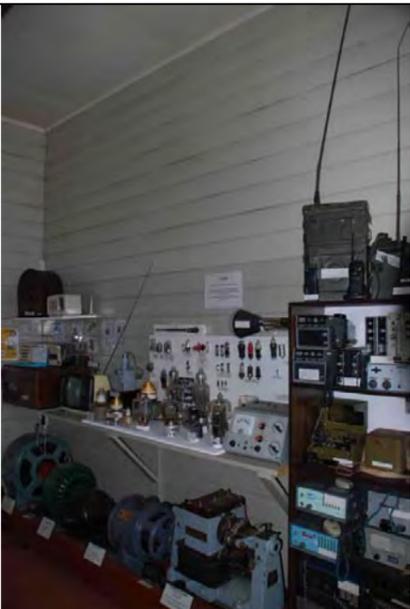
<ul style="list-style-type: none"> Horizontal sarking boards were found to be in good condition, where visible. The reason for the modern lining to the west wall is unknown, but it may relate to concealment of fire damage (see above).

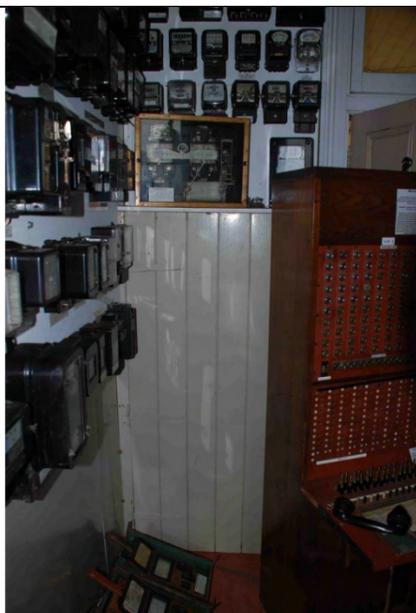
<ul style="list-style-type: none"> Good condition

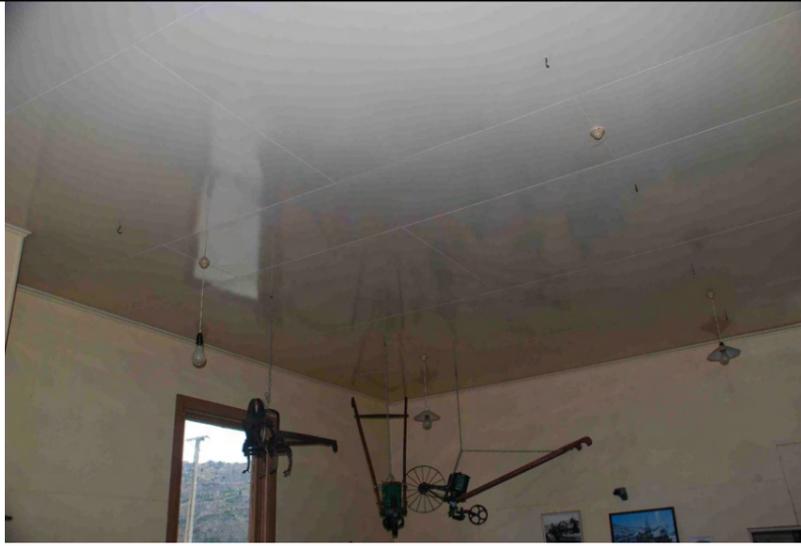
<ul style="list-style-type: none"> • The modern ceiling finish is in good condition. • The upper face of the original lining is visible in the roof space. Generally, it appears to be in good condition, although fixing of the modern lining to the underside will no doubt have caused some disturbance to the latter face. Removal may reveal fire damage to the east end of the room in particular. 	
	<p>Walls</p> <p>Timber-framing finished internally with a painted, modern lining board. It appears that original tongue and groove sarking boards remain behind. Modern linings are considered to have a negative effect on the room.</p> <p>Inspection was restricted by exhibits/displays and modern lining boards fixed to the walls.</p> <p>A missing area of internal tongue and groove linings above the opening in the west wall seem to indicate the earlier position of the electrical meter/fuse board.</p>

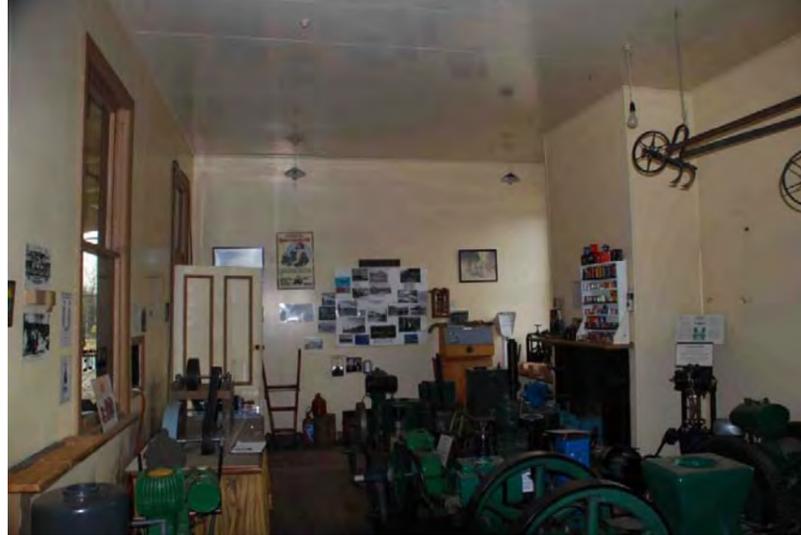
<ul style="list-style-type: none"> • Modern linings were found to be in good condition generally. In places, the original match-lining could be seen behind. Fixing of the modern lining to the inner face will no doubt have caused some disturbance. Removal may reveal fire damage to the east end of the room in particular. • The internal wall at the west end of the room has been opened up to allow easy circulation between the main station rooms. This is the area where the construction plans show the parcels office/counter was. Evidently there was no opening here originally. • The ticket window has been covered over by the modern linings. Shelving or other units shown on plans as having been located along the east internal wall, no longer remain.

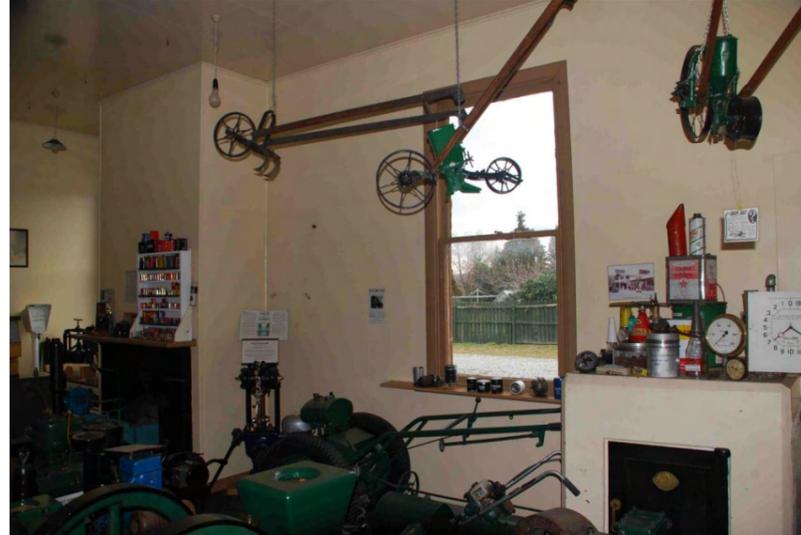
<ul style="list-style-type: none"> • Windows and doors are generally in good condition. See section 1.1 regarding the external condition of the windows.

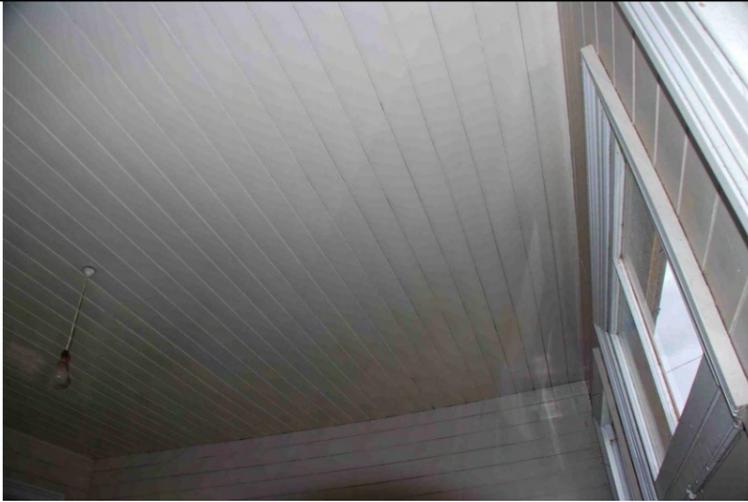
<ul style="list-style-type: none"> The ceiling is in good condition. 	
	<p>Walls</p> <p>Timber-framing with tongue and groove sarking boards internally, laid horizontally and painted.</p> <p>The east wall contains the original ticket window.</p> <p>The former entrance in the south wall has been boarded over.</p> <p>In addition to a new opening into the office on the east, a similar opening has been formed in the west wall between the fireplace and north wall.</p>

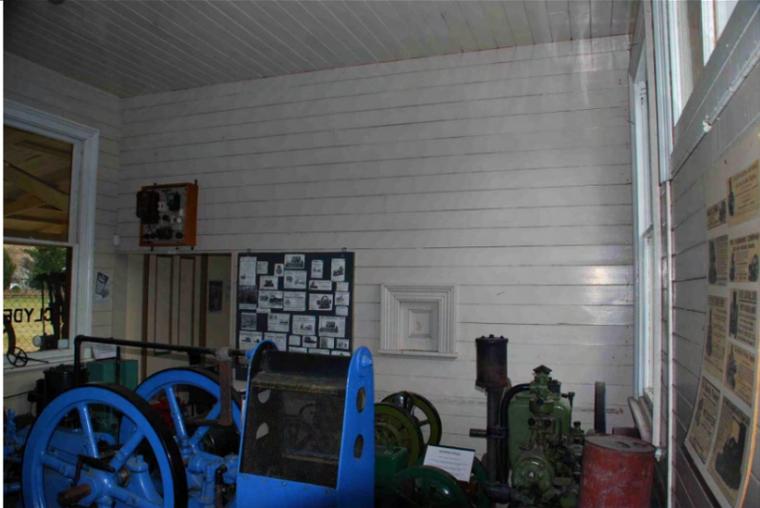
<ul style="list-style-type: none"> The walls are generally in good condition.

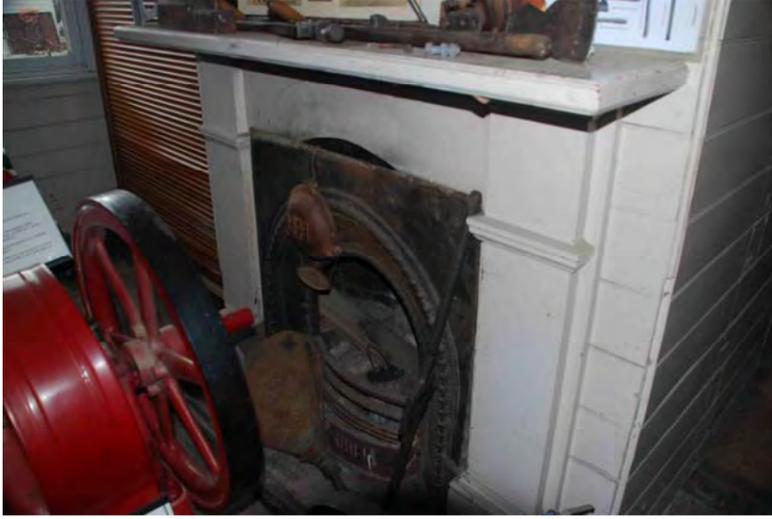
<ul style="list-style-type: none"> Generally remaining features are in good condition. The condition of chimney flues here and in other rooms is not known.

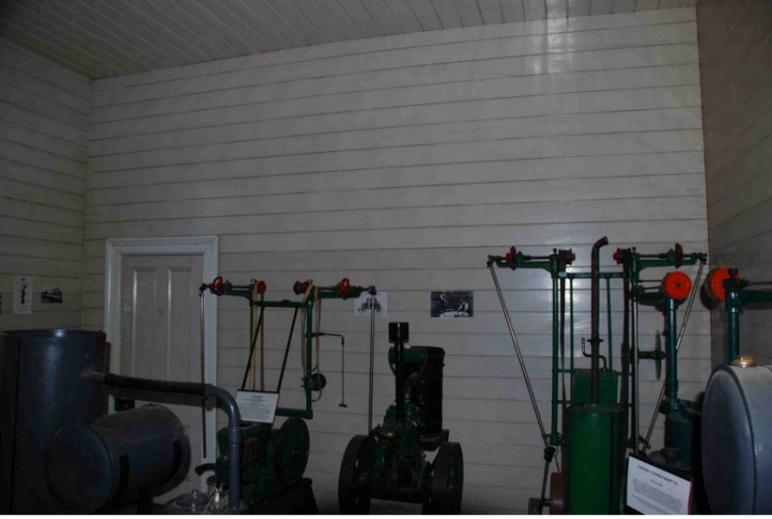
<p>2.4</p>	<p>Ladies' waiting room</p>			
	<p>Ceiling</p> <p>Original timber matchlining of painted tongue and groove boarding remains.</p>

<ul style="list-style-type: none"> The ceiling is in good condition.

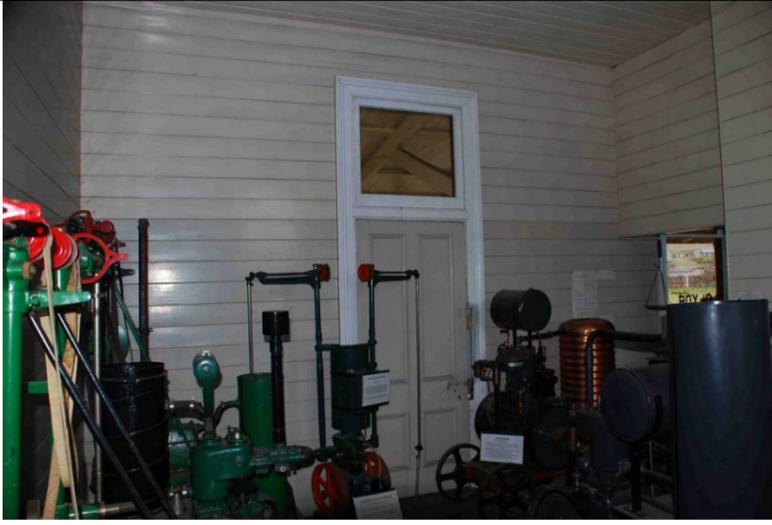
<ul style="list-style-type: none"> The walls are generally in good condition. 	
<p>Windows & doors</p> <p>The room has a south-facing sash window, comprising two large panes of glass.</p> <p>The north wall has a four-panel painted, timber door leading onto the platform with a fanlight over.</p>

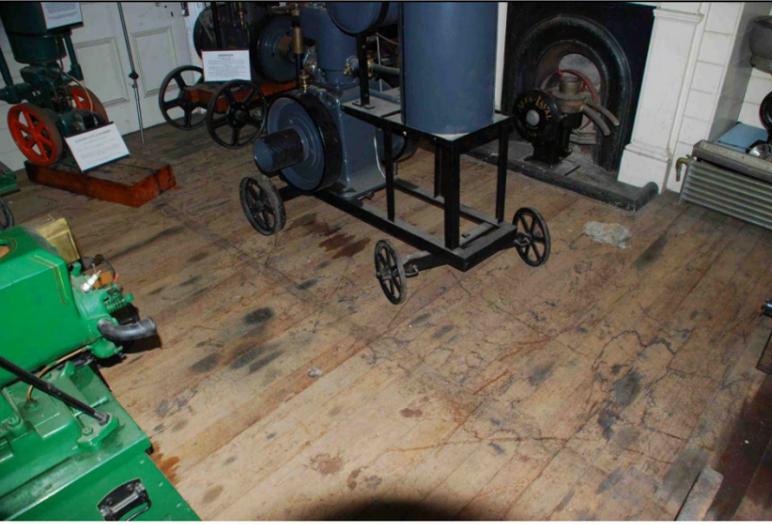
<ul style="list-style-type: none"> The floor is reasonably level and is generally in good condition.

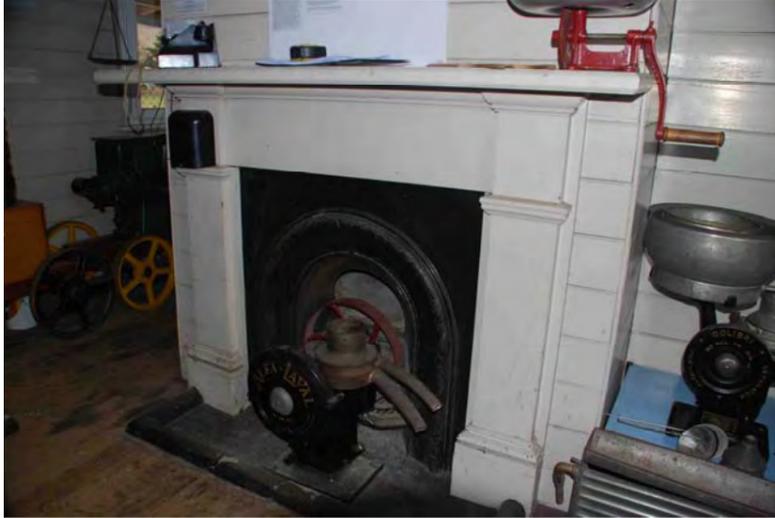
<ul style="list-style-type: none"> • Generally in good condition but the safety/adequacy of the chimney flue is not known.

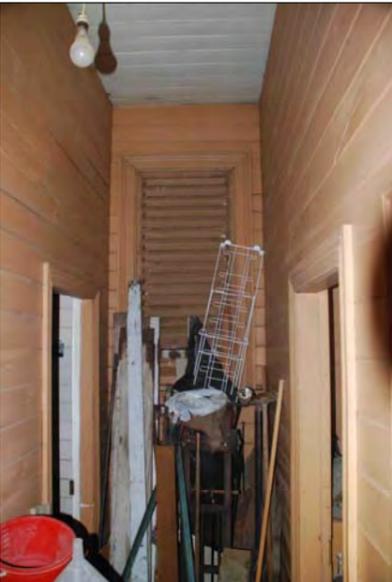
<ul style="list-style-type: none"> • The walls are generally in good condition.

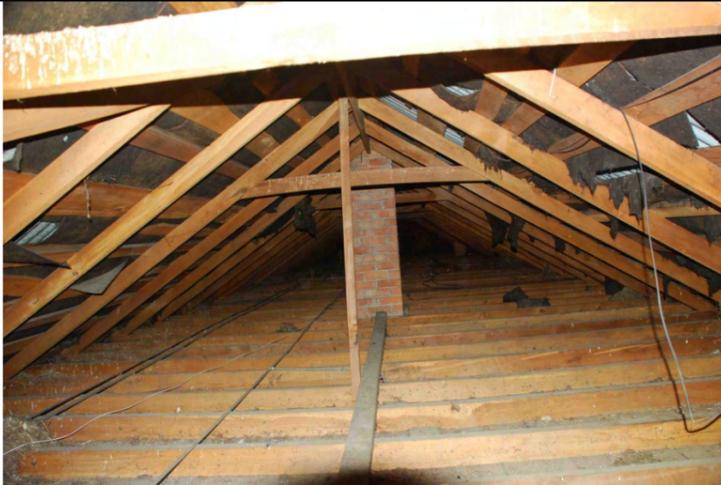
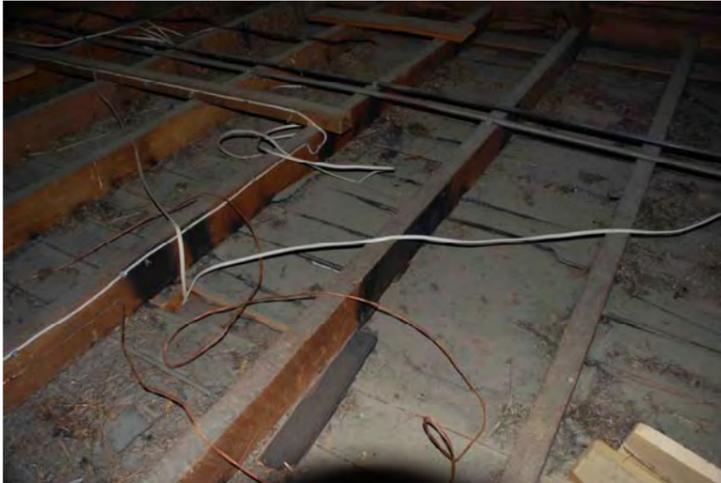
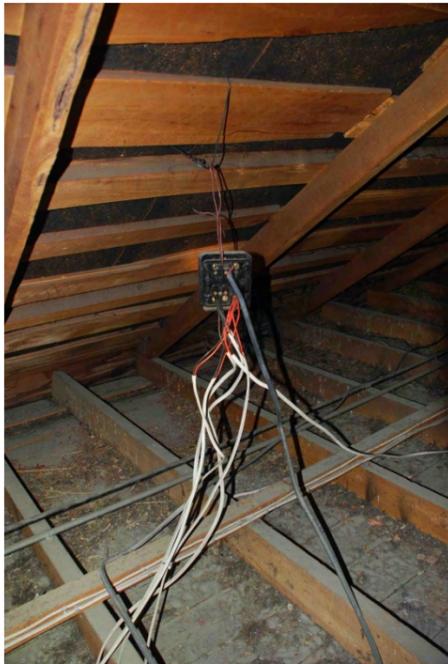
<ul data-bbox="1668 184 2546 1096" style="list-style-type: none"> • Generally the roof frame was found to be in good condition with no signs of significant distortion/distress or timber decay/borer infestation. There is scope for additional bracing/strengthening to the frame, but this is not considered an urgent requirement at the present time. • The roofing felt is heavily decayed in places and missing in some others. It will require renewal during future re-roofing works. • The underside of the corrugated roofing sheets was visible in places and was found to be in good condition with no sign of significant or widespread corrosion. • The roof void contains many birds' nests, which are a potential fire hazard and which should be removed after nesting season. • The roof void is un-insulated. • Whilst there were no signs of significant water ingress through the roof coverings at the time of inspection, water staining was evident to the west gable weatherboards and framing; there are gaps and daylight showing through here. Some staining was also noted on the rear face of the fascia boards, which is likely to be due to water blowing back under the eaves or the rainwater gutters backing up and overflowing. These are maintenance issues that need to be checked. • There are electrical cables and associated fitting in the roof void, although it is understood that main electricity is not connected to the building – a generator is used instead. Some of the cabling is old and the wiring is suspect. It is recommended that an inspection and test is carried out by a qualified electrician and any recommended rewiring or improvements carried out. • The lower photograph shows charring to some of the ceiling joists and timber boards as a result of the 1960s fire at this end of the building. 	<p data-bbox="2570 331 2617 357">C+</p> <p data-bbox="2570 487 2599 512">B</p> <p data-bbox="2570 642 2599 667">A</p> <p data-bbox="2570 823 2599 848">A</p>

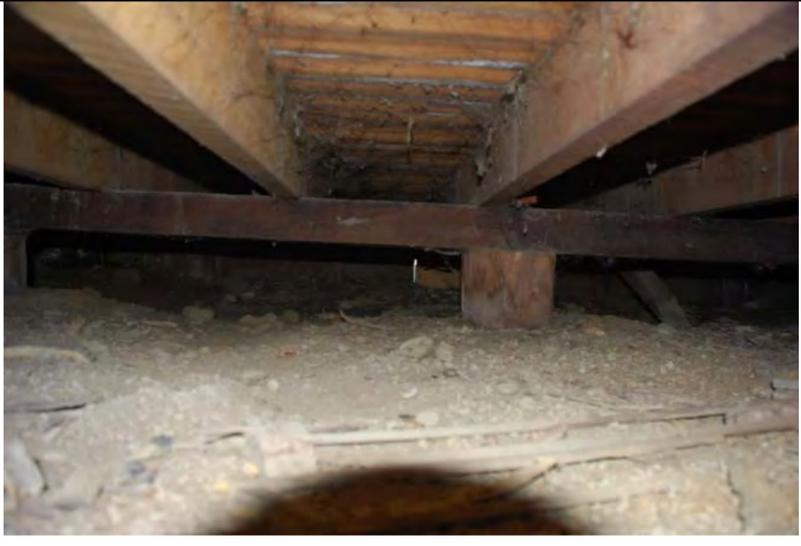
2.7	Subfloor void

<ul style="list-style-type: none">• The void is relatively shallow, but the visible area in the vicinity of the manhole in the Entrance was found to be dry.• No signs of decay or borer were noted in the vicinity of the manhole.	
-----	---------------	--	--	--

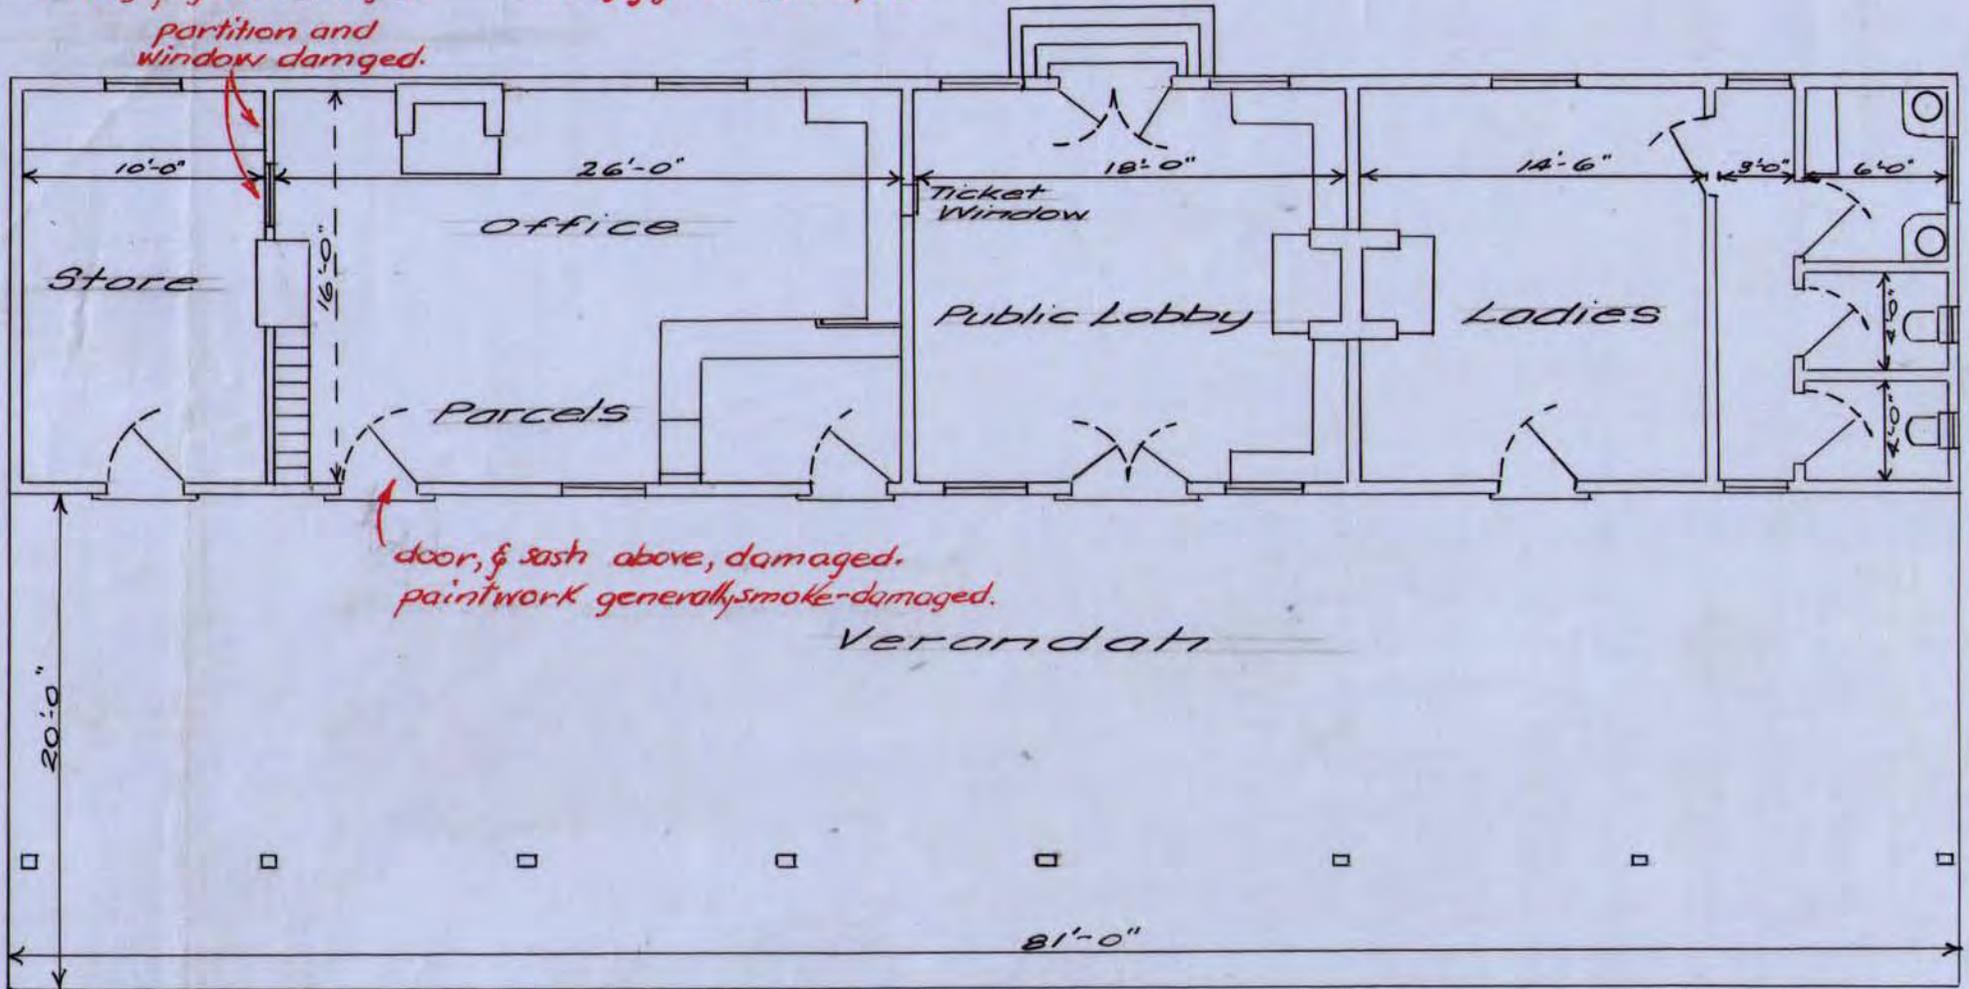
PROJECT: CLYDE-Station Building
 DRAWN BY: Fire Damage Suffered
 DATE: on 28-8-66

Store.
 floor damaged.
 ceiling & joists damaged.

Office.
 floor damaged.
 ceiling & joists damaged.

partition and
 window damaged.
