VALLANCE COTTAGE ALEXANDRA

Conservation Plan

July 2016

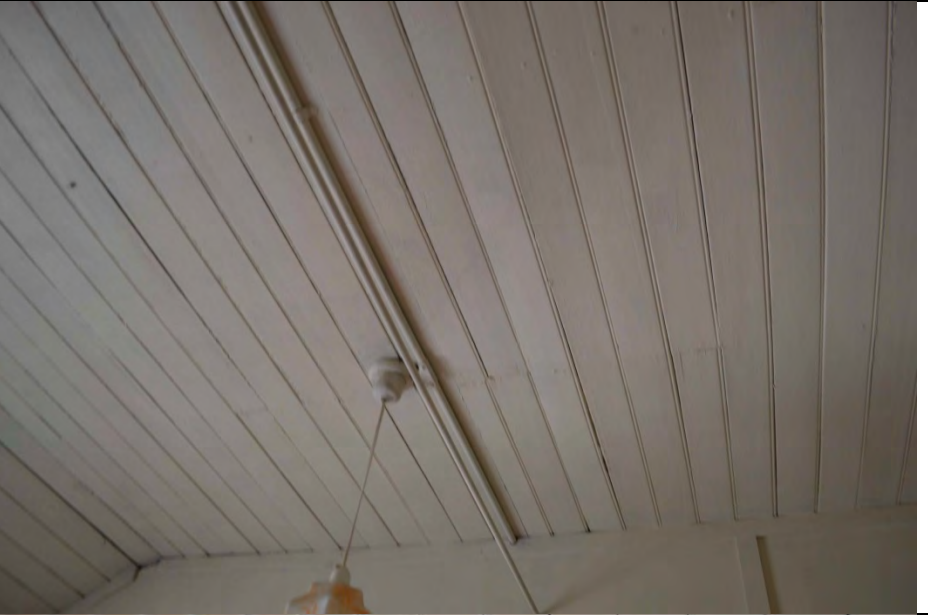
2.0	Interior			
2.1	<p>Ceilings Ceilings in the main rooms are clad with painted tongue and groove timber boards. There are some remaining sections of scotia mouldings to the perimeter of ceilings. The boards in room 3 are stained. The scullery has a painted board and batten skillion ceiling. <u>Heritage significance:</u> T&G ceilings – high Board & batten ceiling - low</p>	<ul style="list-style-type: none"> • The main t&g ceilings are in good condition for their age. They are affected by some borer attack and there are localised areas where the boards are sagging or have bulges or open joints, but these do not appear to be a serious issue. Decorations are fair. • The board and batten ceiling in the scullery is stained beneath the roof valley gutter indicating the gutter overflows or leaks. The stained area was however dry at the time of inspection.

<p>General maintenance required on a 5 yearly basis.</p>

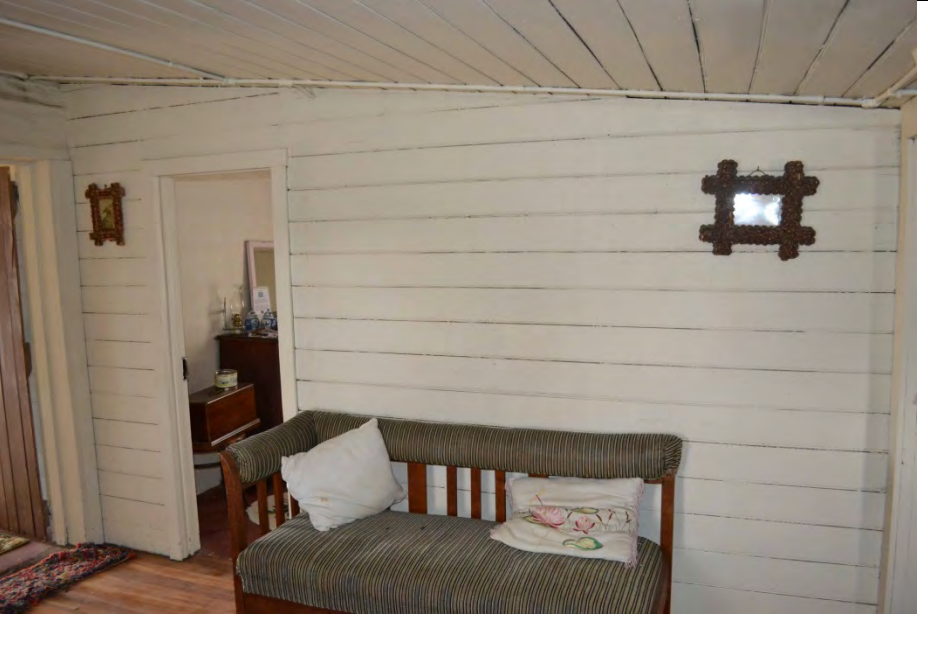
2.2	<p>Internal partition walls There are three internal partition walls as follows:</p> <ul style="list-style-type: none"> • A timber walls dividing the hall (room 5) from the front bedroom (room 1). This is lined on the east side with painted ply and boarded joints and painted, horizontal t&g timber boards on the west face; • A timber wall between the hall (room 5) and living room (room 2) lined both sides with ply and boarded joints; and • A timber wall between the bedroom (room 3) and kitchen (room 4) lined on the east side with painted ply and on the west with painted, horizontal t&g timber boards. <p><u>Heritage significance:</u> Framing – unknown but assumed medium/high Timber t&g boards - high Ply sheet and battens - low</p>	<ul style="list-style-type: none"> • As with the ceilings the partition linings are in good condition for their age. • 1994-96 photographs indicate that the concrete floors have been laid in individual rooms with the partitions in place. This raises the possibility that unless the bottoms of the partitions were lined with a damp-proof membrane, they will be acting as a wick for any moisture in the ground beneath the cottage in a similar manner to the earth walls. If so, they will be at risk of decay and borer infestation.

<p>General maintenance required on a 5 yearly basis.</p>

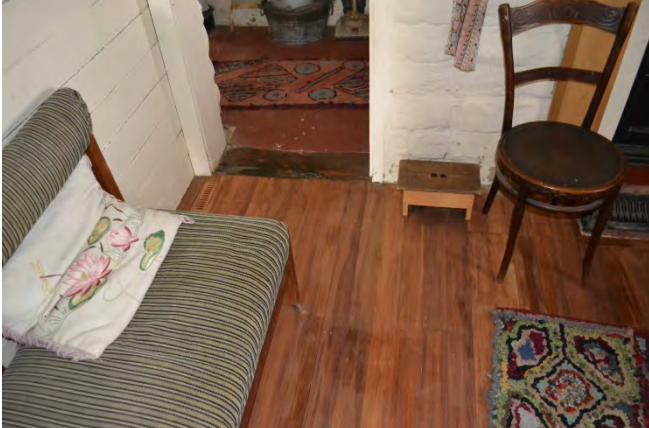
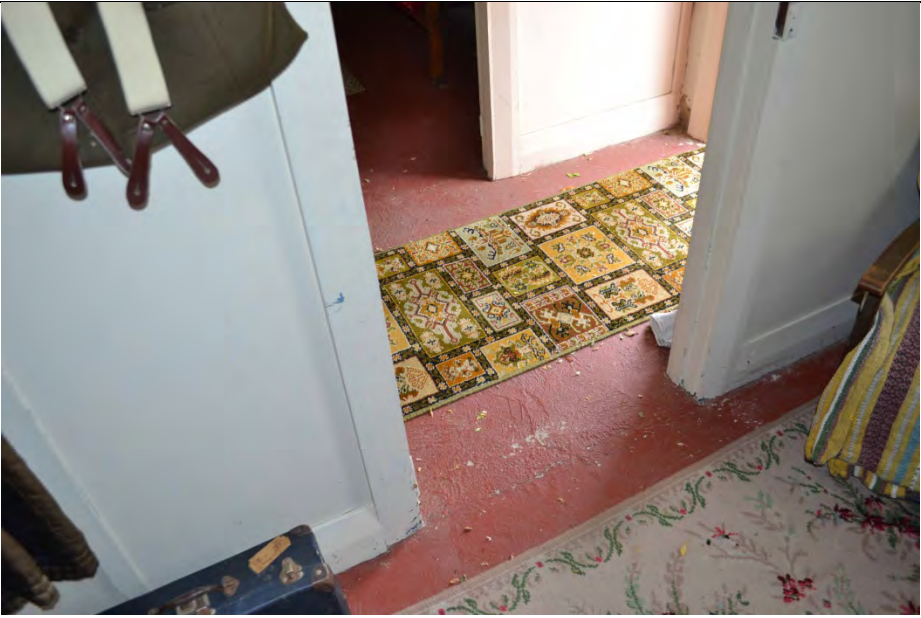
<p>2.3</p>	<p>Floors The floors in the cottage are all believed to date from the mid-1990s repairs when the decayed timber floors were taken up and new concrete floors finished with masonry paint were laid in 5 of the rooms. The floor in the kitchen was replaced with sanded and varnished t&g timber flooring. <u>Heritage significance:</u> Floors – low</p>	<ul style="list-style-type: none"> • The floors themselves are in good condition, where visible. Reference has been made above to the effect of the concrete floors on the earth and timber walls. • Ventilation grilles have been provided to the timber floor. The condition of subfloor timbers could not be seen.

<p>General maintenance required on a 5 yearly basis.</p>
<p>2.4</p>	<p>Internal joinery Internal joinery is limited to:</p> <ul style="list-style-type: none"> • a braced and ledged painted timber plank door between the hall and living room; • Skirtings to internal partitions; • The mantle pieces; • Shelving in the scullery. 	<ul style="list-style-type: none"> • Generally good condition

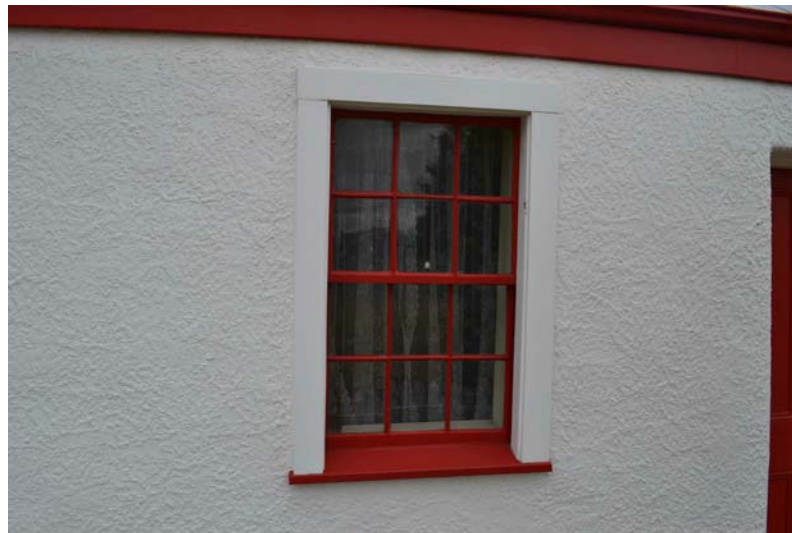
5.
Window W1 (left of the front door) - 6 over 6 sliding sash
